## ARGO Incident

Marine Safety Unit Toledo, OH  
U.S. Coast Guard Sector Detroit, MI  
Ohio Environmental Protection Agency

- ARGO Background: Built 1911, sunk in 1937 (78 yrs ago), 120ft x 35ft x 12ft with 4 to 5ft visible above mudline, lays in 50ft of water
  - Carrying approx 200,000 gal of product
  - Thought to be in Canadian waters off Pelee Island, discovered in U.S. waters 9 mi east of Kelly's Island
  - Subject of NOAA RULET in 2013

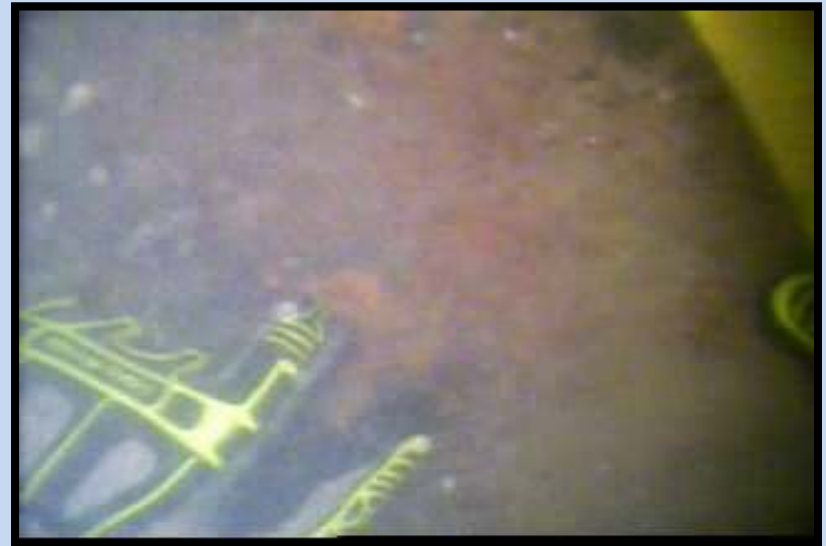
Penetration in Tank Top

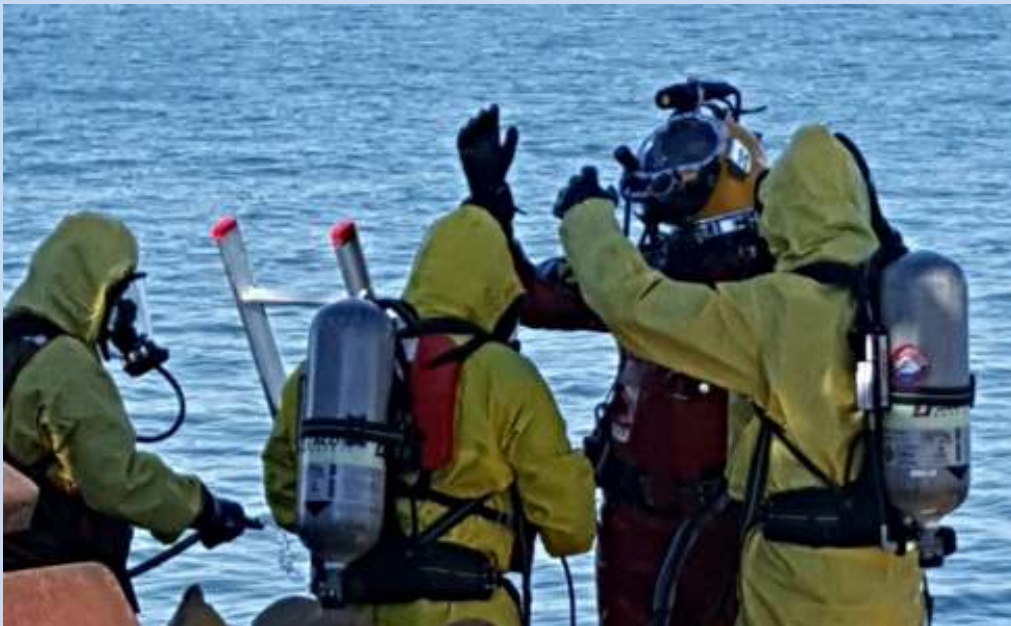
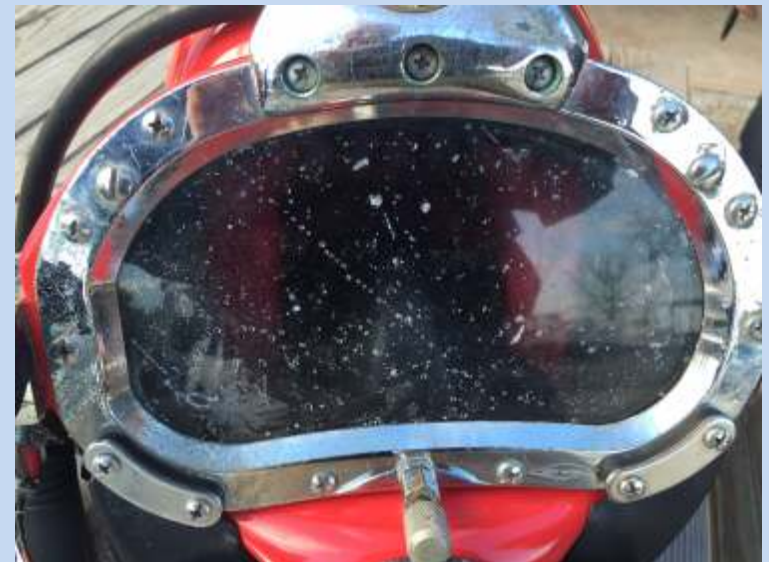
- During preparation of the Argo for cargo offload a rivet popped free and product was released.
- Released product damaged the diver's mask and suit.

- Following the release, a new dive suit was used to prevent injury
  - Positive pressure suit to repel product if suit was punctured
  - Upgraded dive helmet
