## **Chicory Plant Location**

1125 12<sup>th</sup> Ave Port Huron, MI

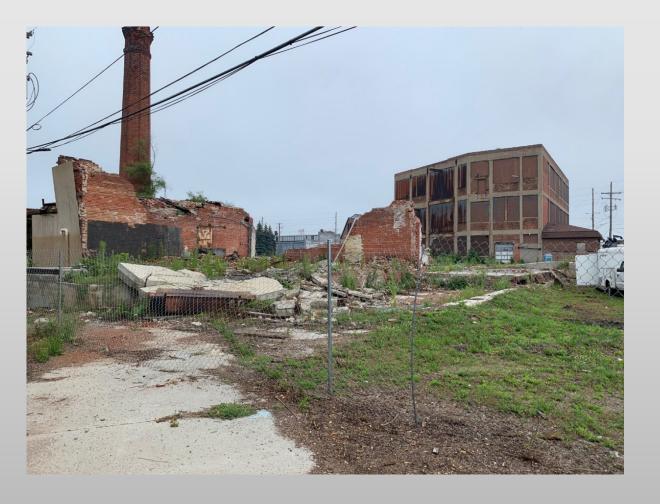
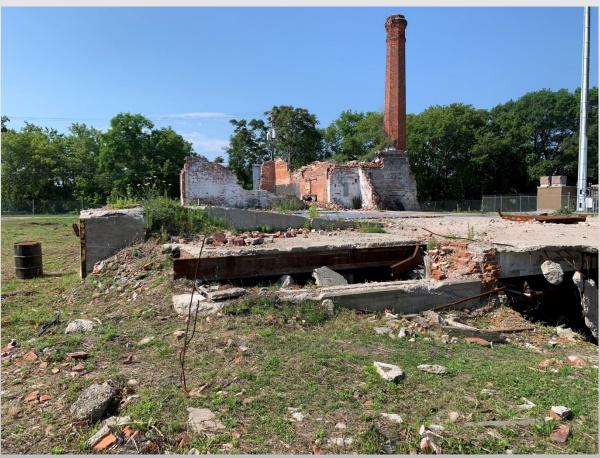
## Site View

- Building demolished during fire
- Basement below concrete slab in view

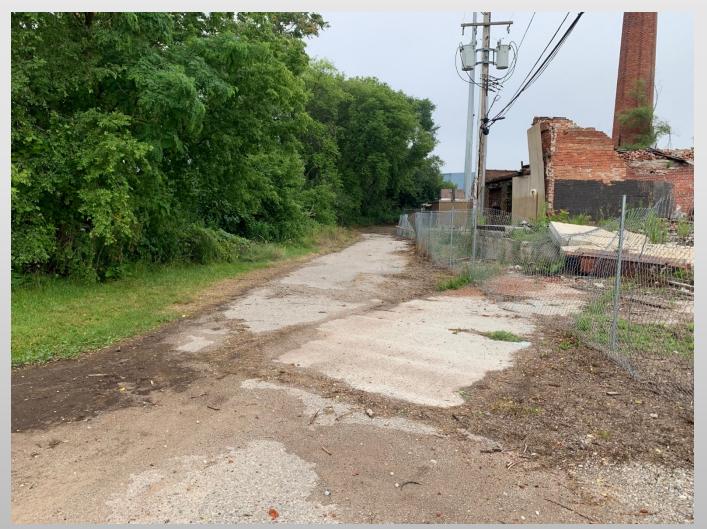
## **Utility Easement**

- Utilities include 24" high pressure sewer line and other potential underground utilities
- Right of way for cell phone tower in back ground

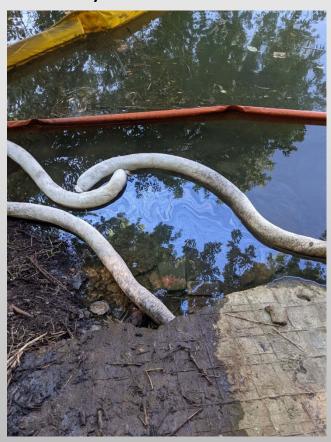
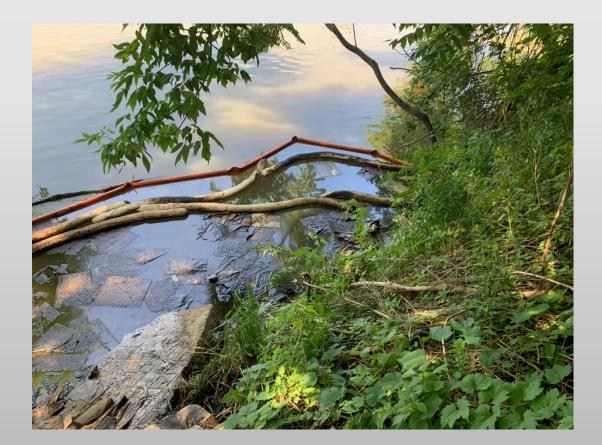
### Black River Embankment

- River bank is steeper than the pictures indicate (approx. 35 degree slope)
- 6" (approx.) clay pipe from basement located under riprap/rocks in right picture
- Significant soil contamination suspected in embankment area and soil in vicinity of basement foundation

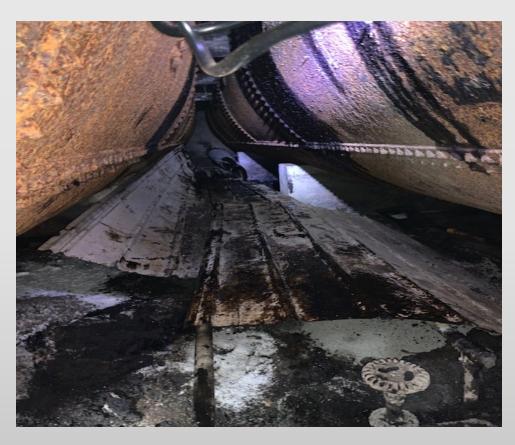
Tank 3 & 4 contents during removal operations
