# Enbridge Oil Spill

# Source Area

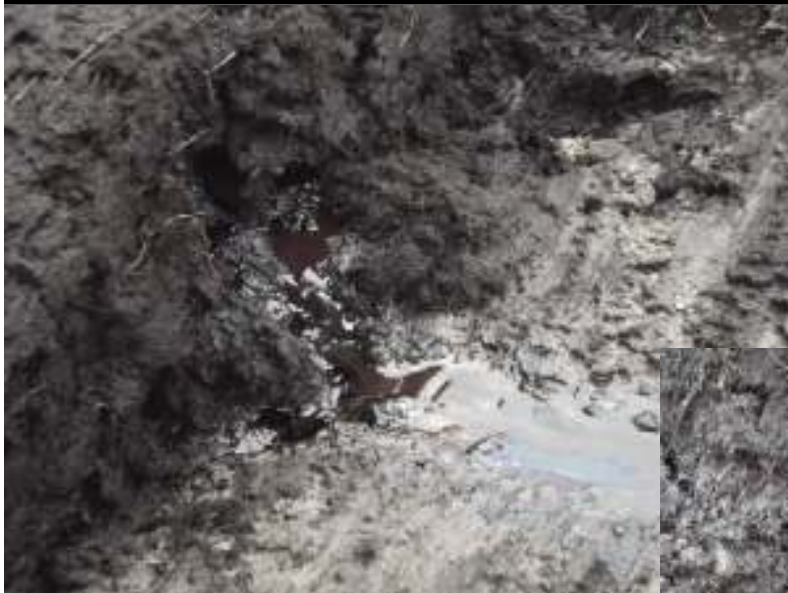
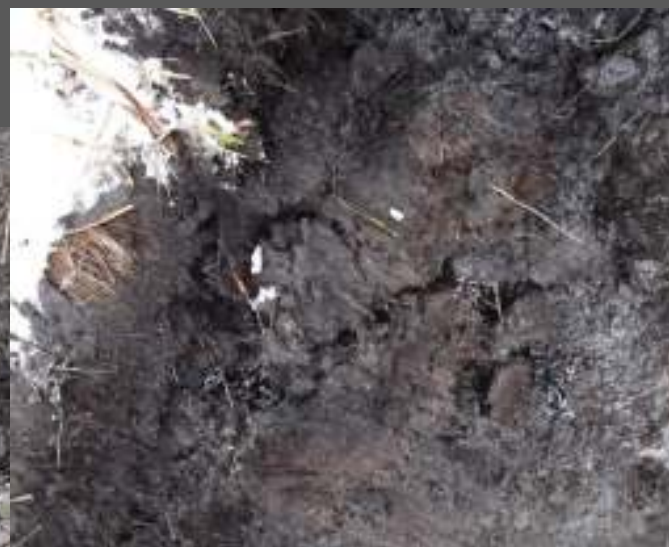
## Impacts Observed During 2011-2012 Remedial Action

Oil accumulated in pockets in the overbanks and presented as seeps during excavation

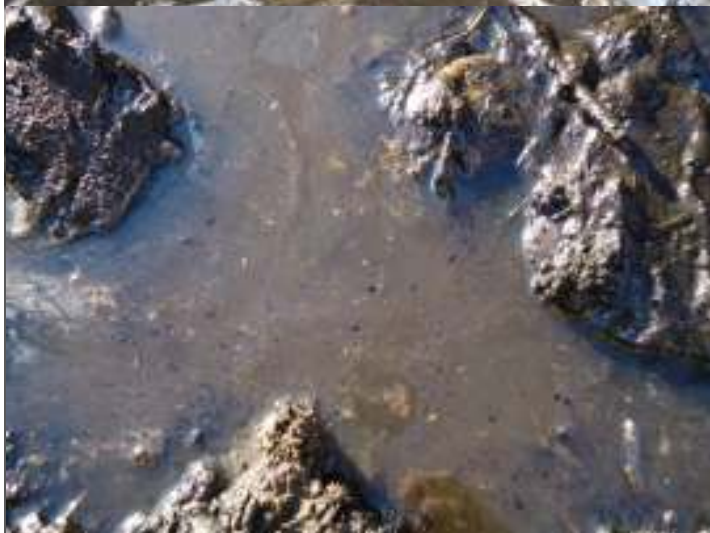
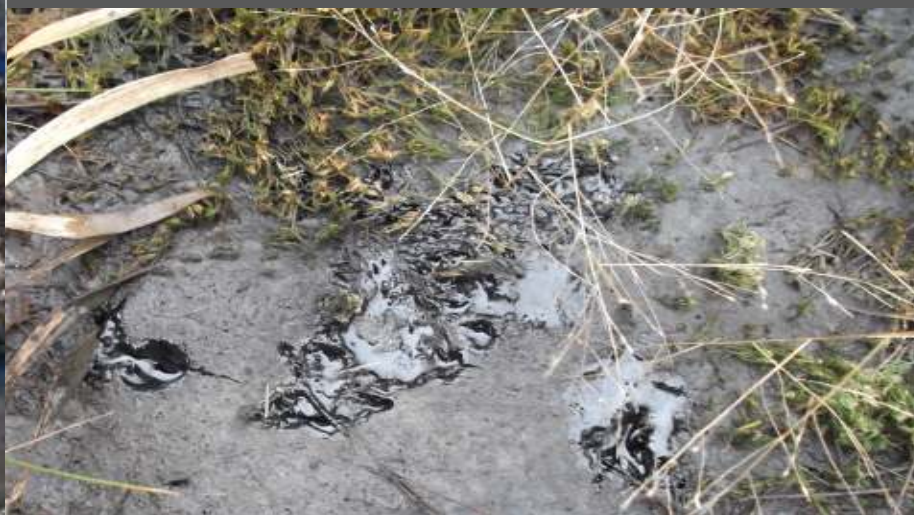
## Talmadge Creek 2011 Remedial Action

During the scraping process oil would seep from the floor of excavations as visible in these photos.
