# Browns, IL Train Derailment

| <b>Name of Incident</b> | <b>Browns Train Derailment</b> |
| <b>Date</b> | <b>July 18, 2025</b> |
| <b>Cause of Spill</b> | <b>Derailment caused by two trains colliding</b> |

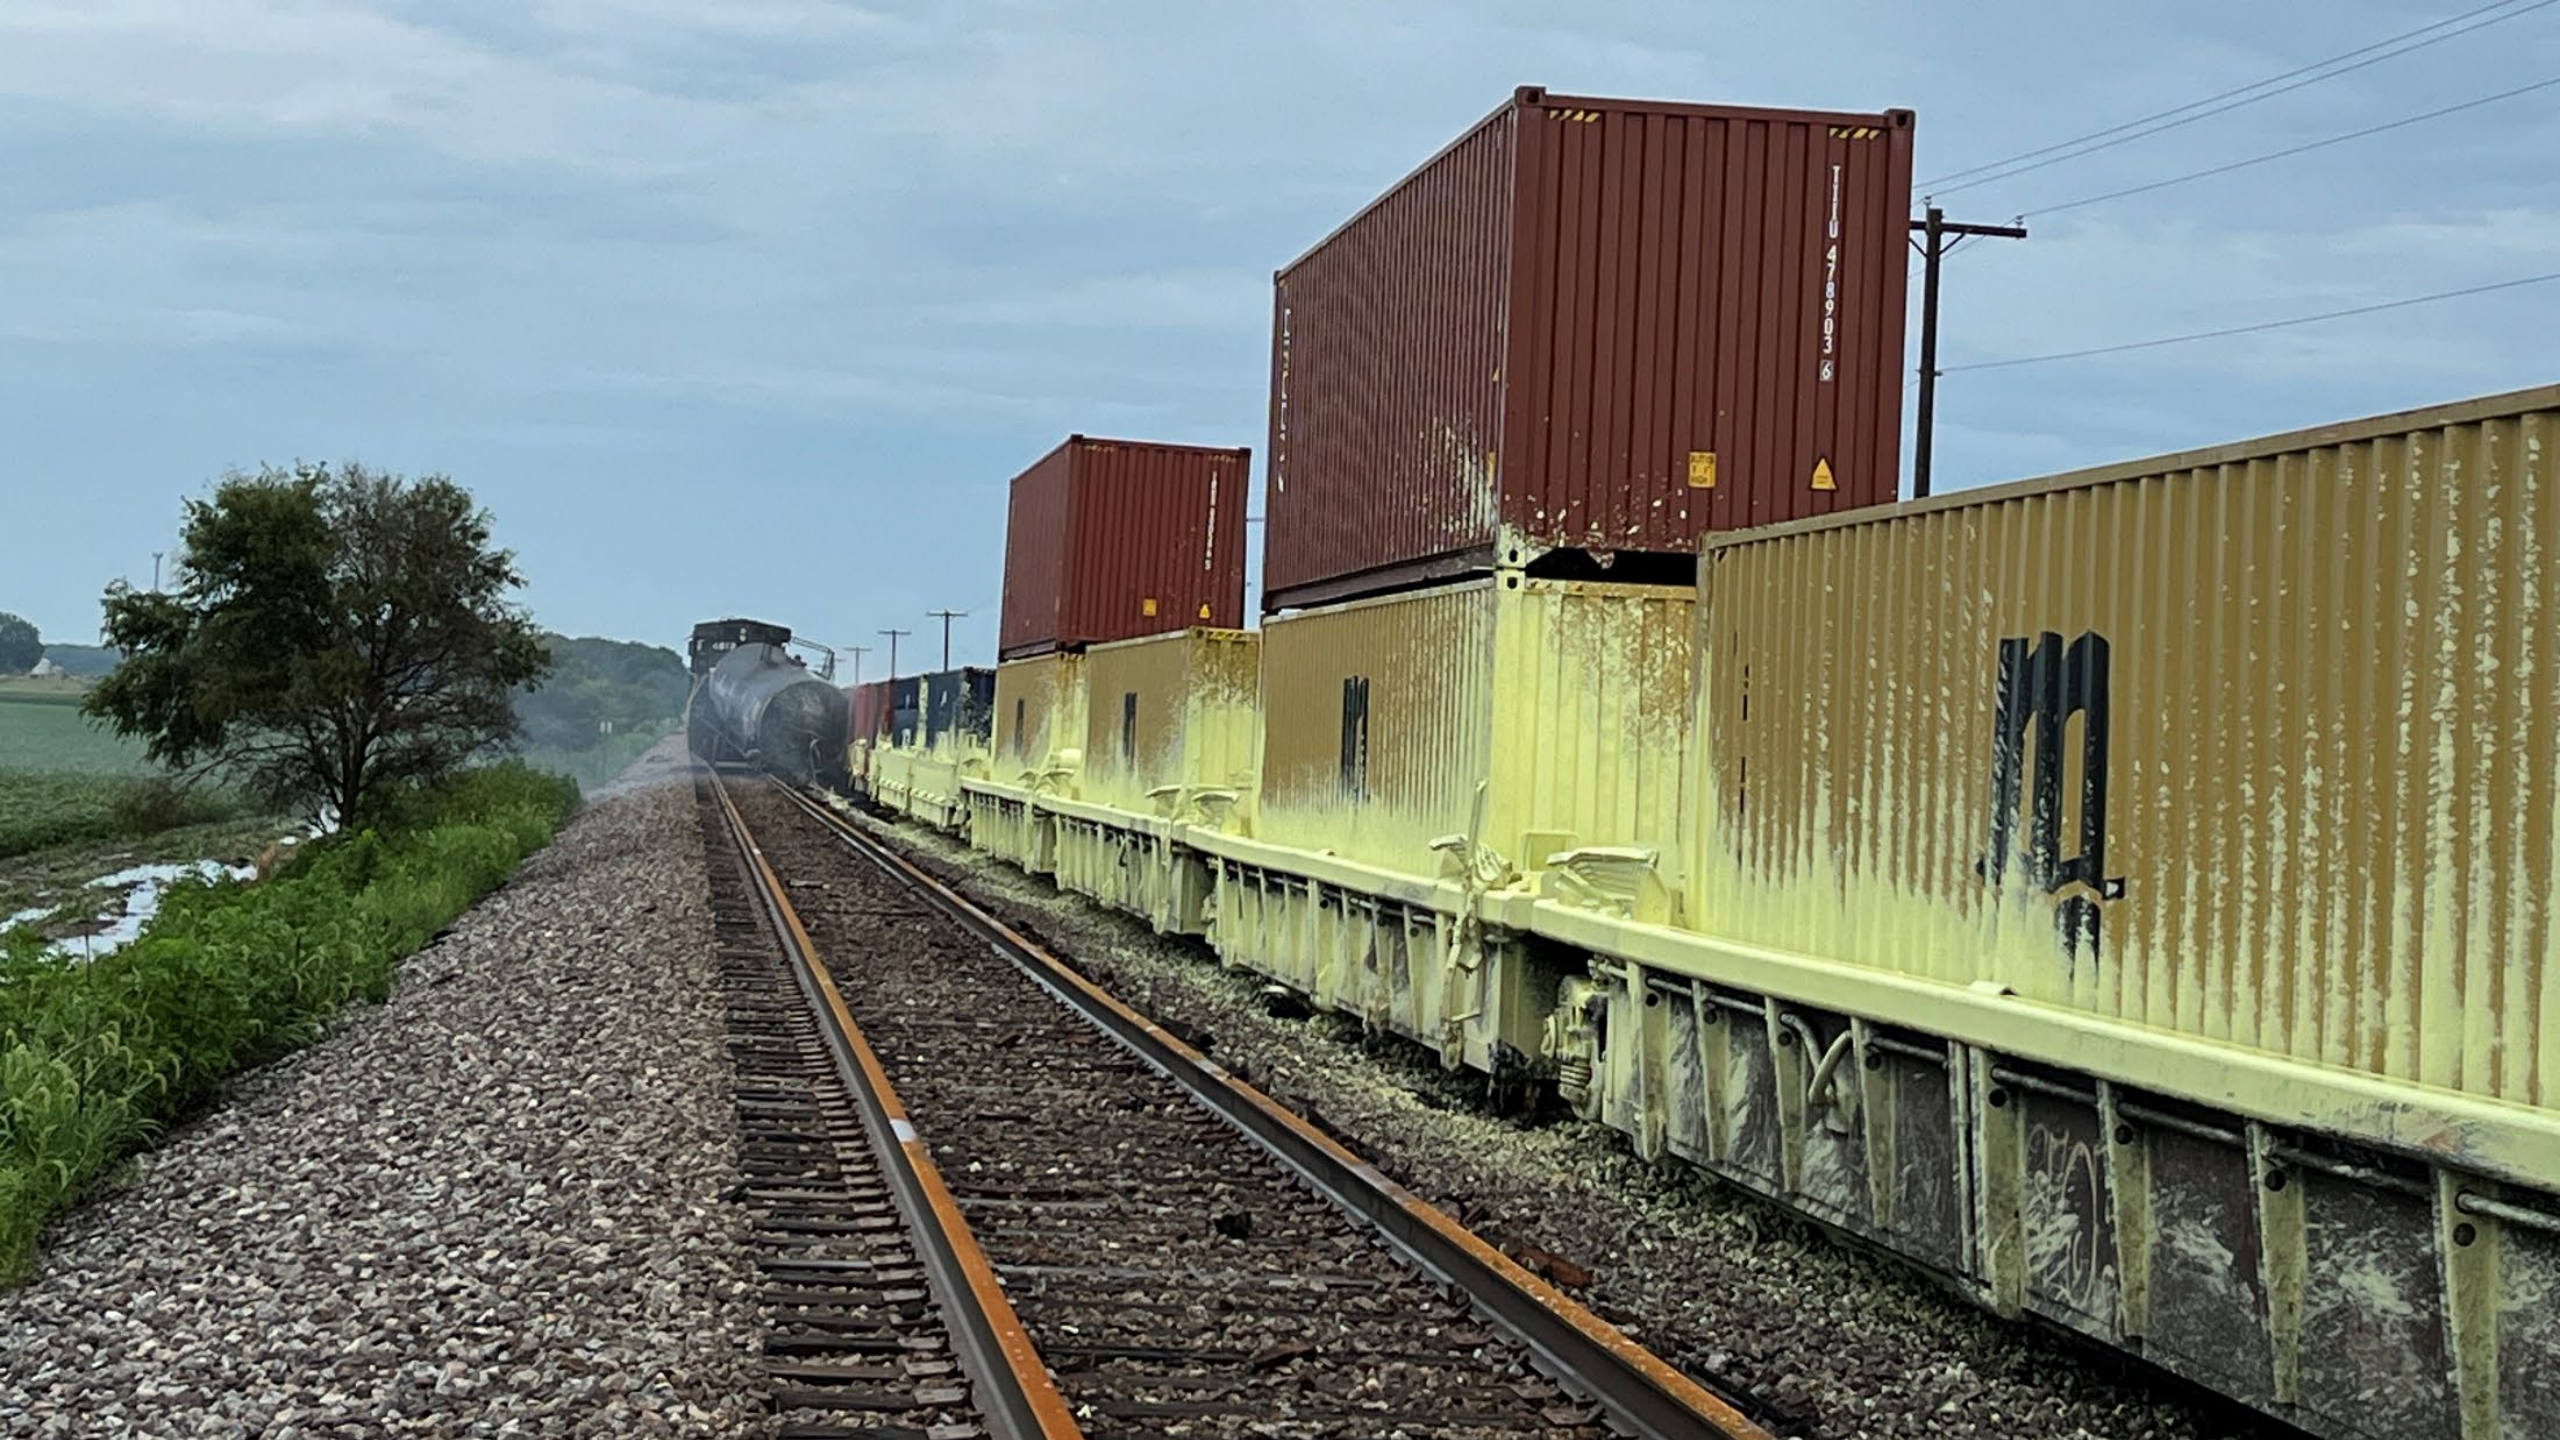
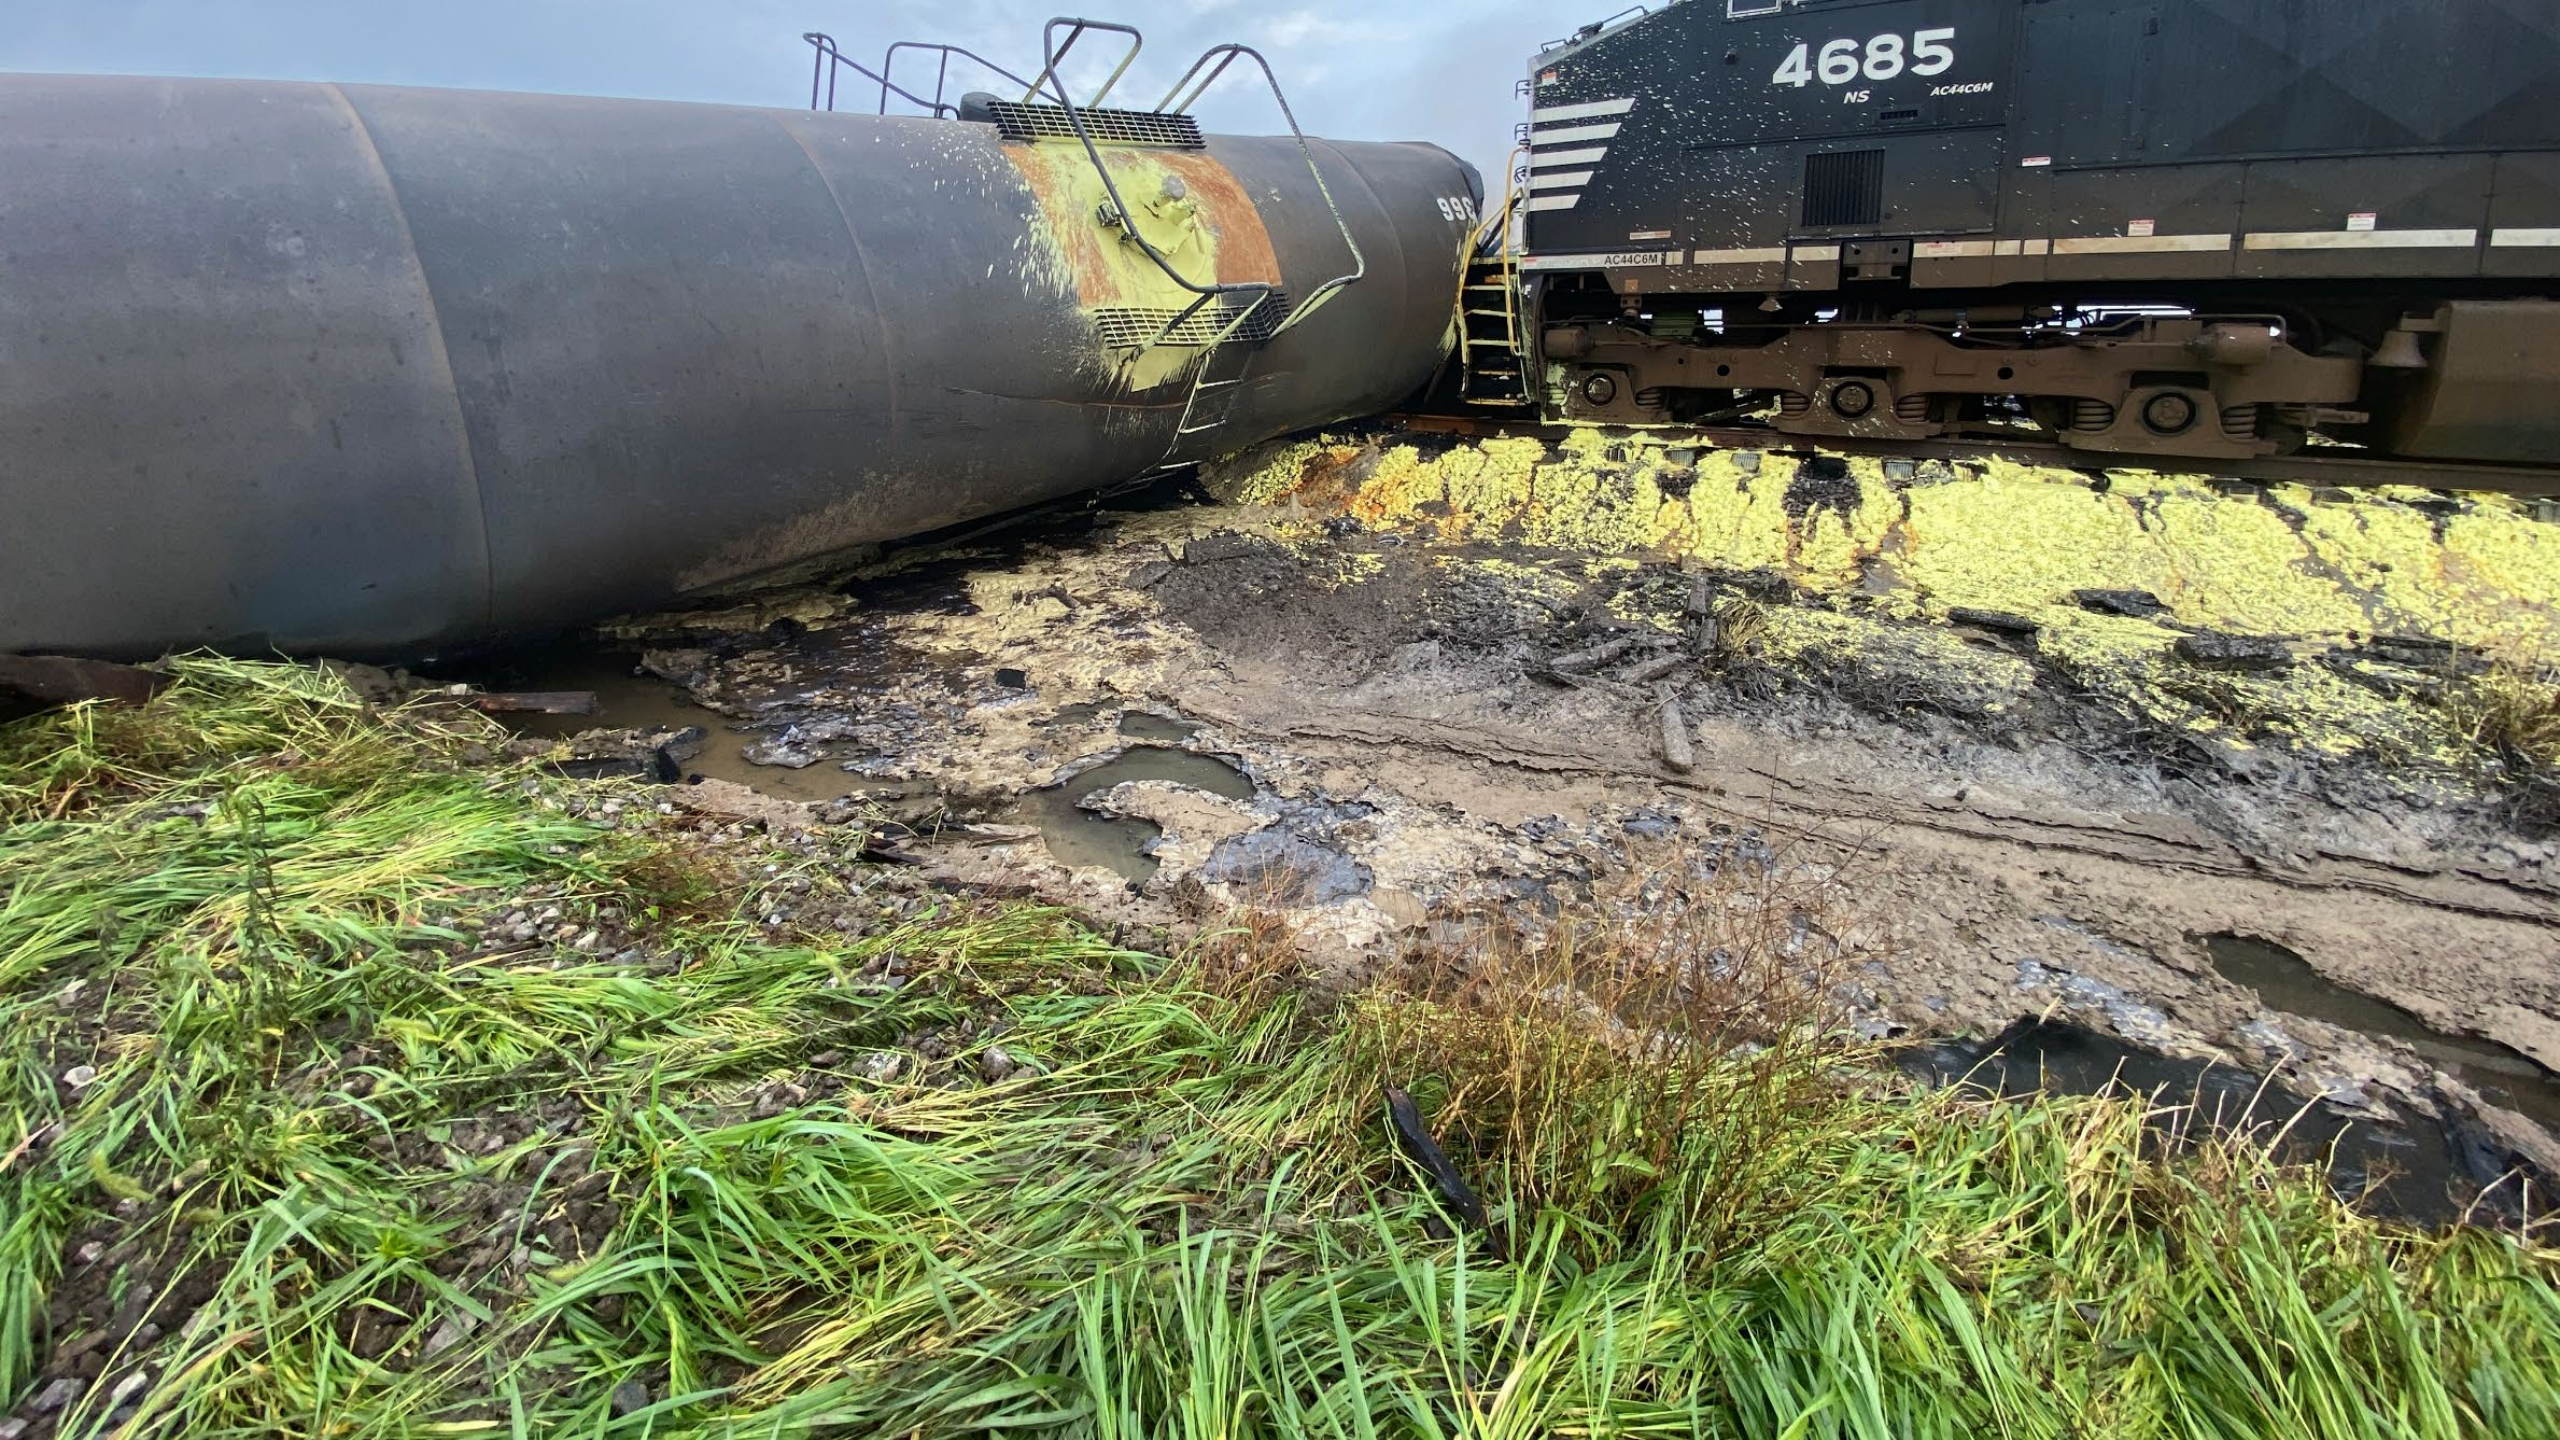
Train collided with the lead locomotive of a train on the adjacent siding track, causing the eastbound train on the mainline to derail

Four molten sulfur cars derailed. Two began leaking molten sulfur and caught on fire.

Six cars carrying powdered lime, and one car containing plastic pellets derailed releasing the cars contents to the rail ballast, adjacent agricultural ditches, and farm fields.

4 cars containing ethanol derailed, 1 car had a small breach of the dome lid.
