Enbridge Line 6B Incident

Public Update and Availability Session

October 14, 2010
(Day 81)

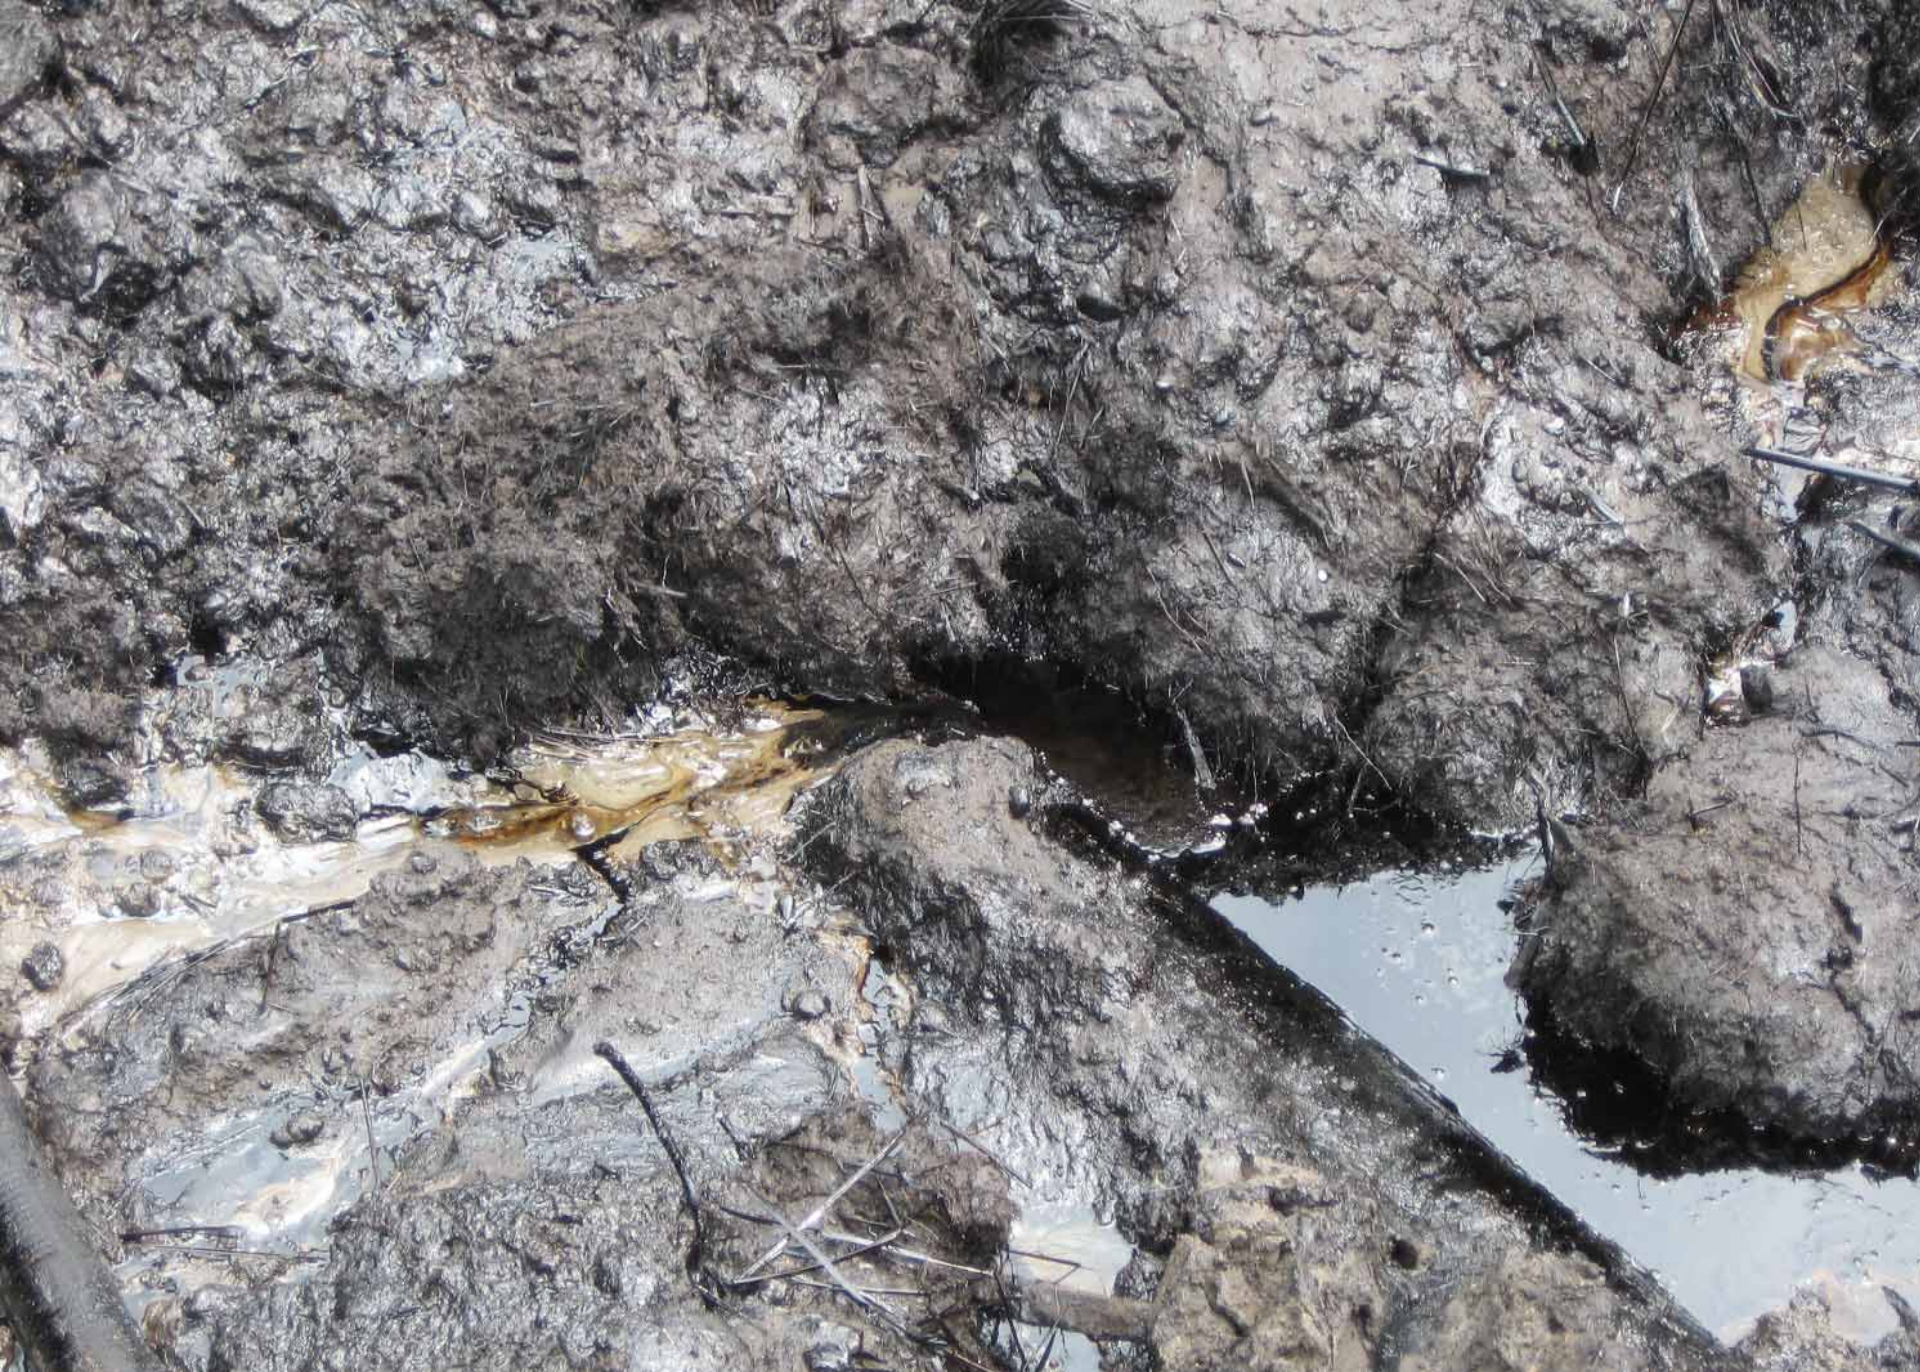
Exposed pipeline during the first week of the oil spill response.

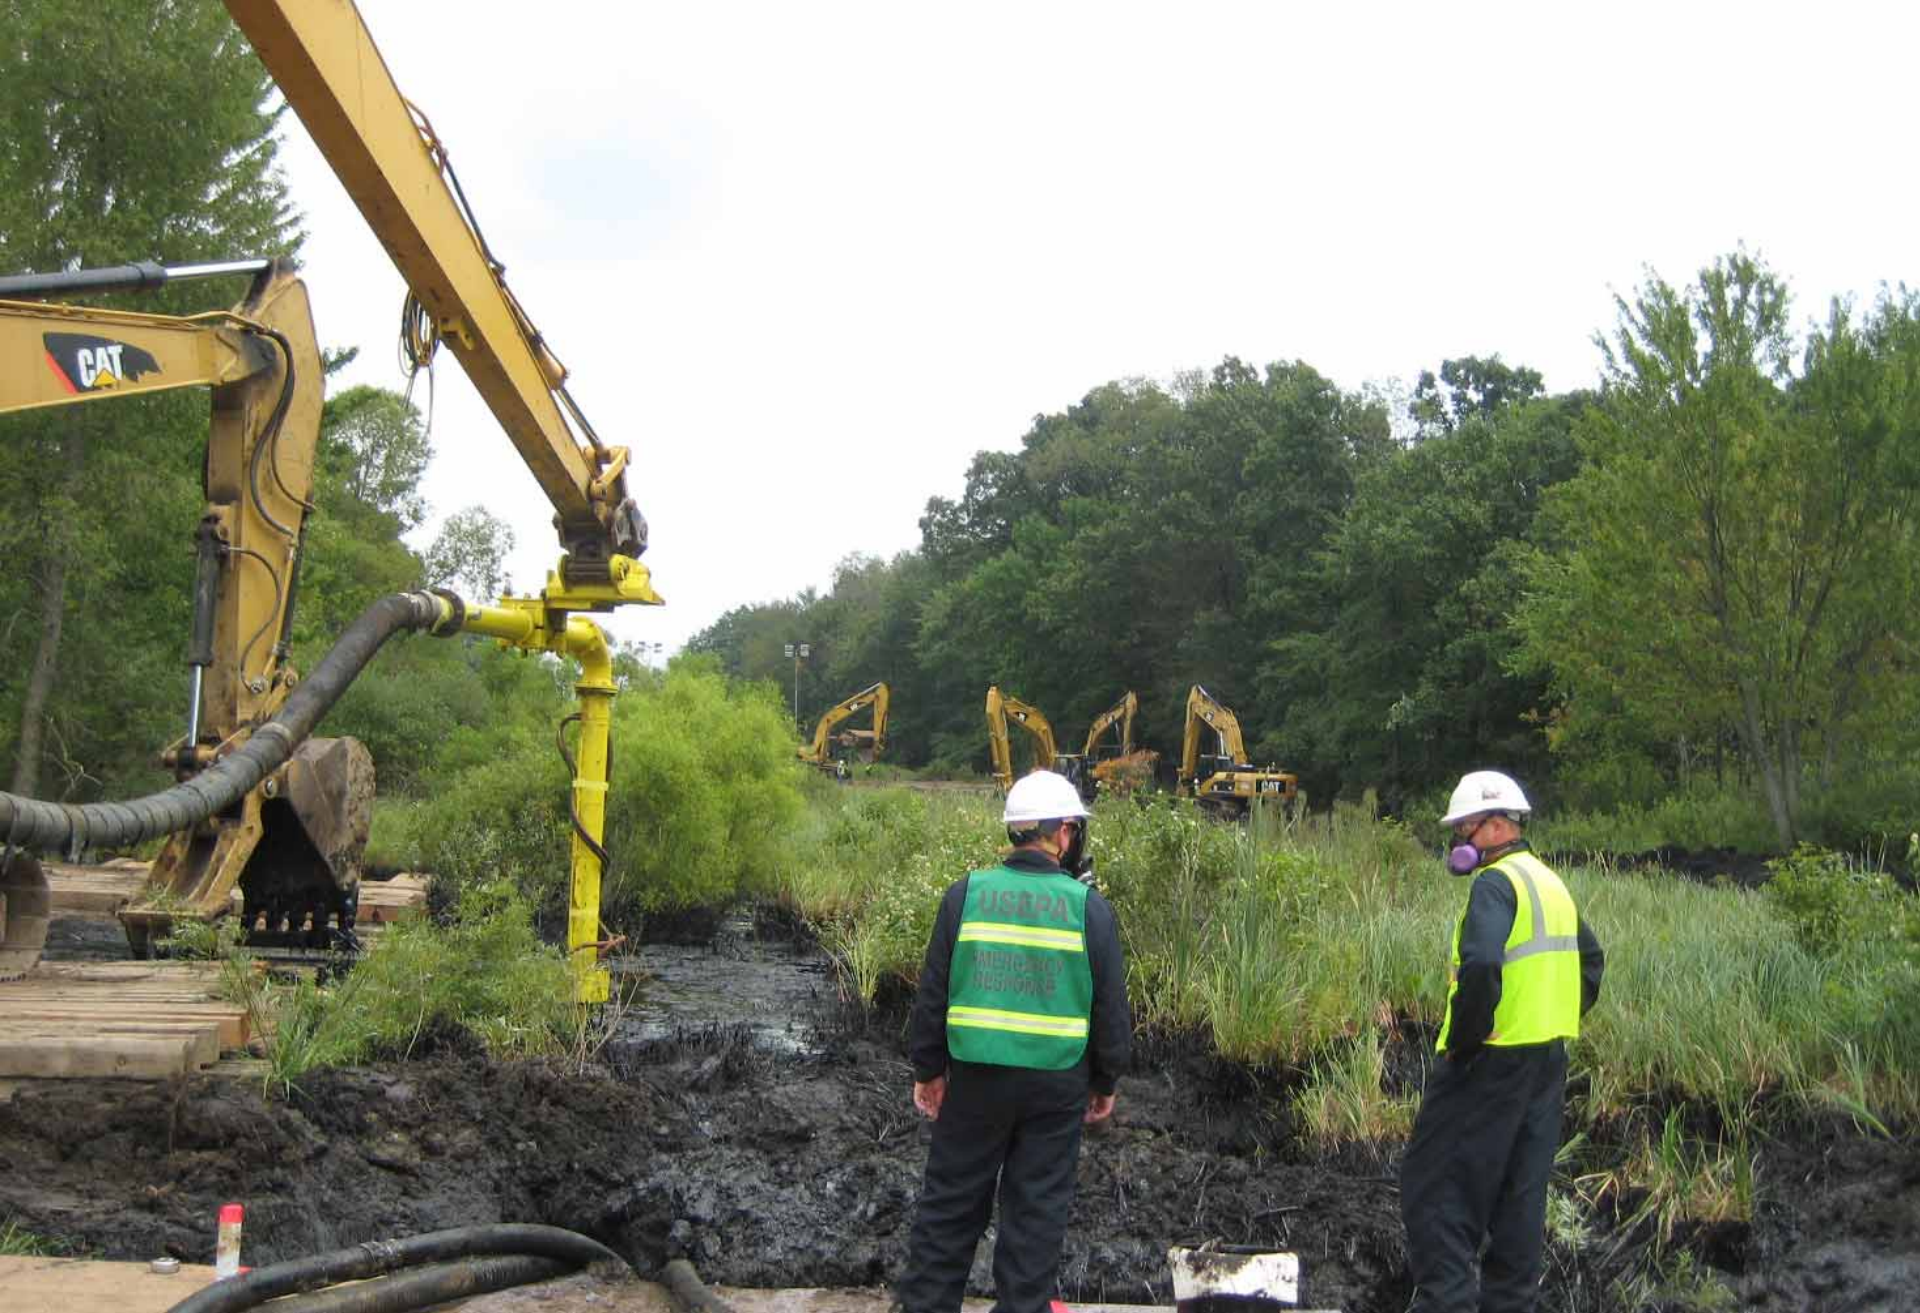
Initial cleanup of a 5-acre contaminated zone in the pipeline break area. Photo shows a dewatering operation.

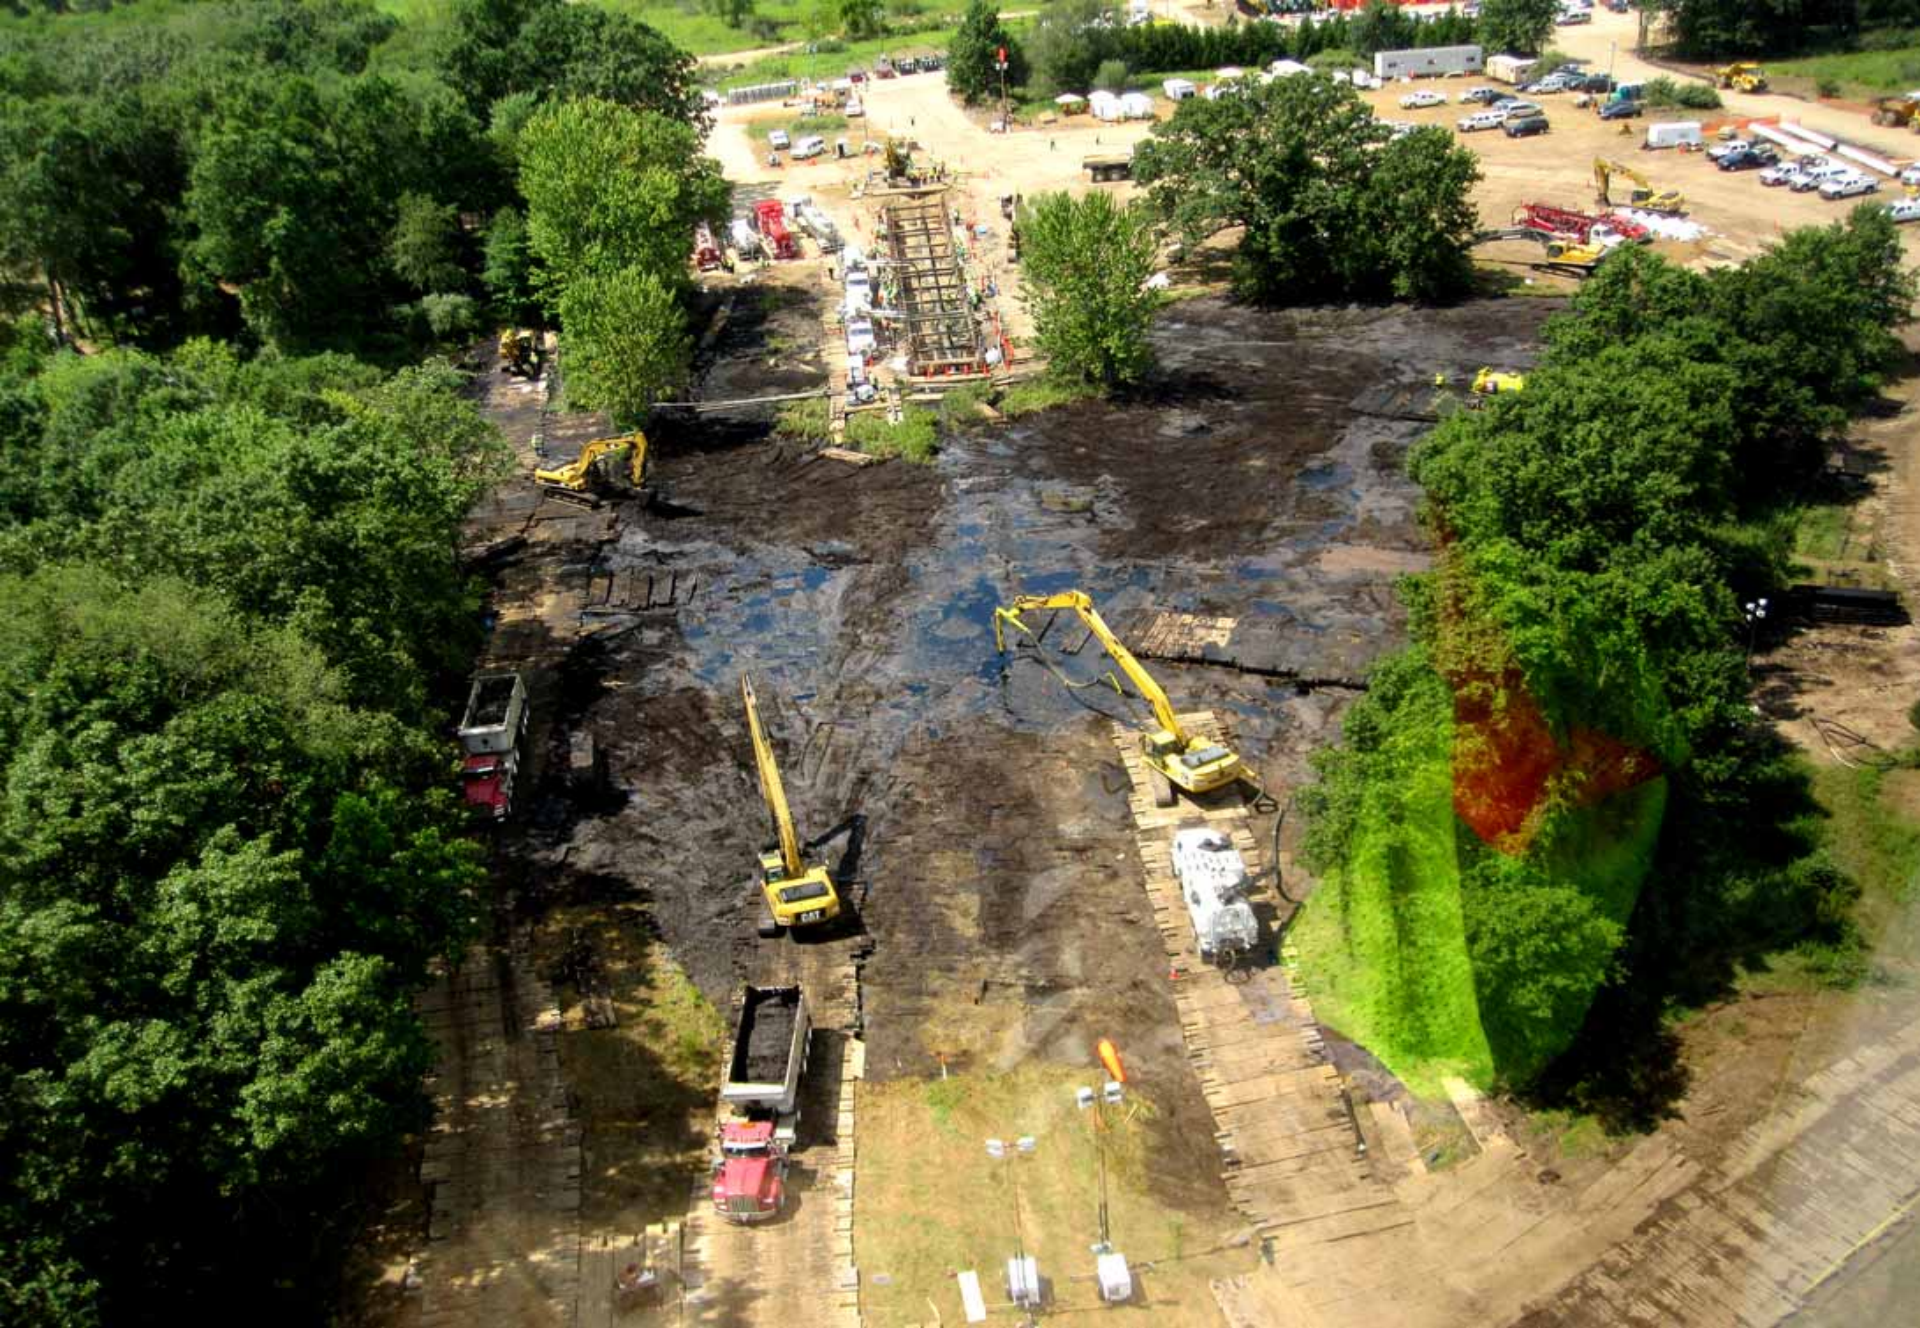
Second week of contaminated soil cleanup near the pipeline break.

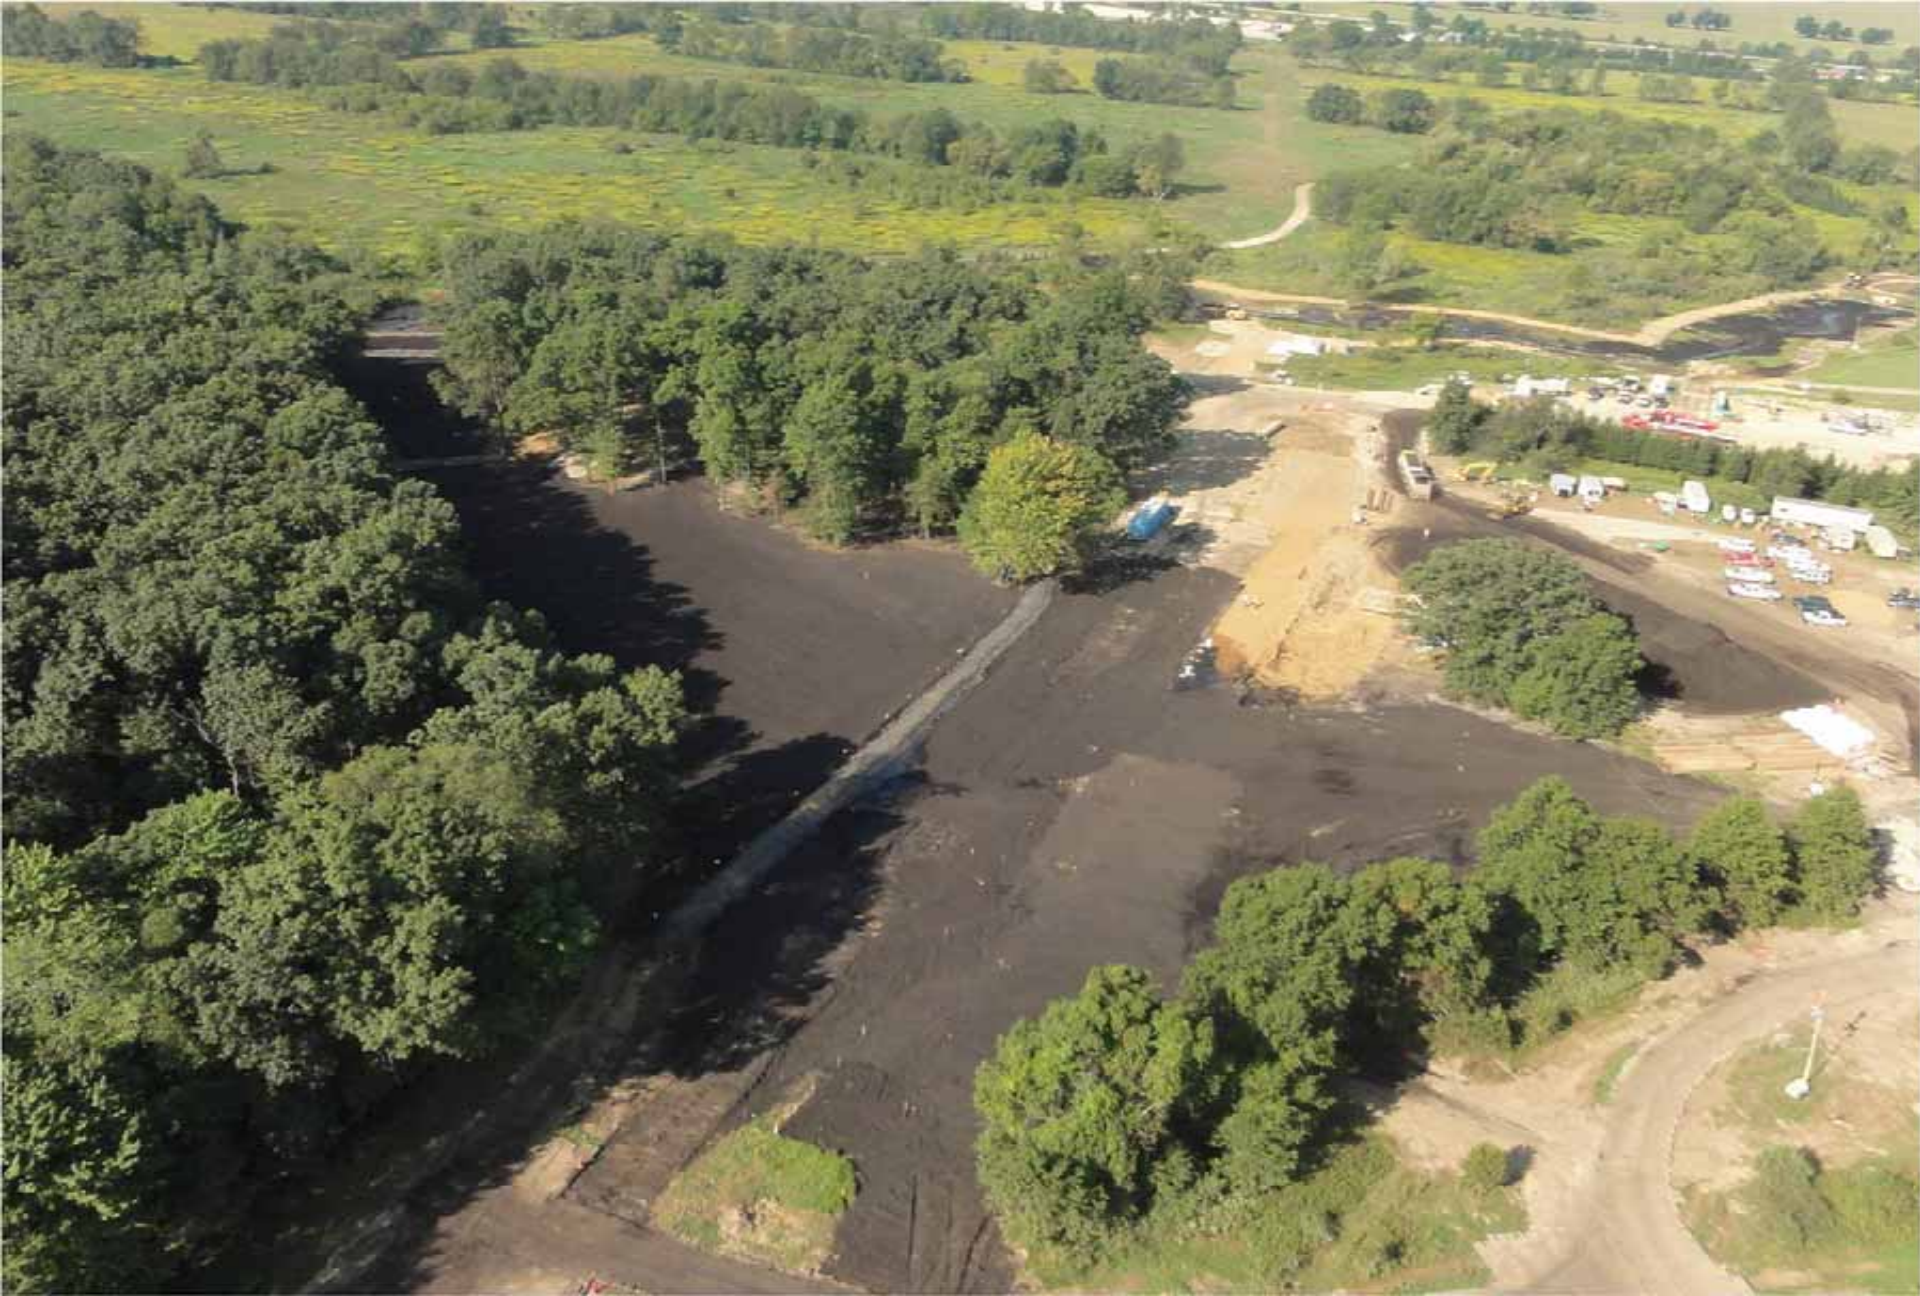
After four weeks, contaminated land located by the pipeline break was backfilled with clean soil.

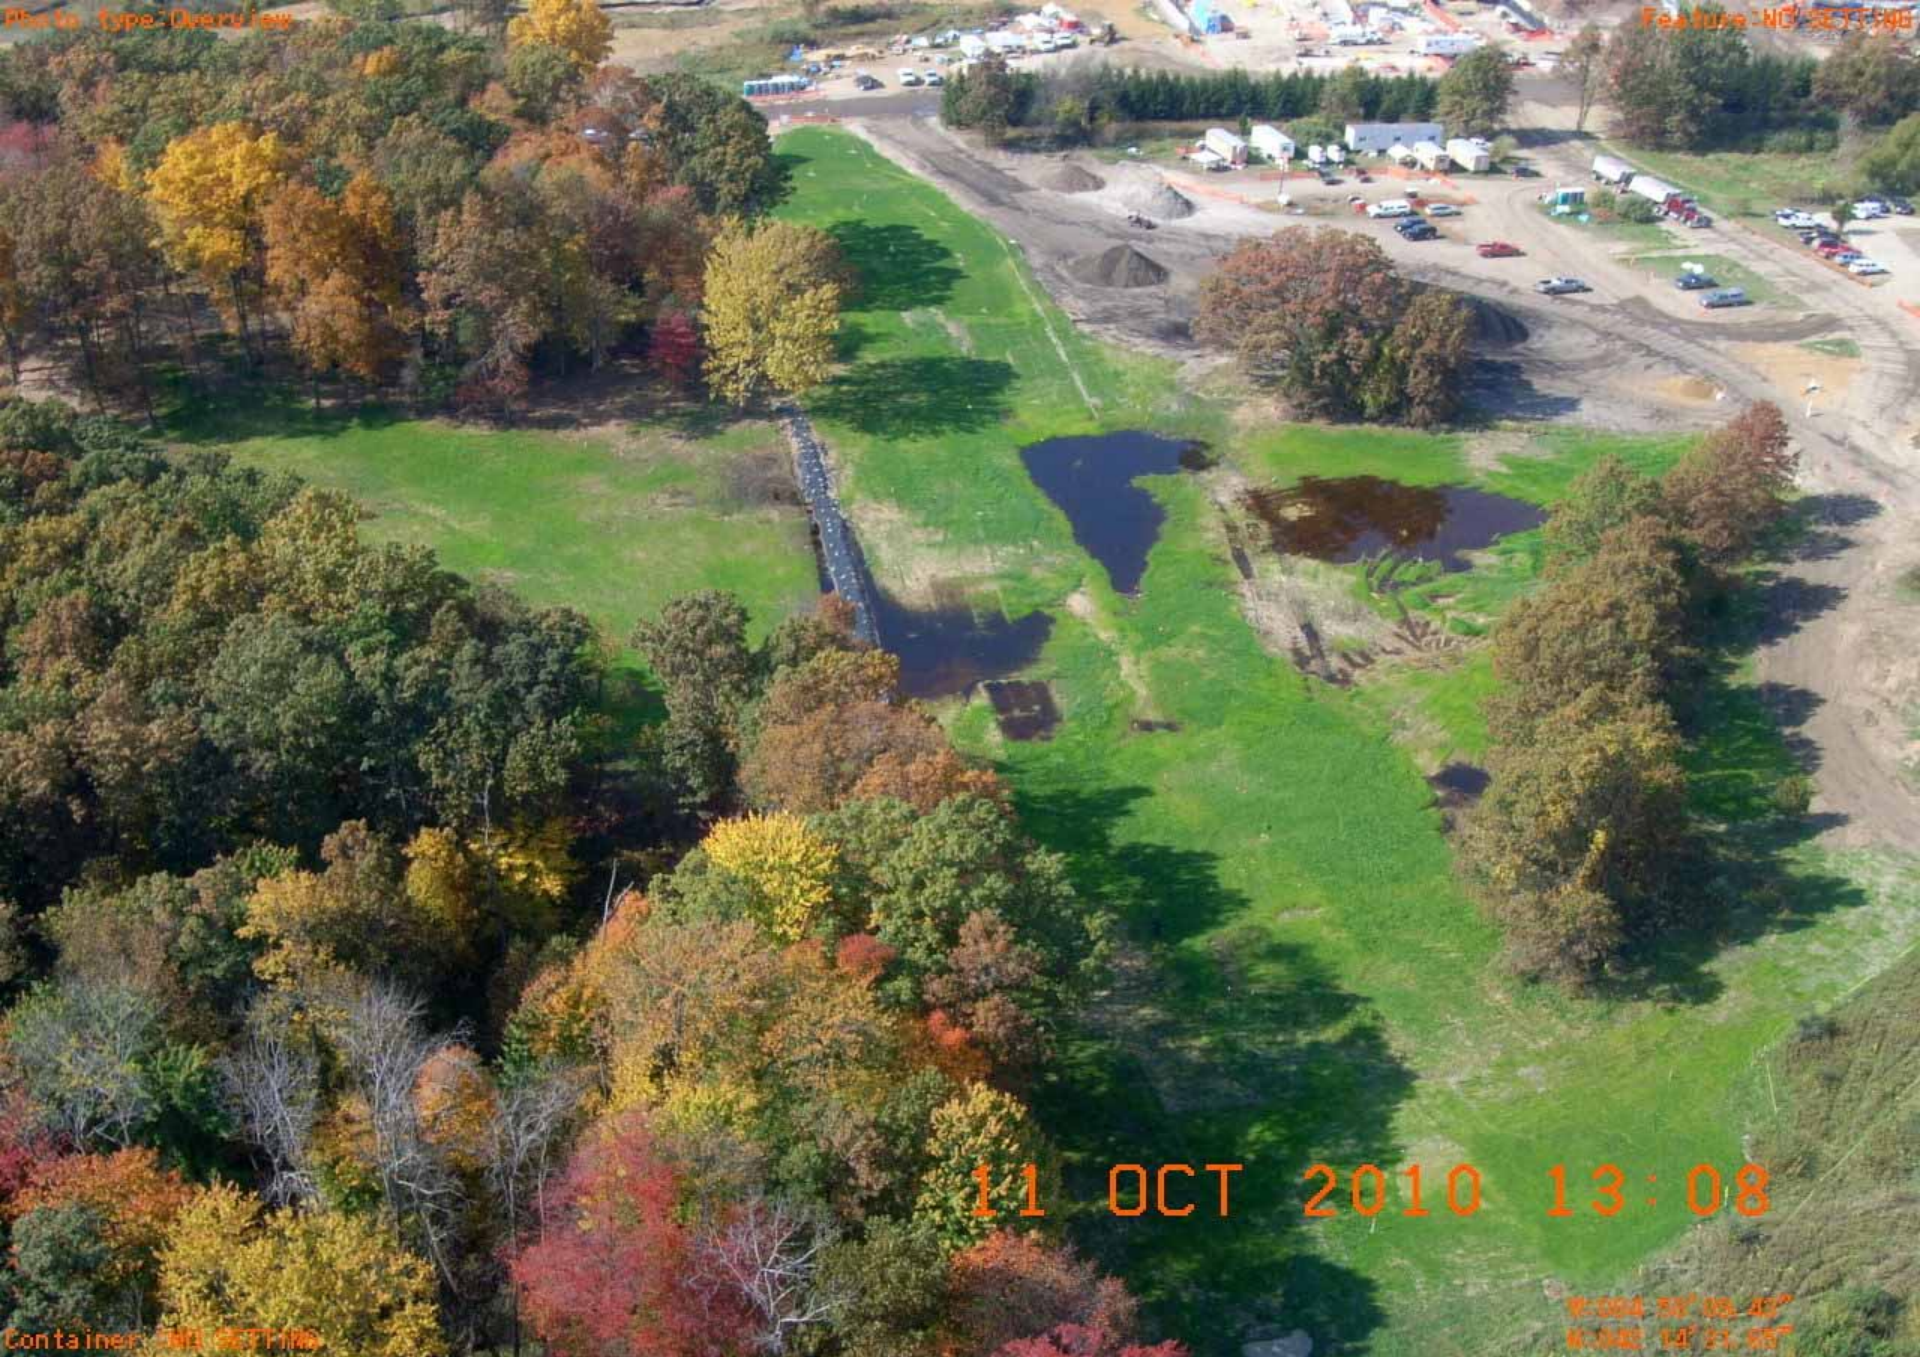
Restored and re-vegetated pipeline break area on Oct. 11, 2010.

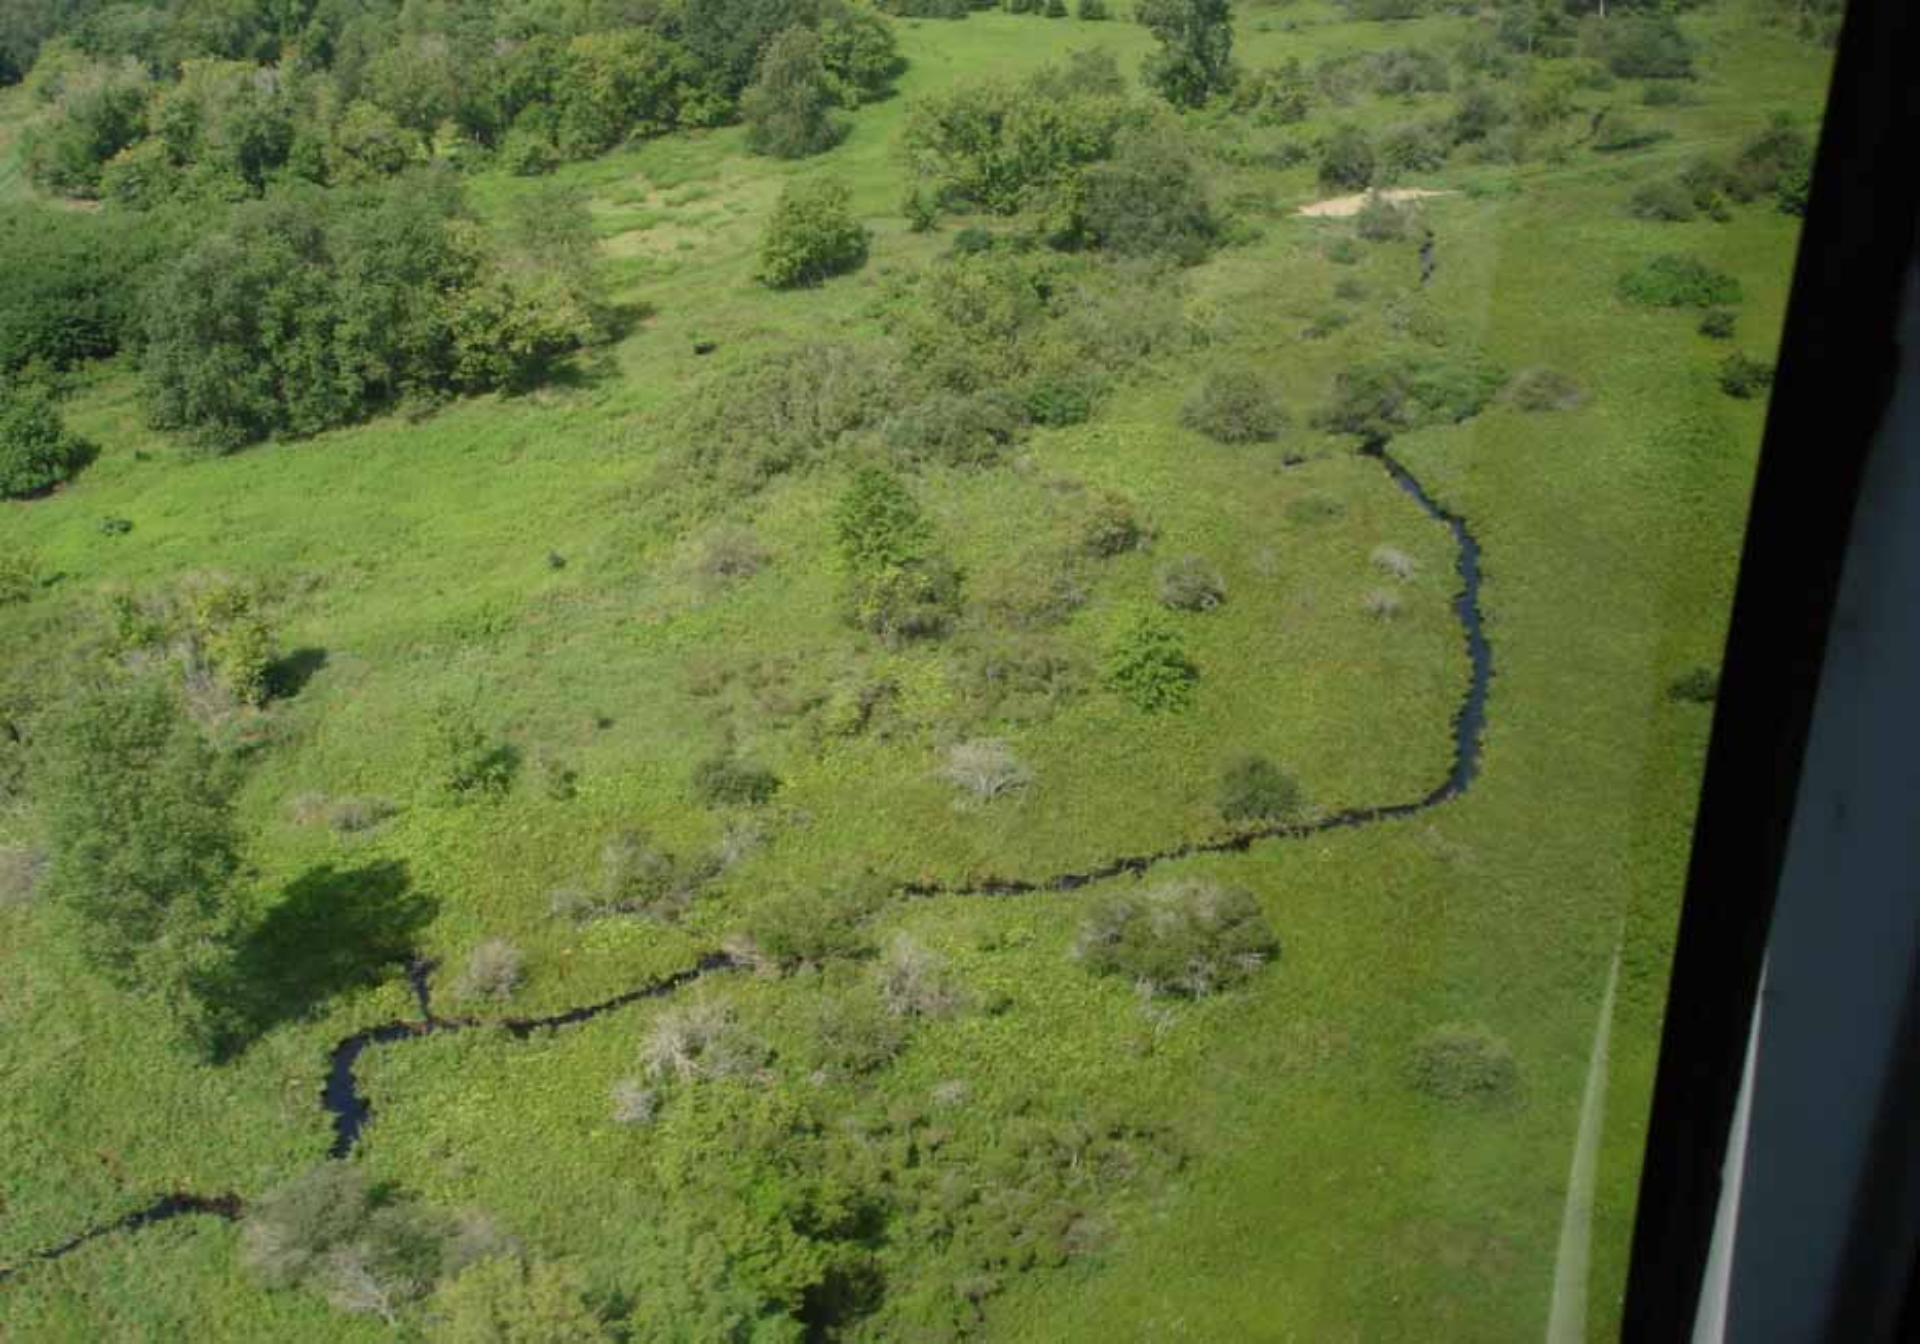
Talmadge Creek day one: creek and floodplain completely oil-covered.

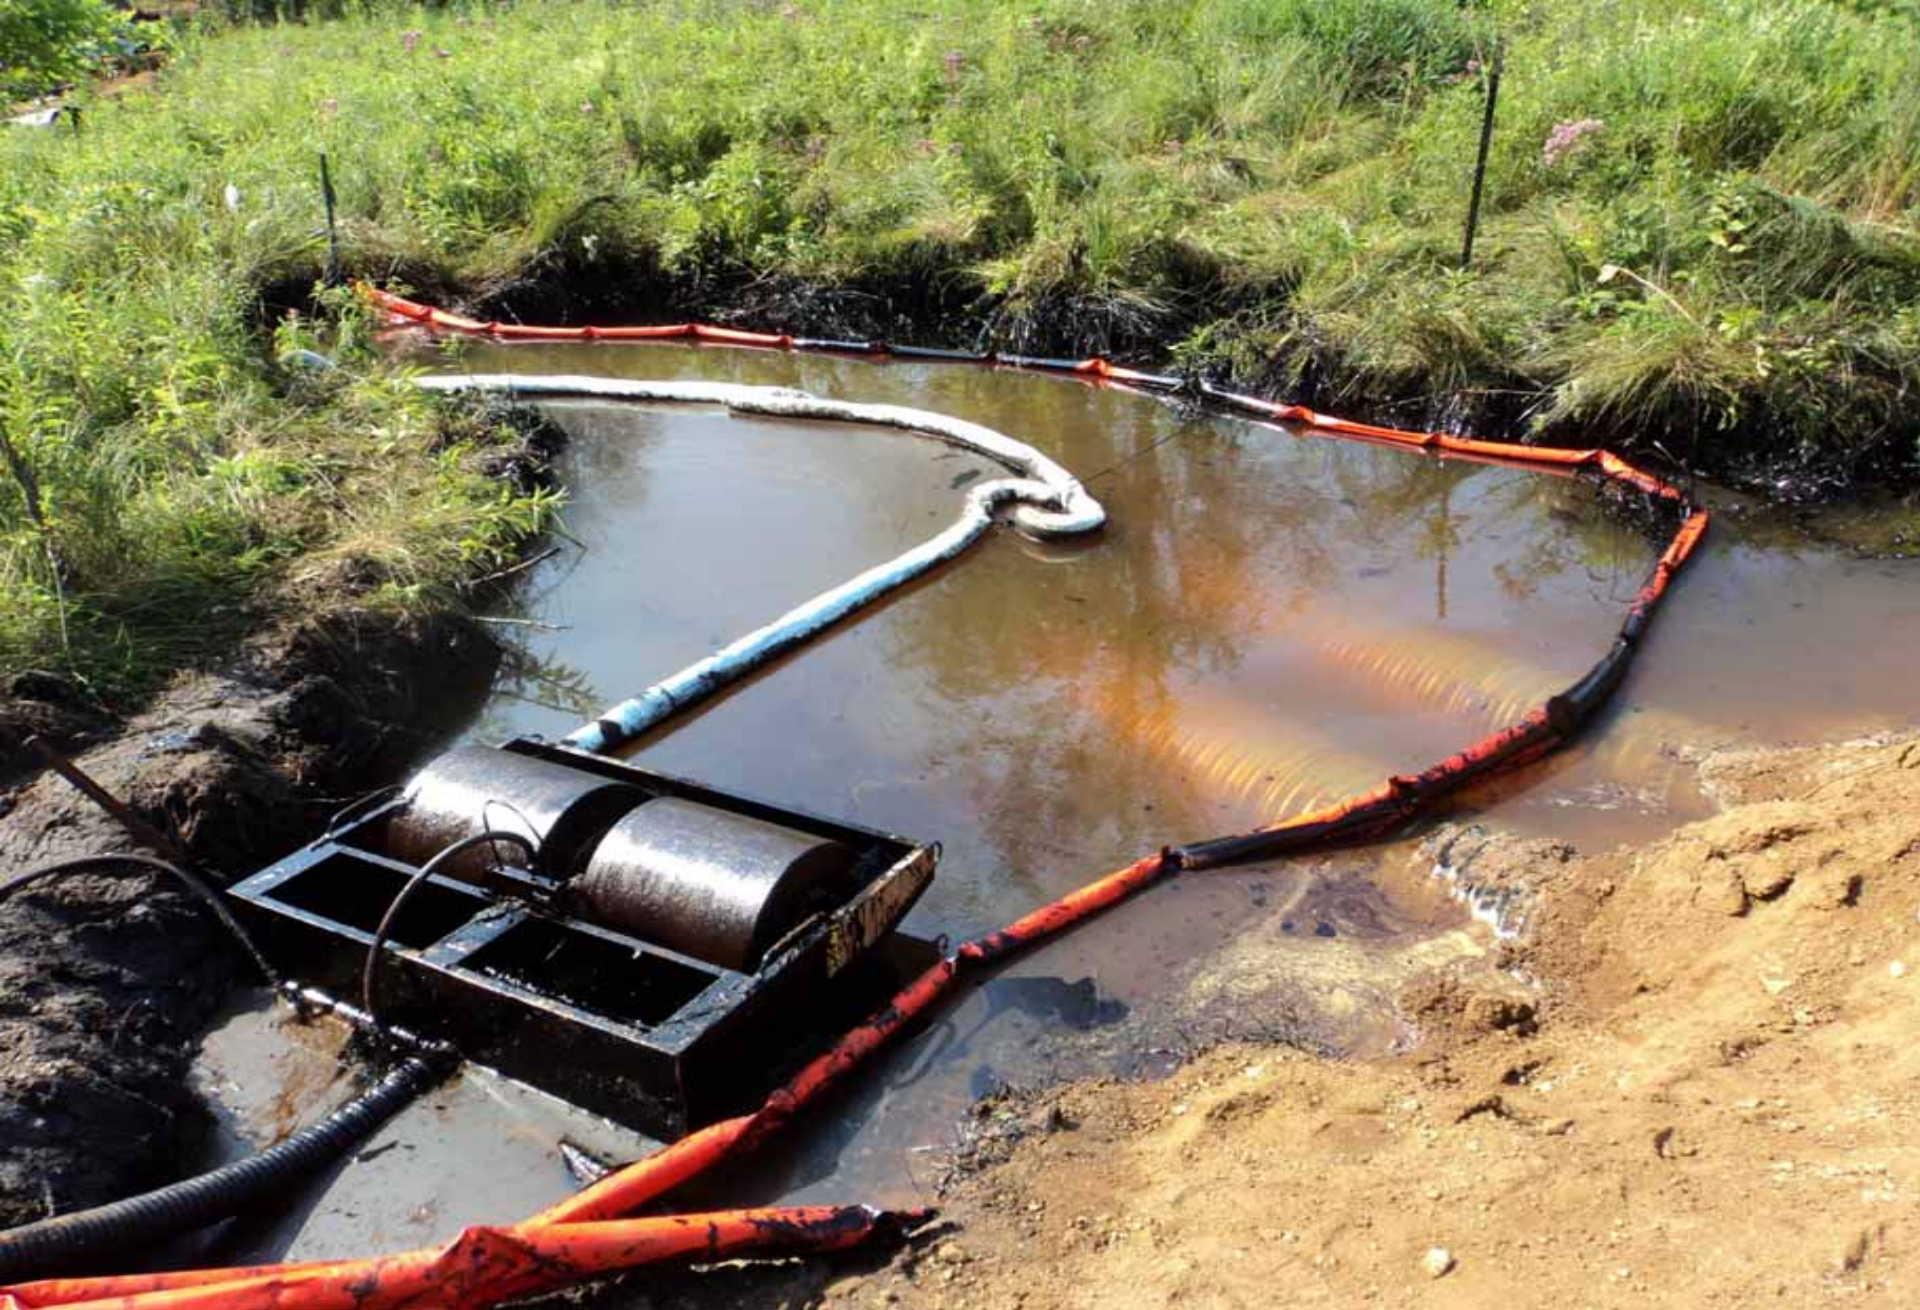
Initial containment measure in the creek includes skimmers, containment booms, and siphon dams.

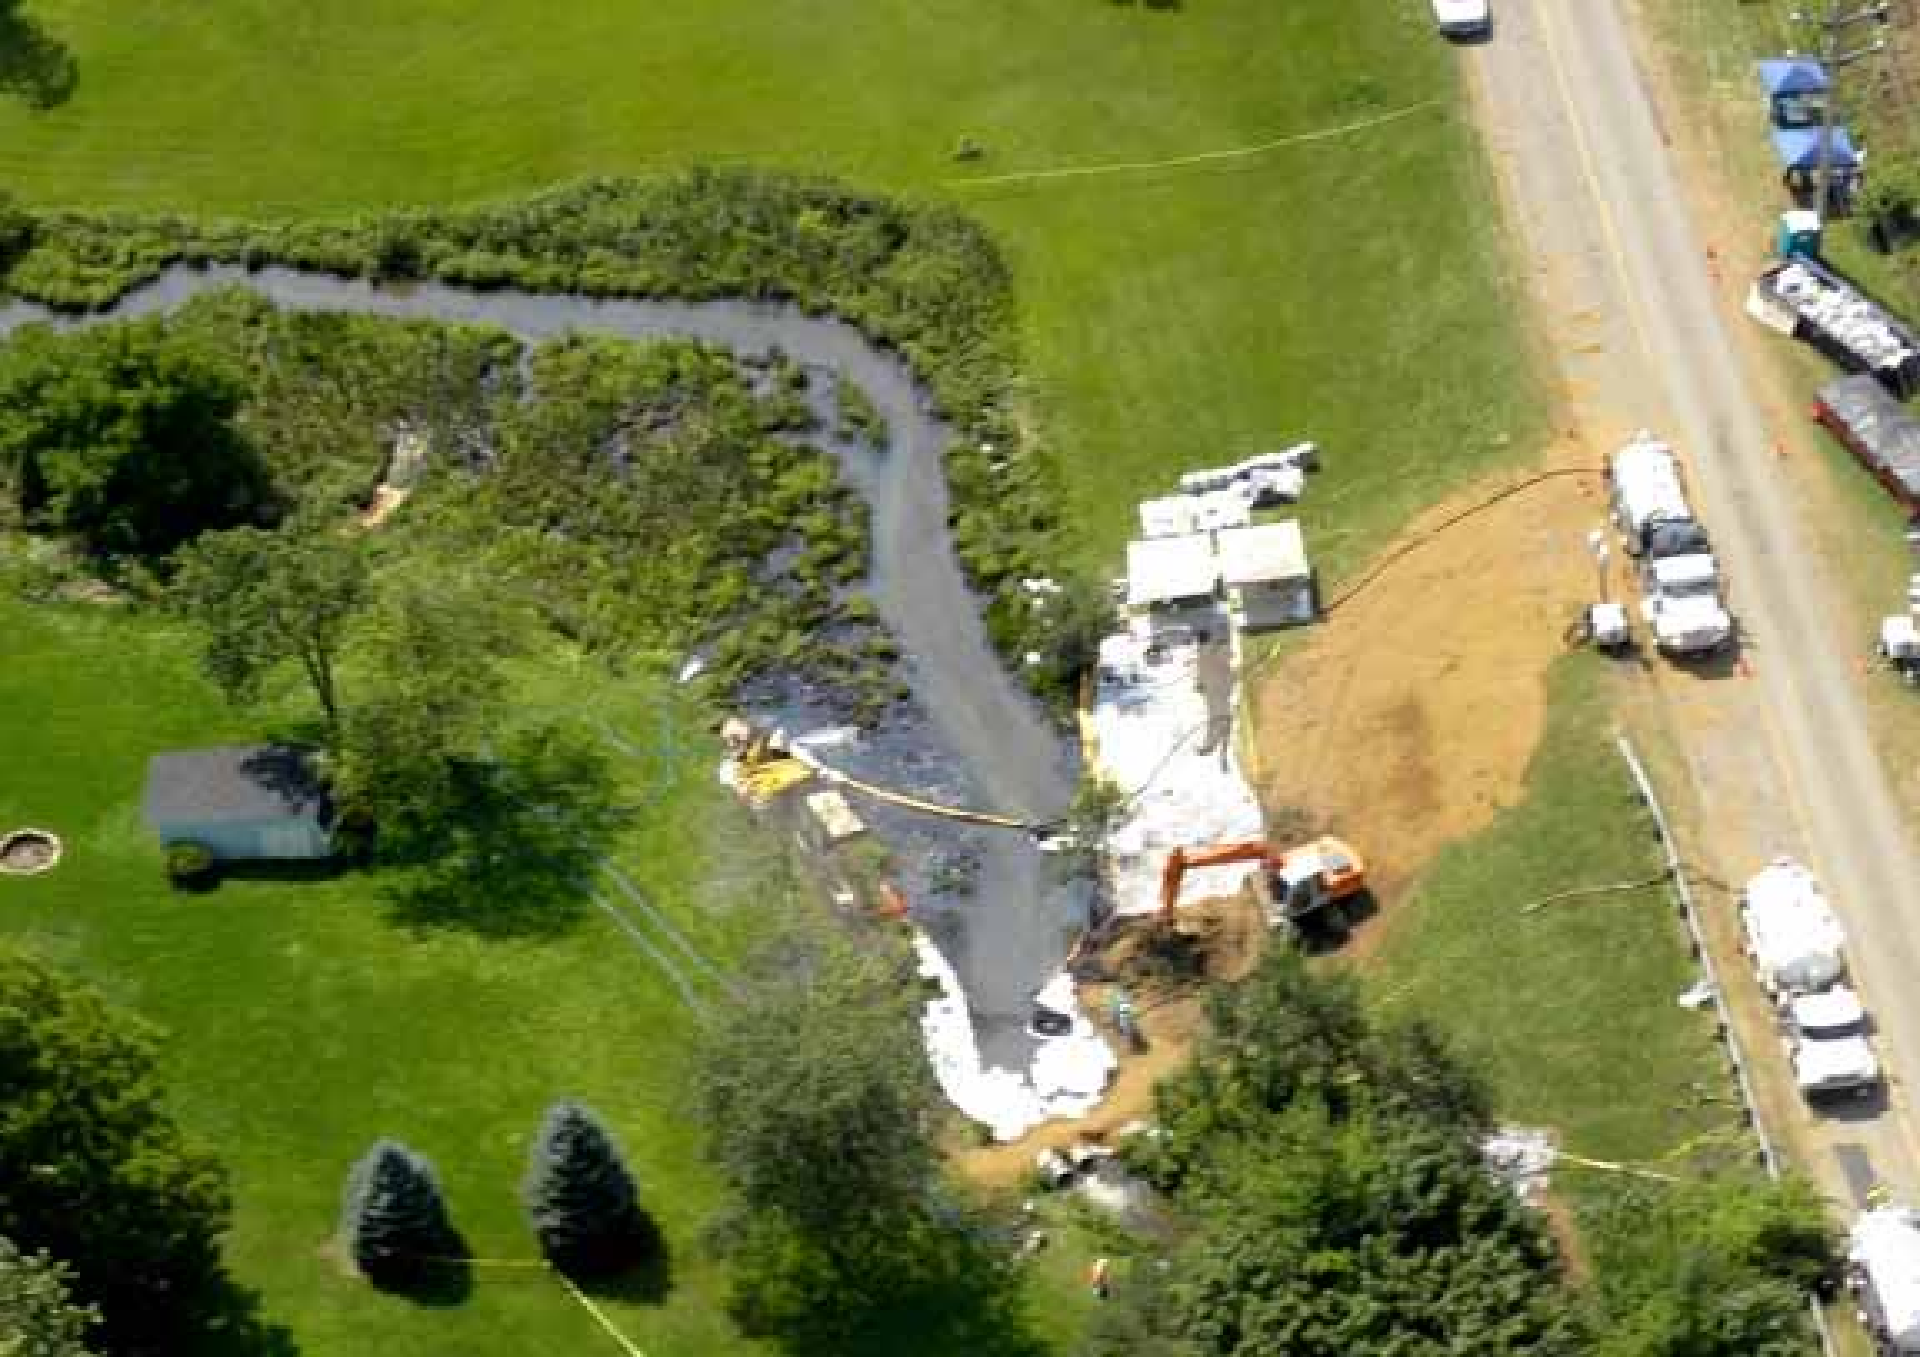
Surface water was reduced to heavy sheen by the end of the response's first week.

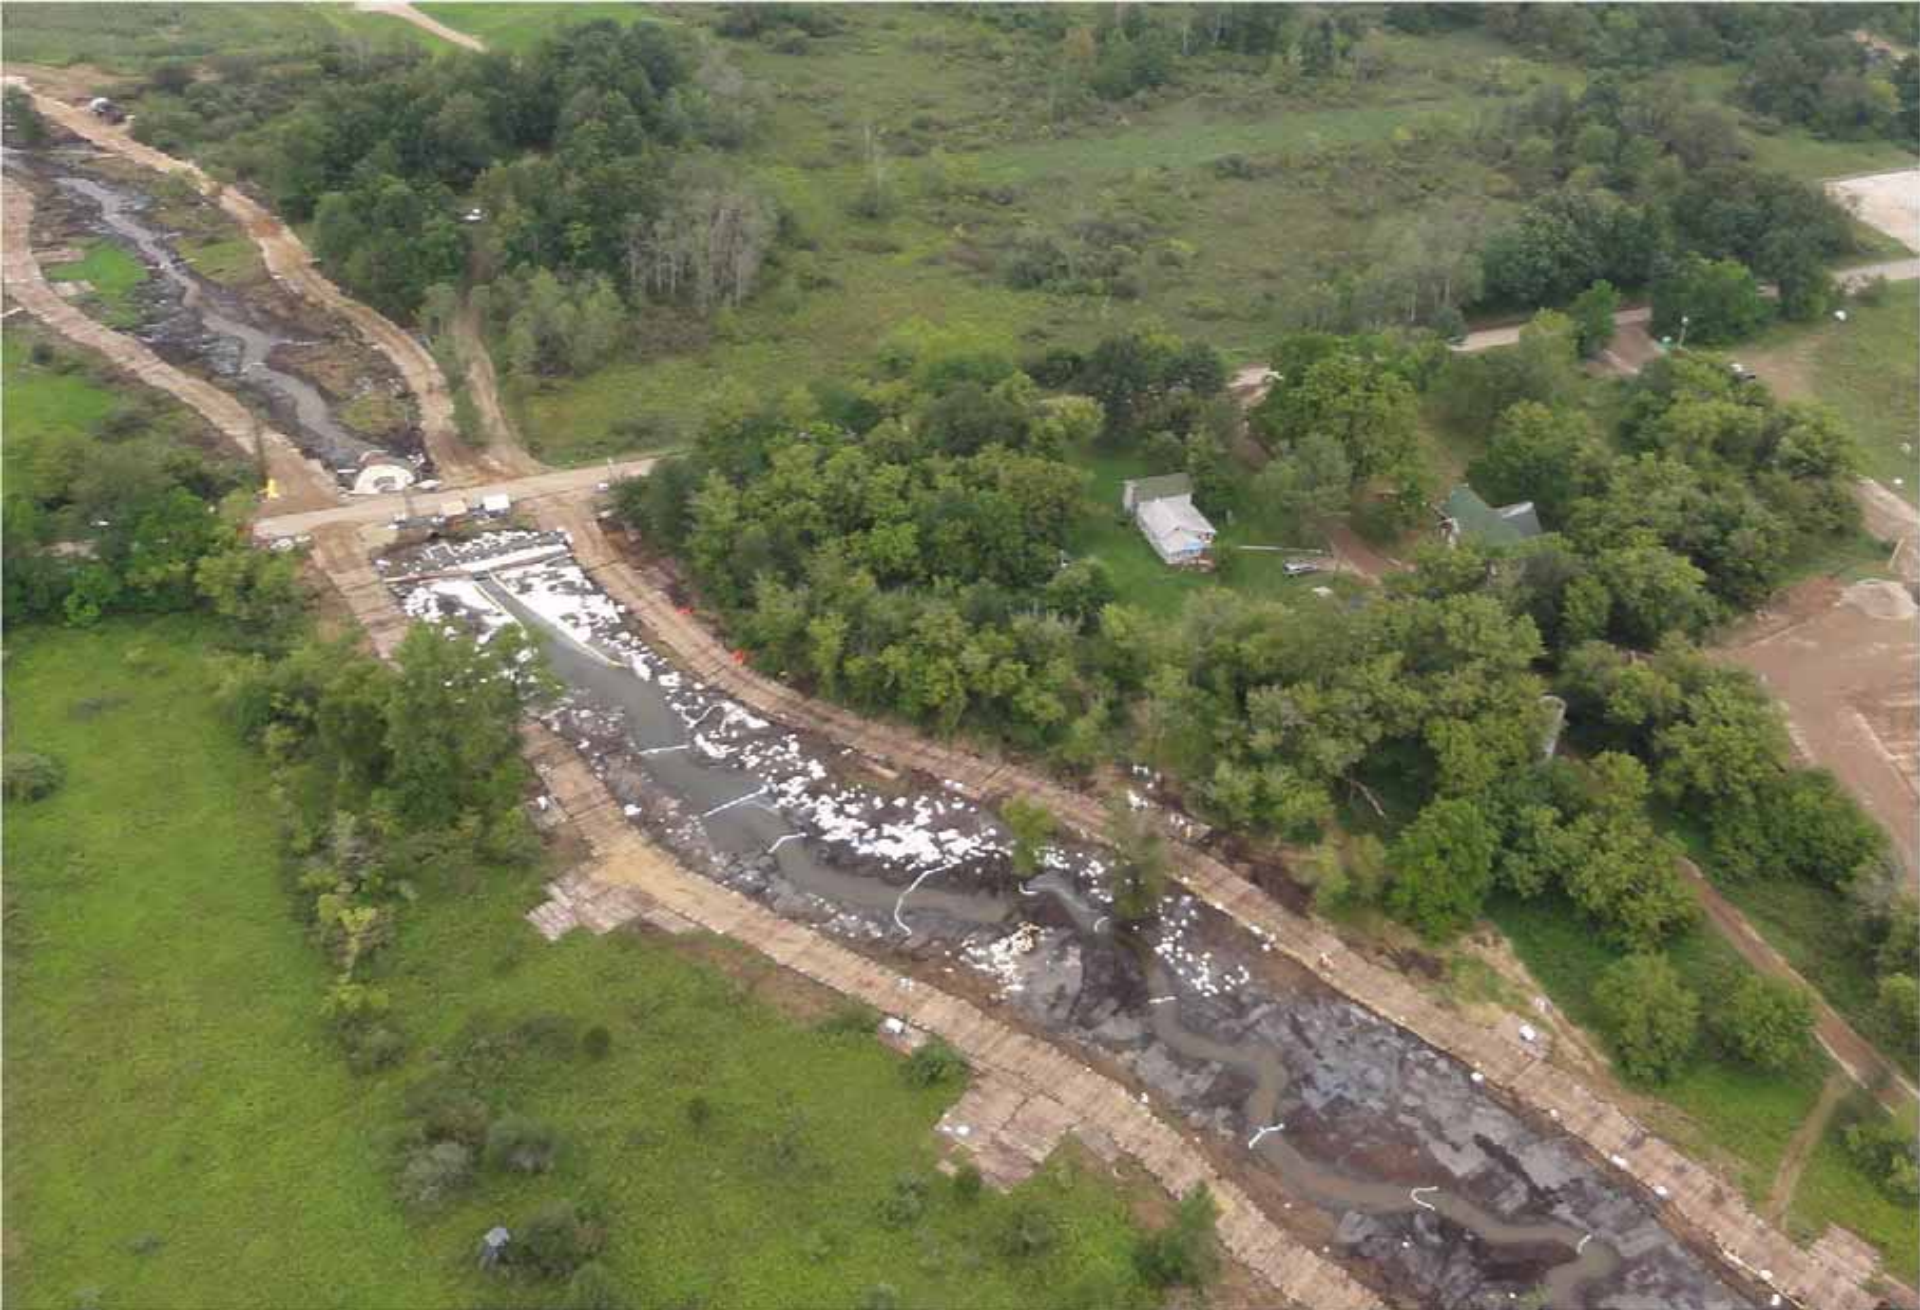
To access the creek in order to remove contaminated soil, swamp mat roads were established. Note white oil pads placed to absorb oil.
