Enbridge Line 6B Incident

Public Update and Availability Session

October 14, 2010
(Day 81)

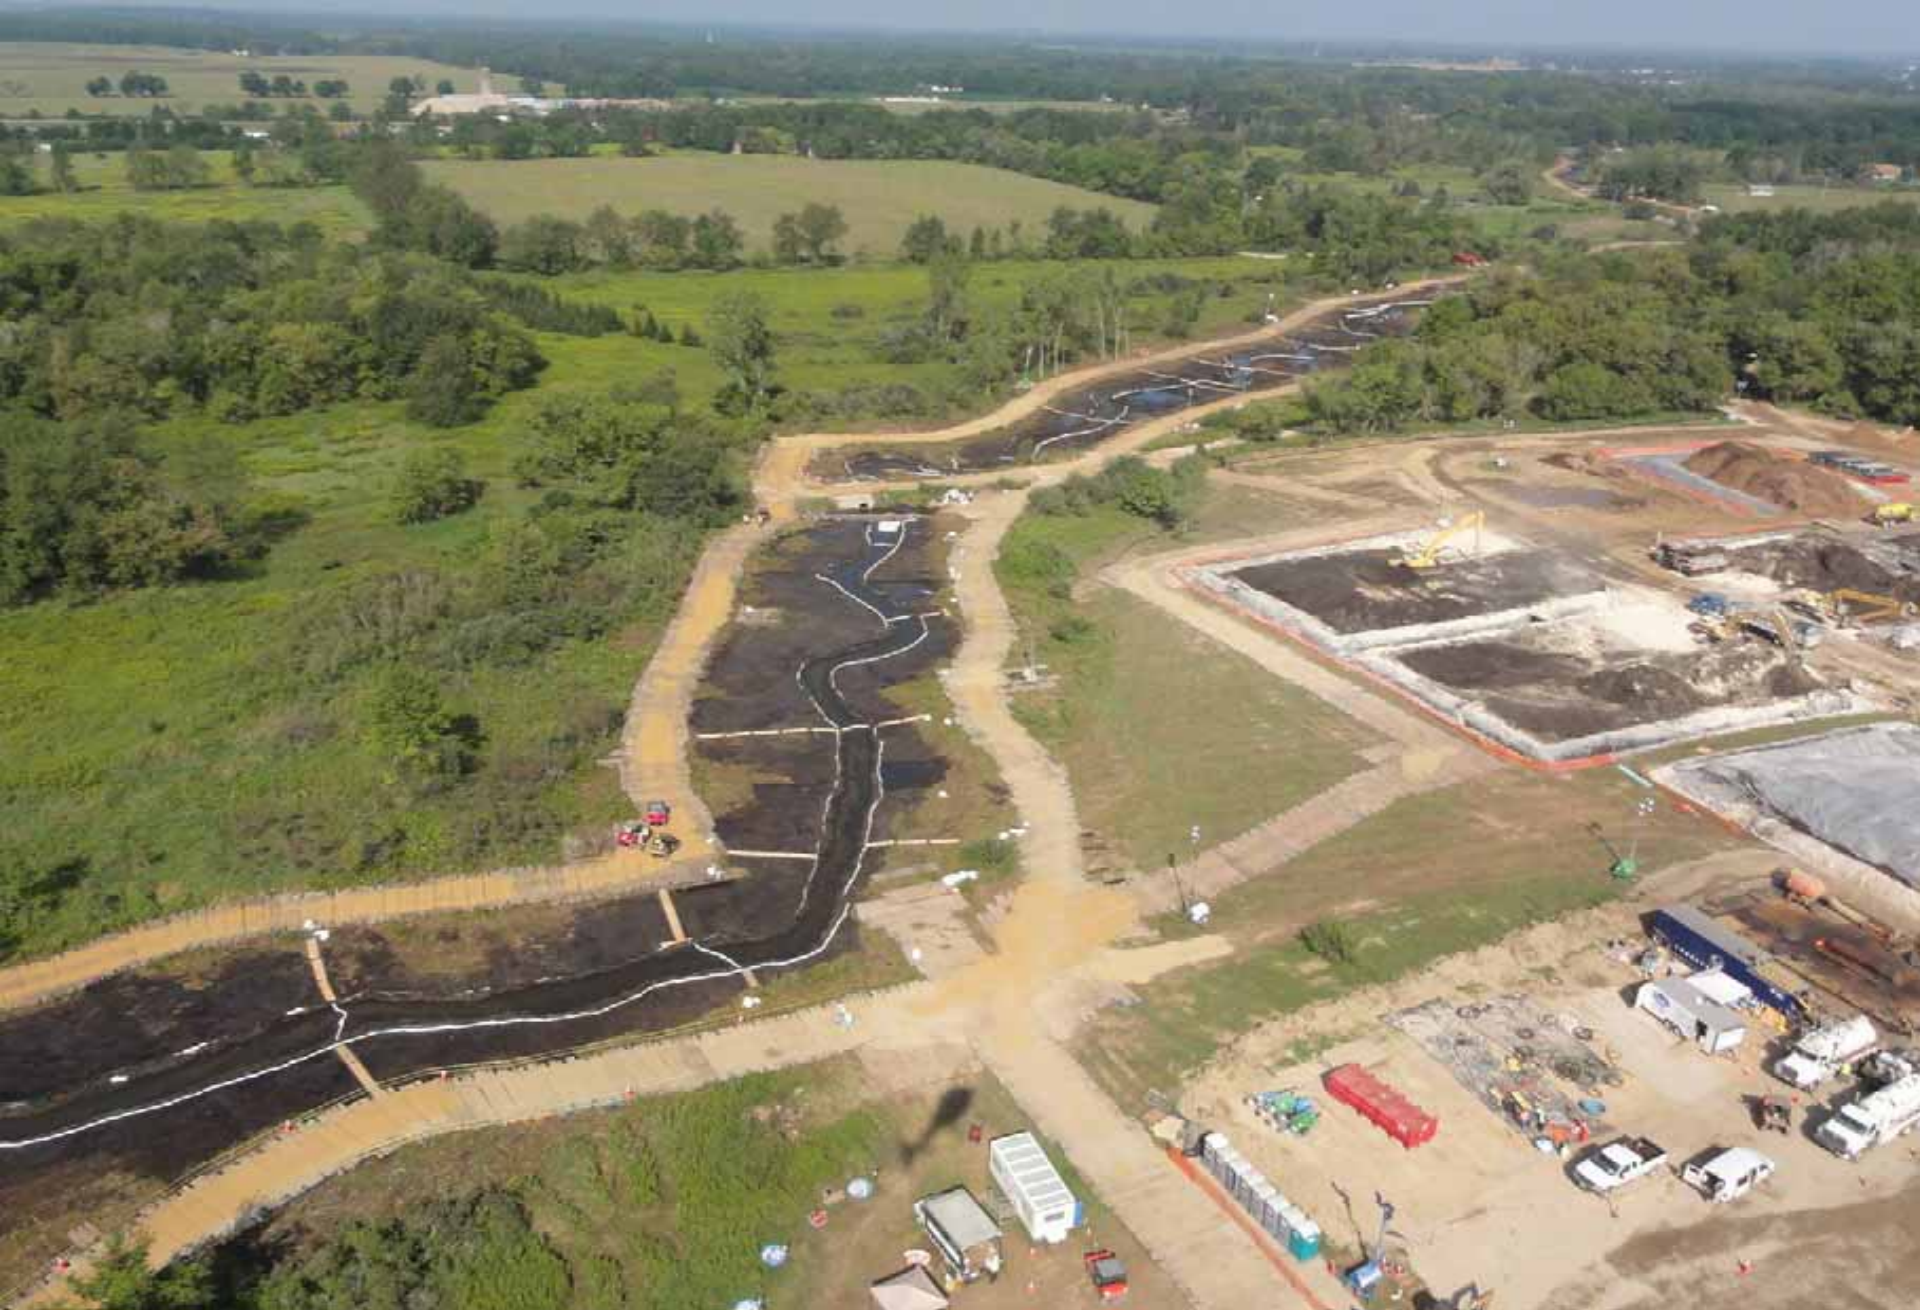
Talmadge Creek after soil scrapping was completed. Contaminated soil staging pads visible on the right side of the picture.

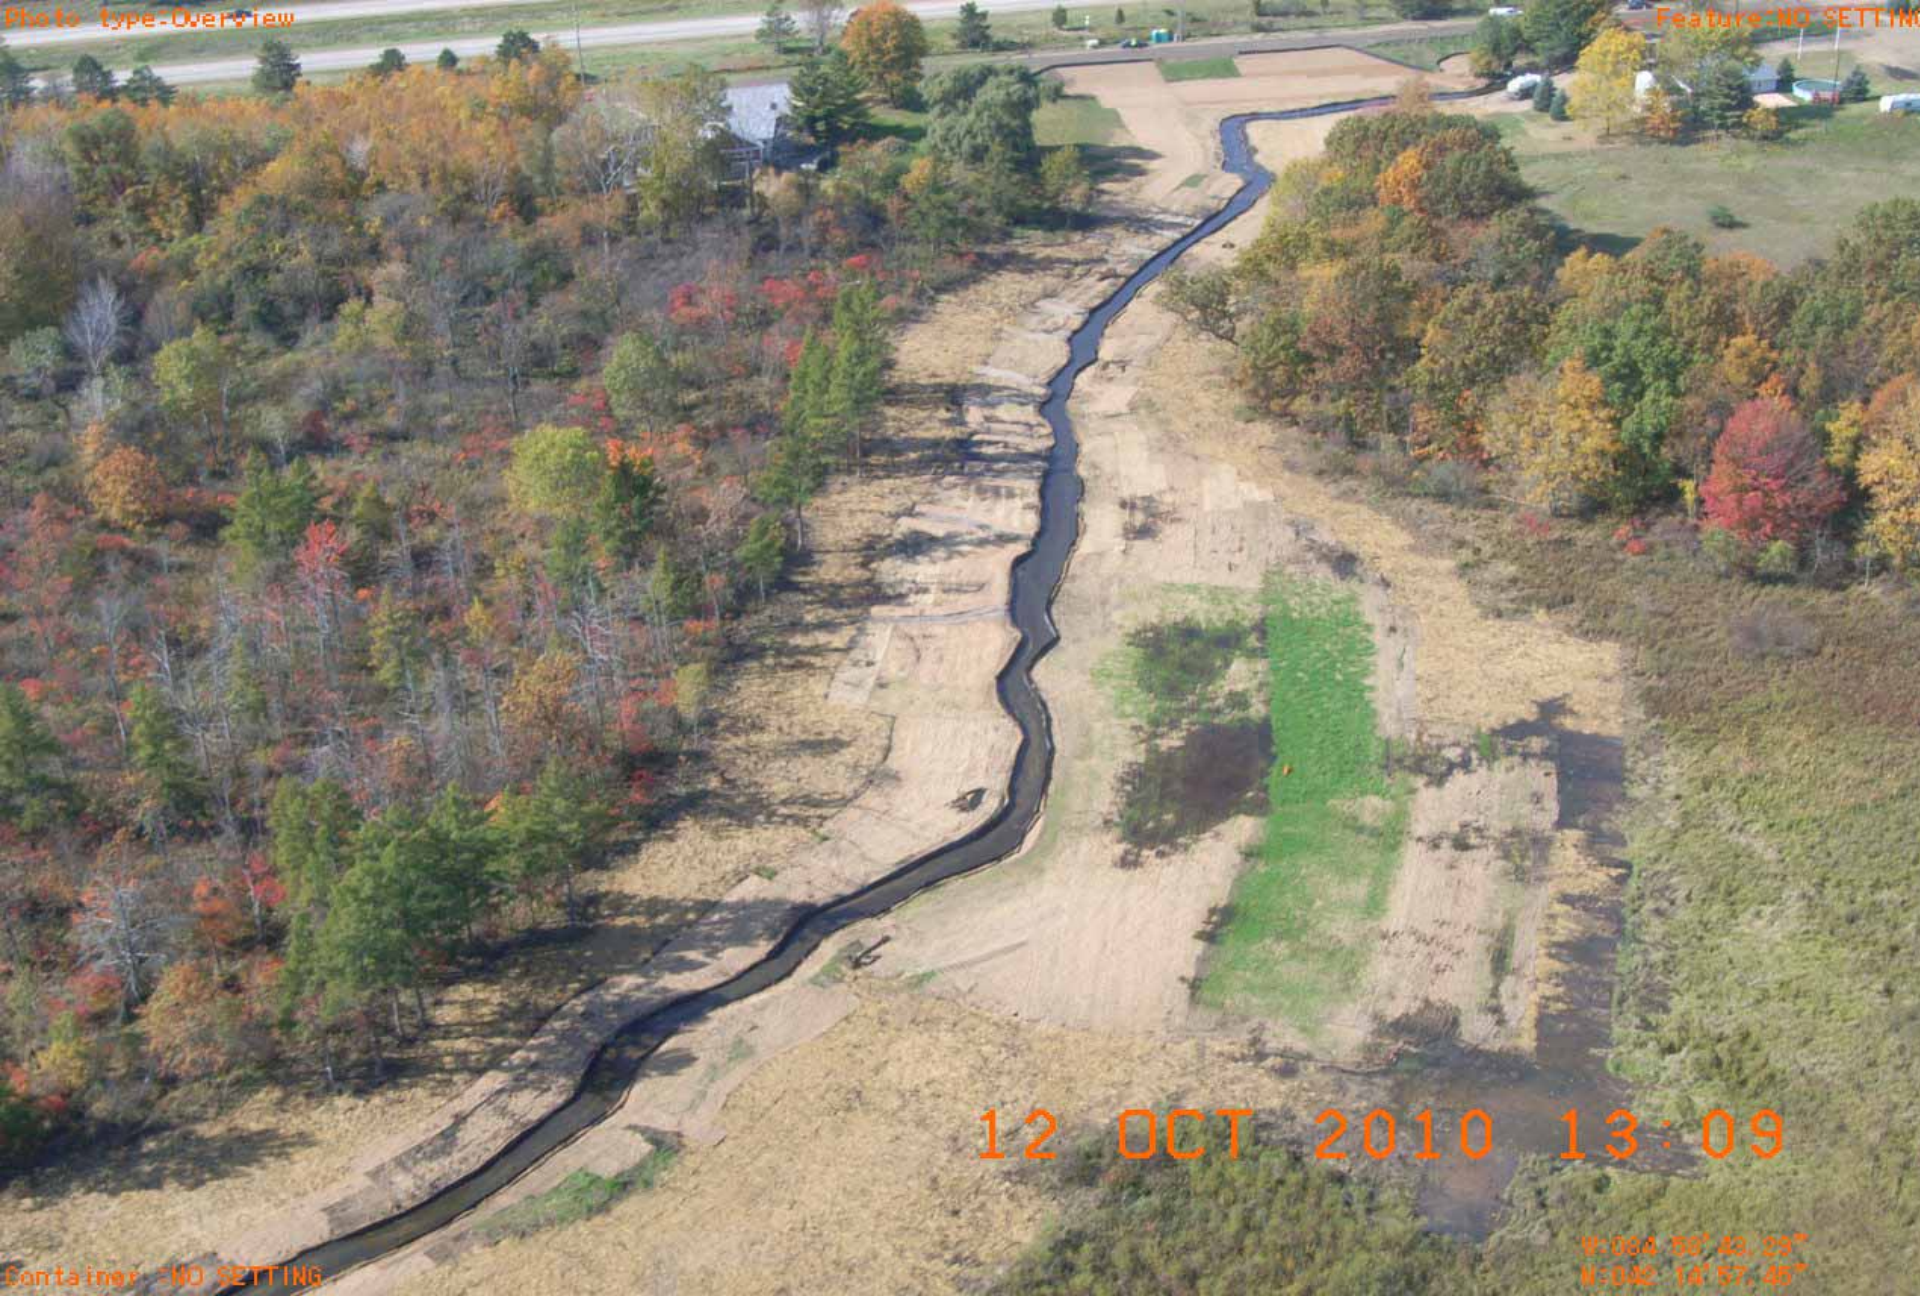
Talmadge Creek following restoration, which included soil backfilling, coconut matting, vegetation seeding, and silt fencing.

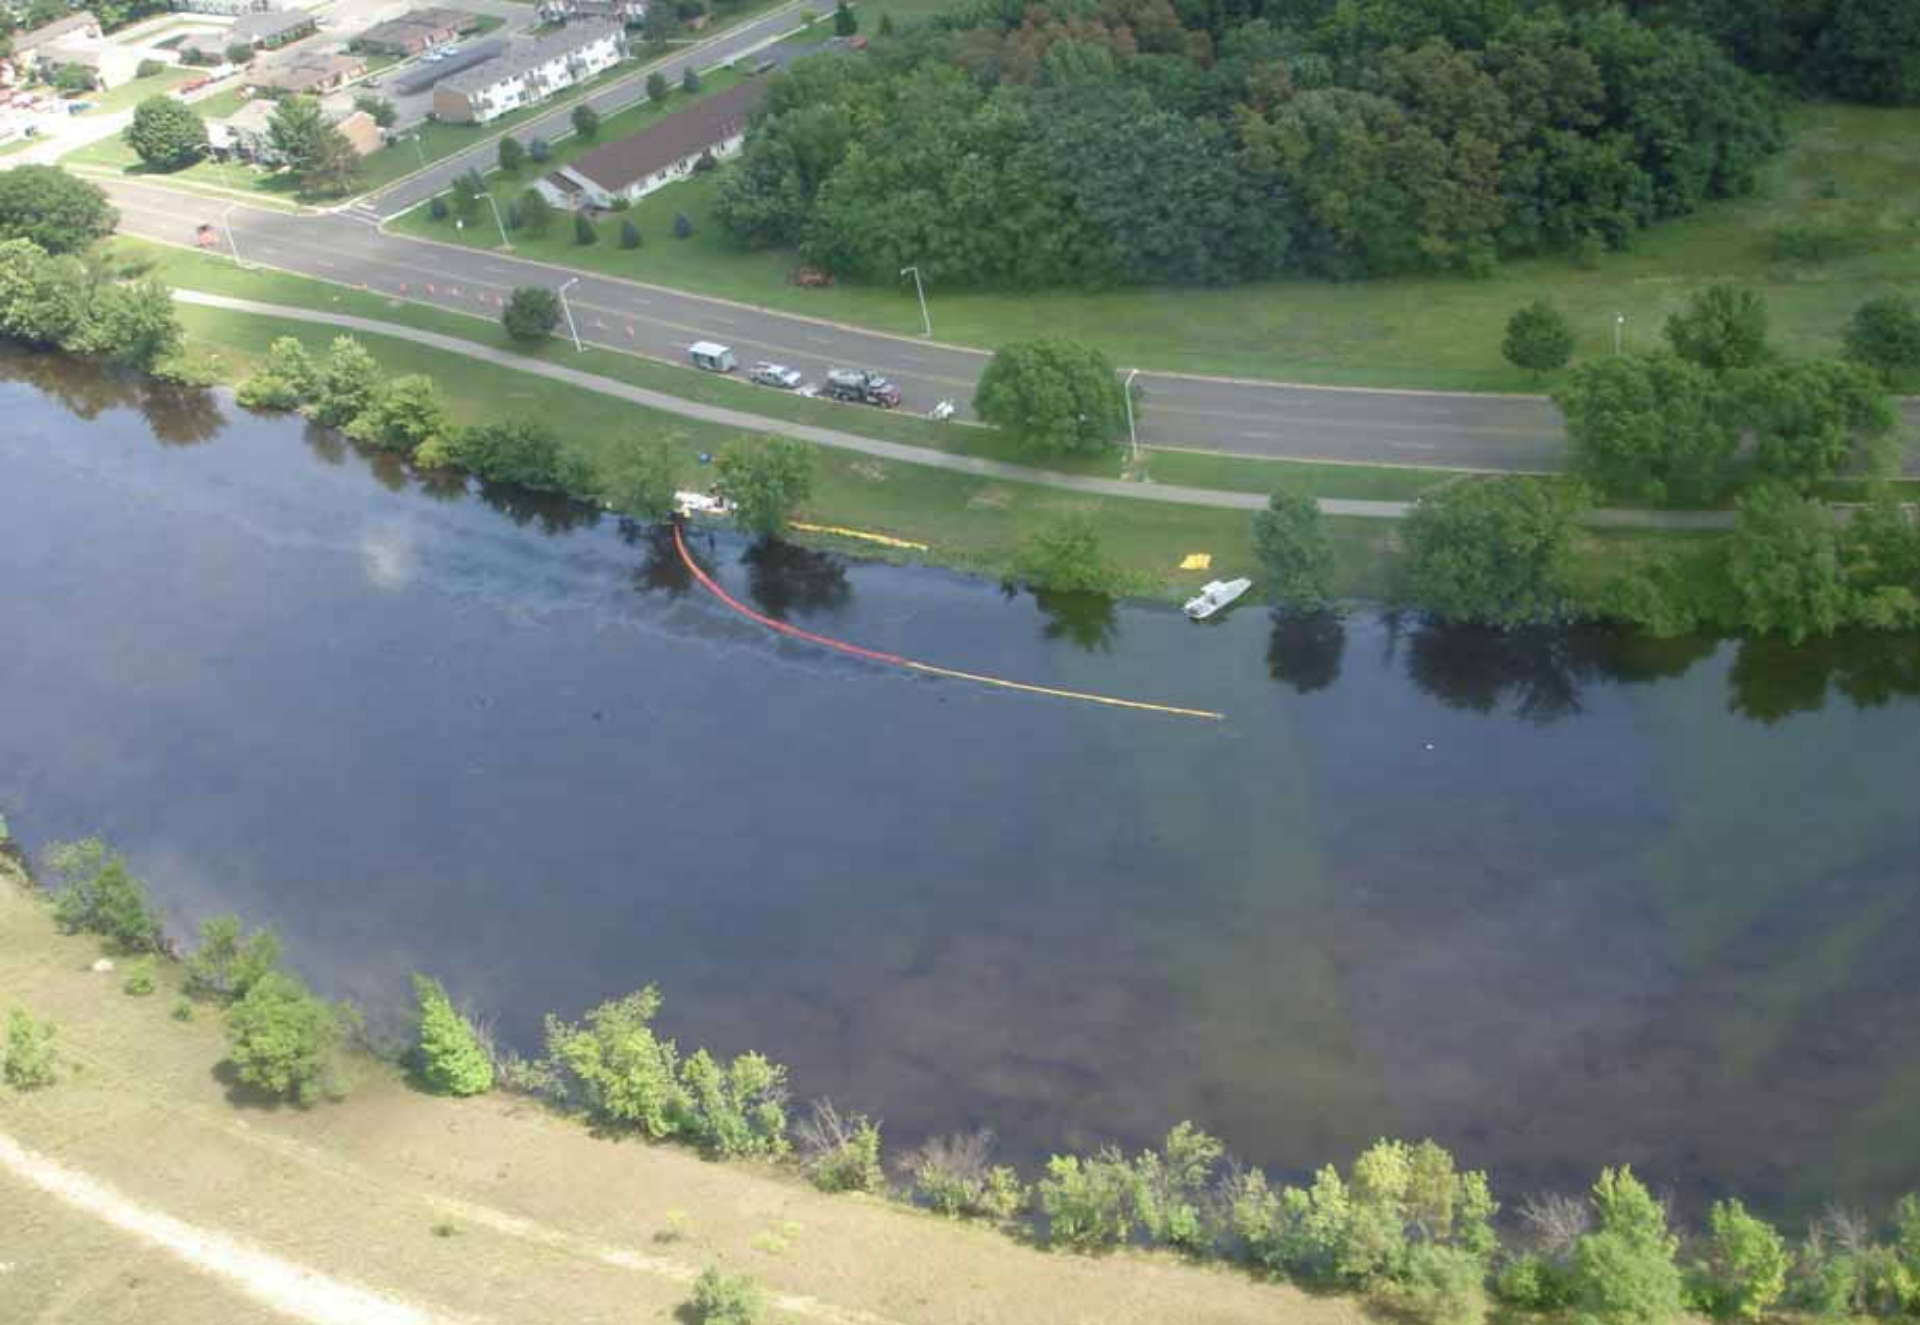
Kalamazoo River on July 26, 2010, day one of the response: oil covered the river from bank to bank.

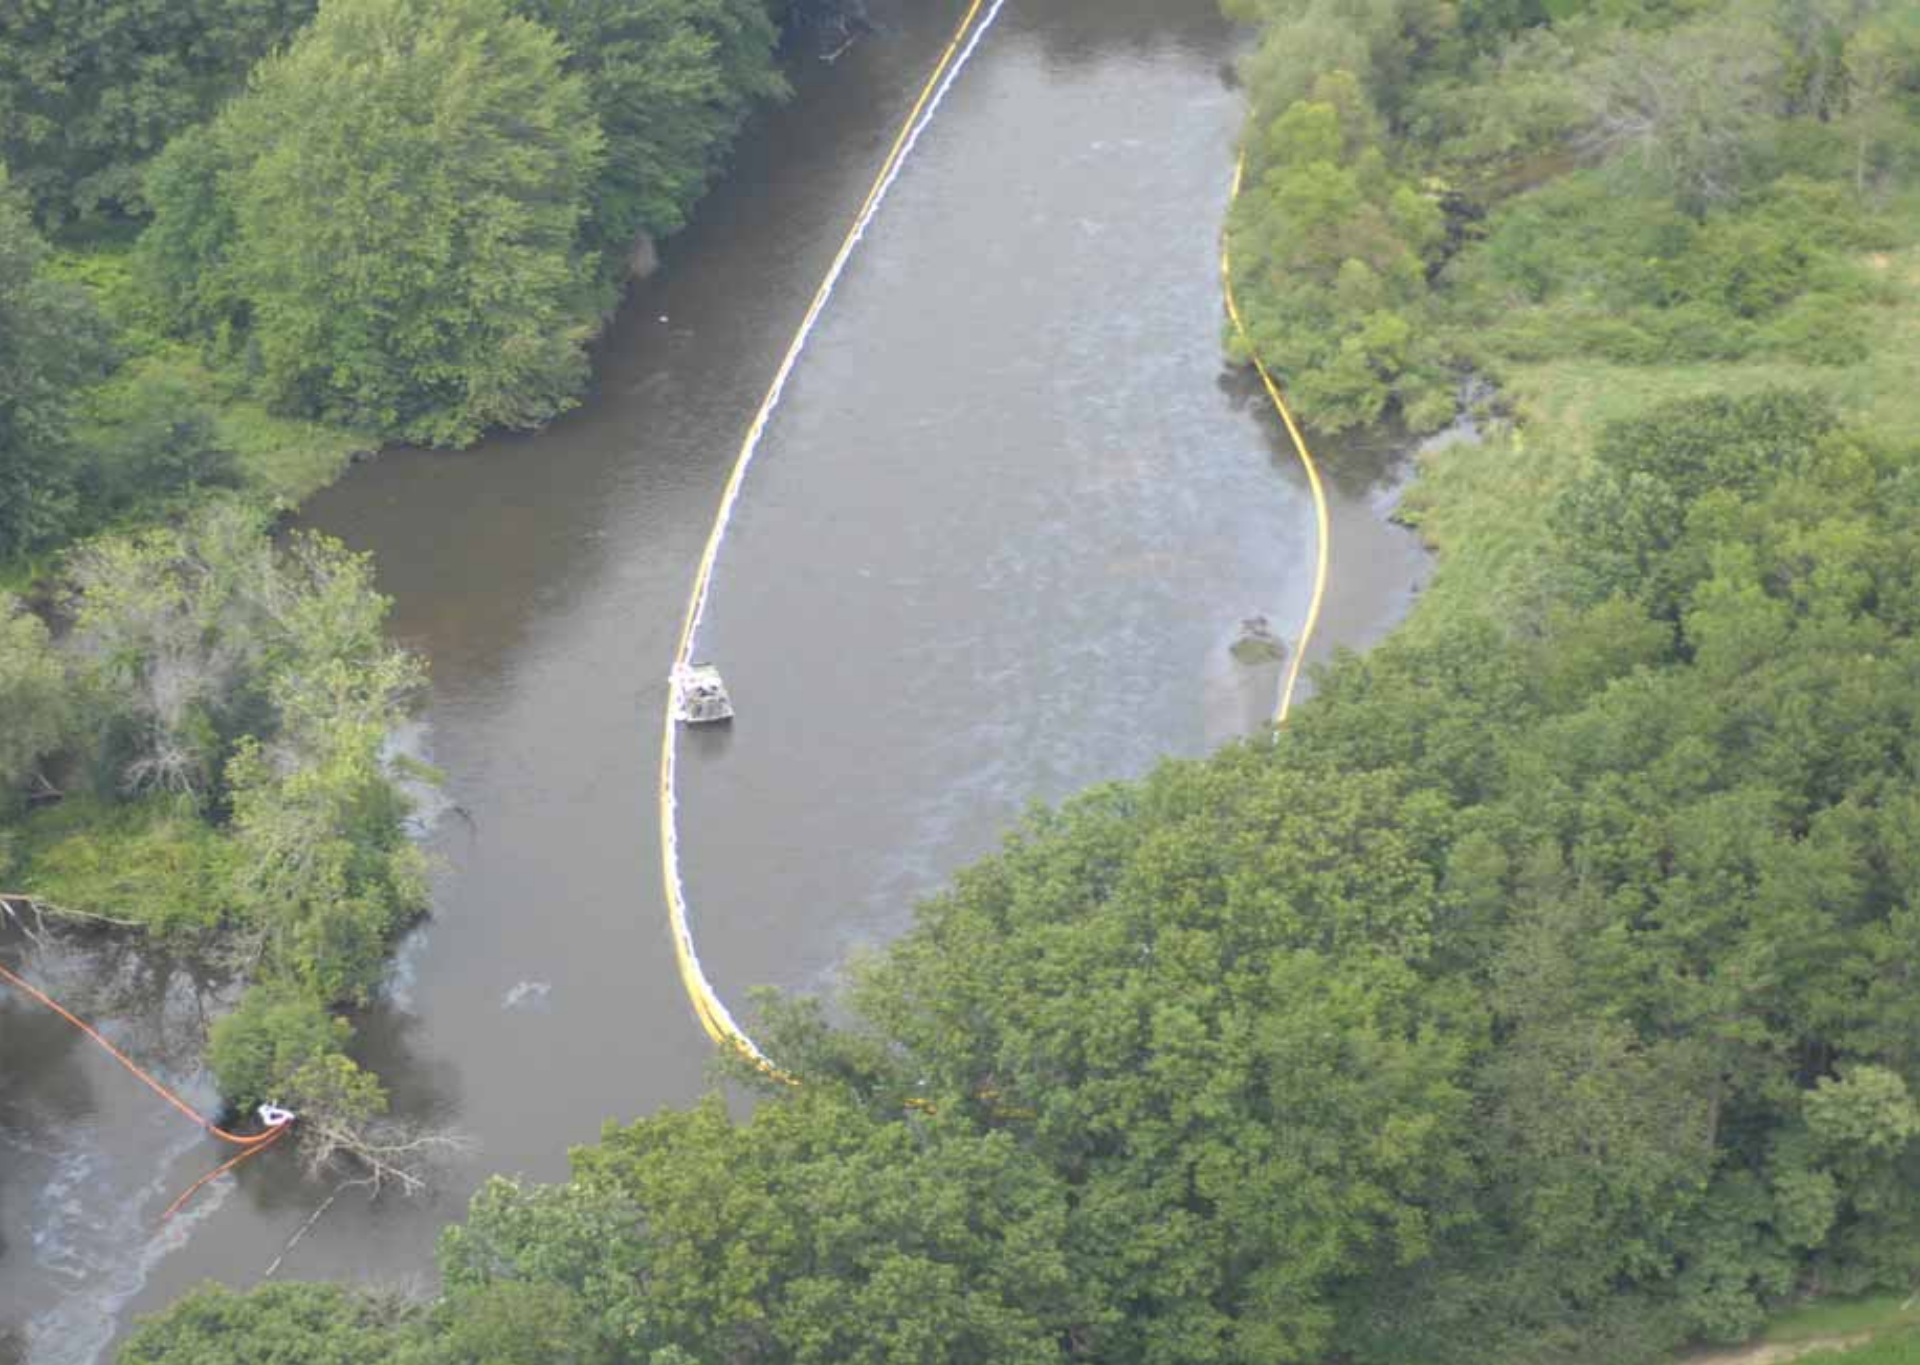
Within one week, presence of heavy oil reduced to a sheen.

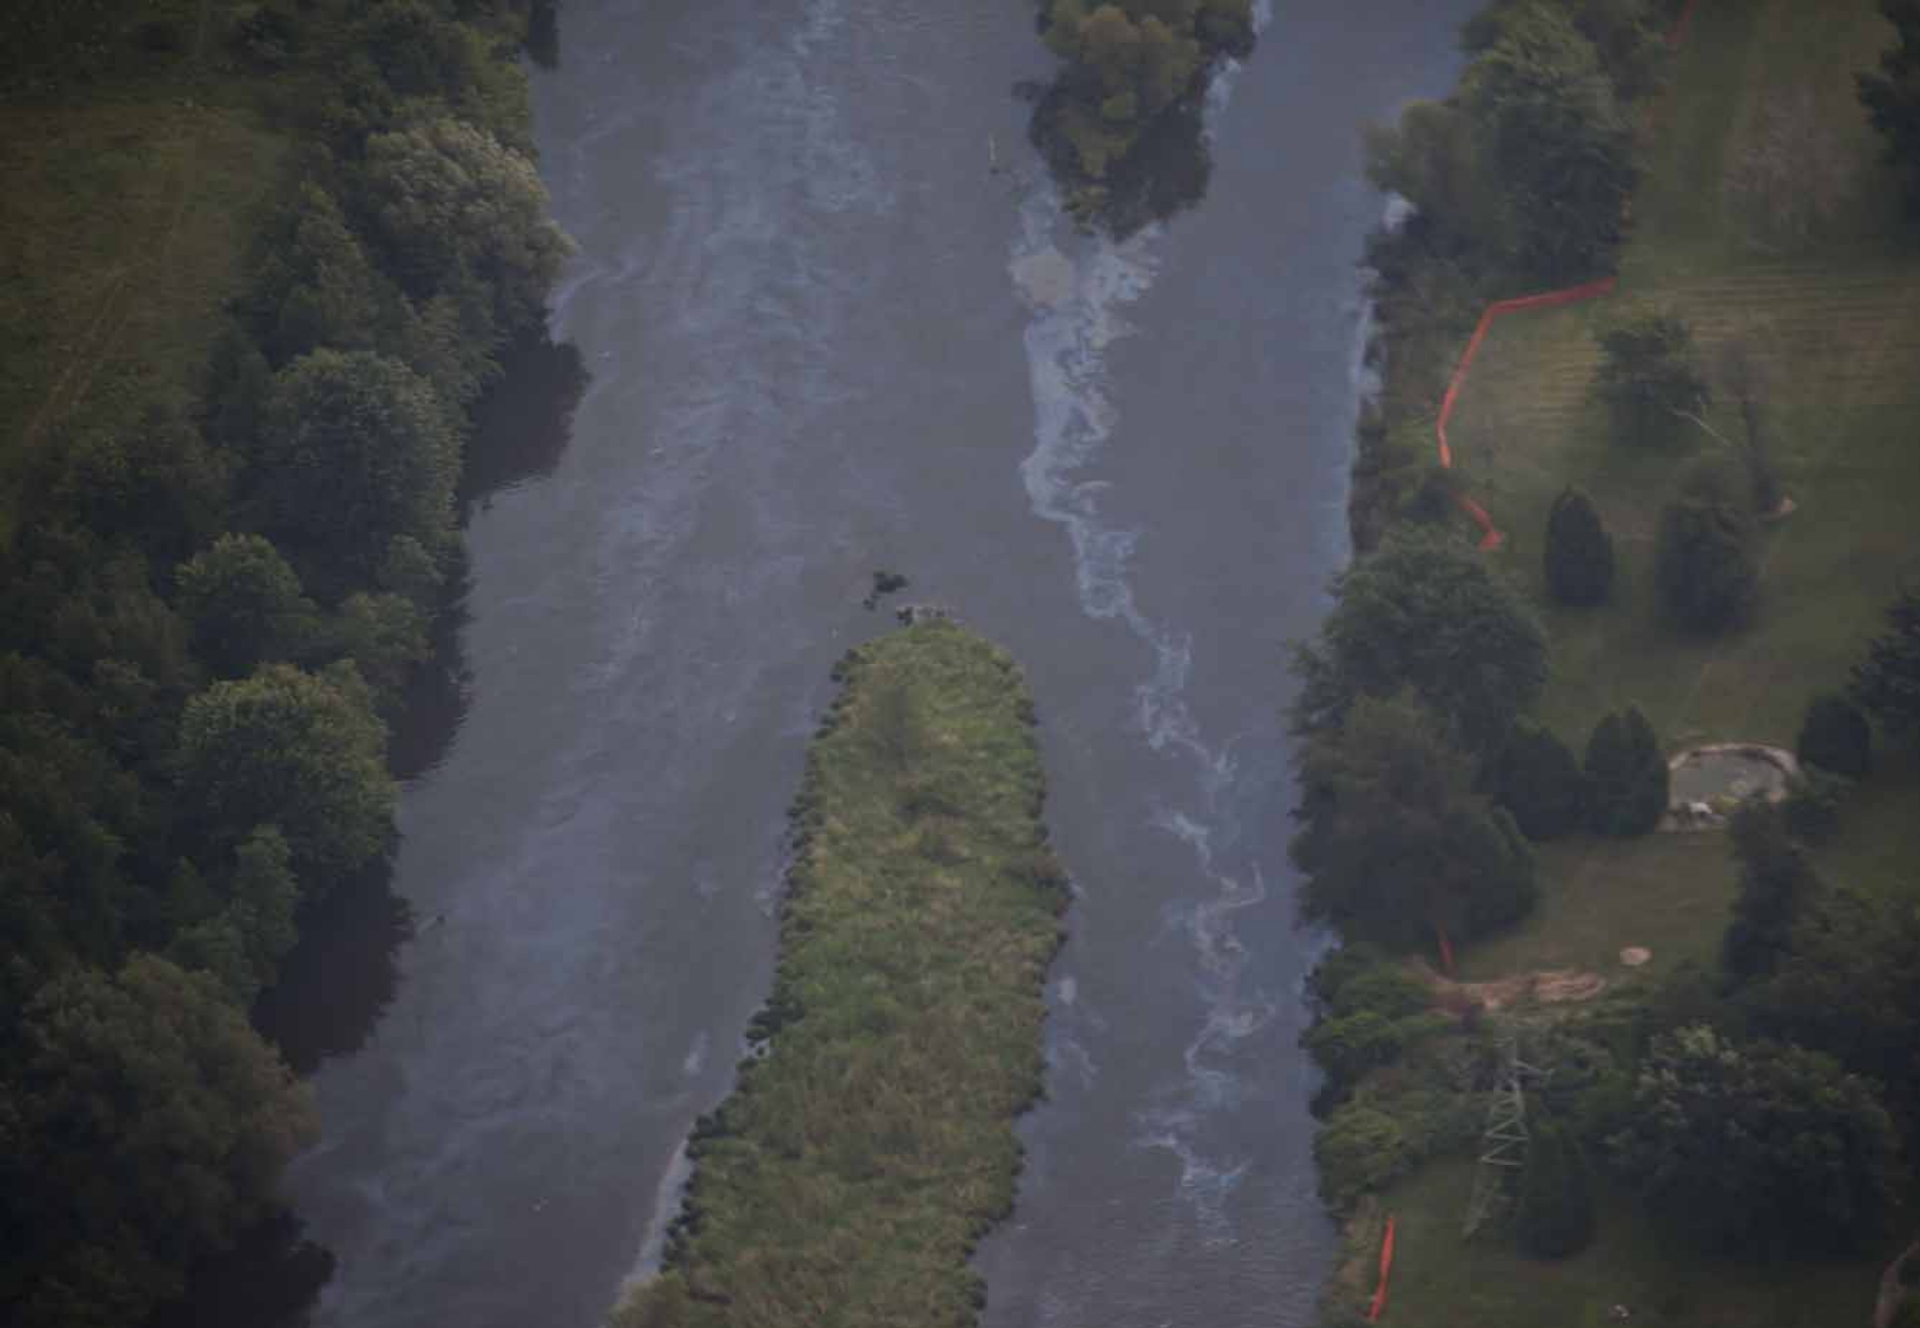
In August 2010, most sheen production came from contaminated vegetation on the riverbanks and islands.

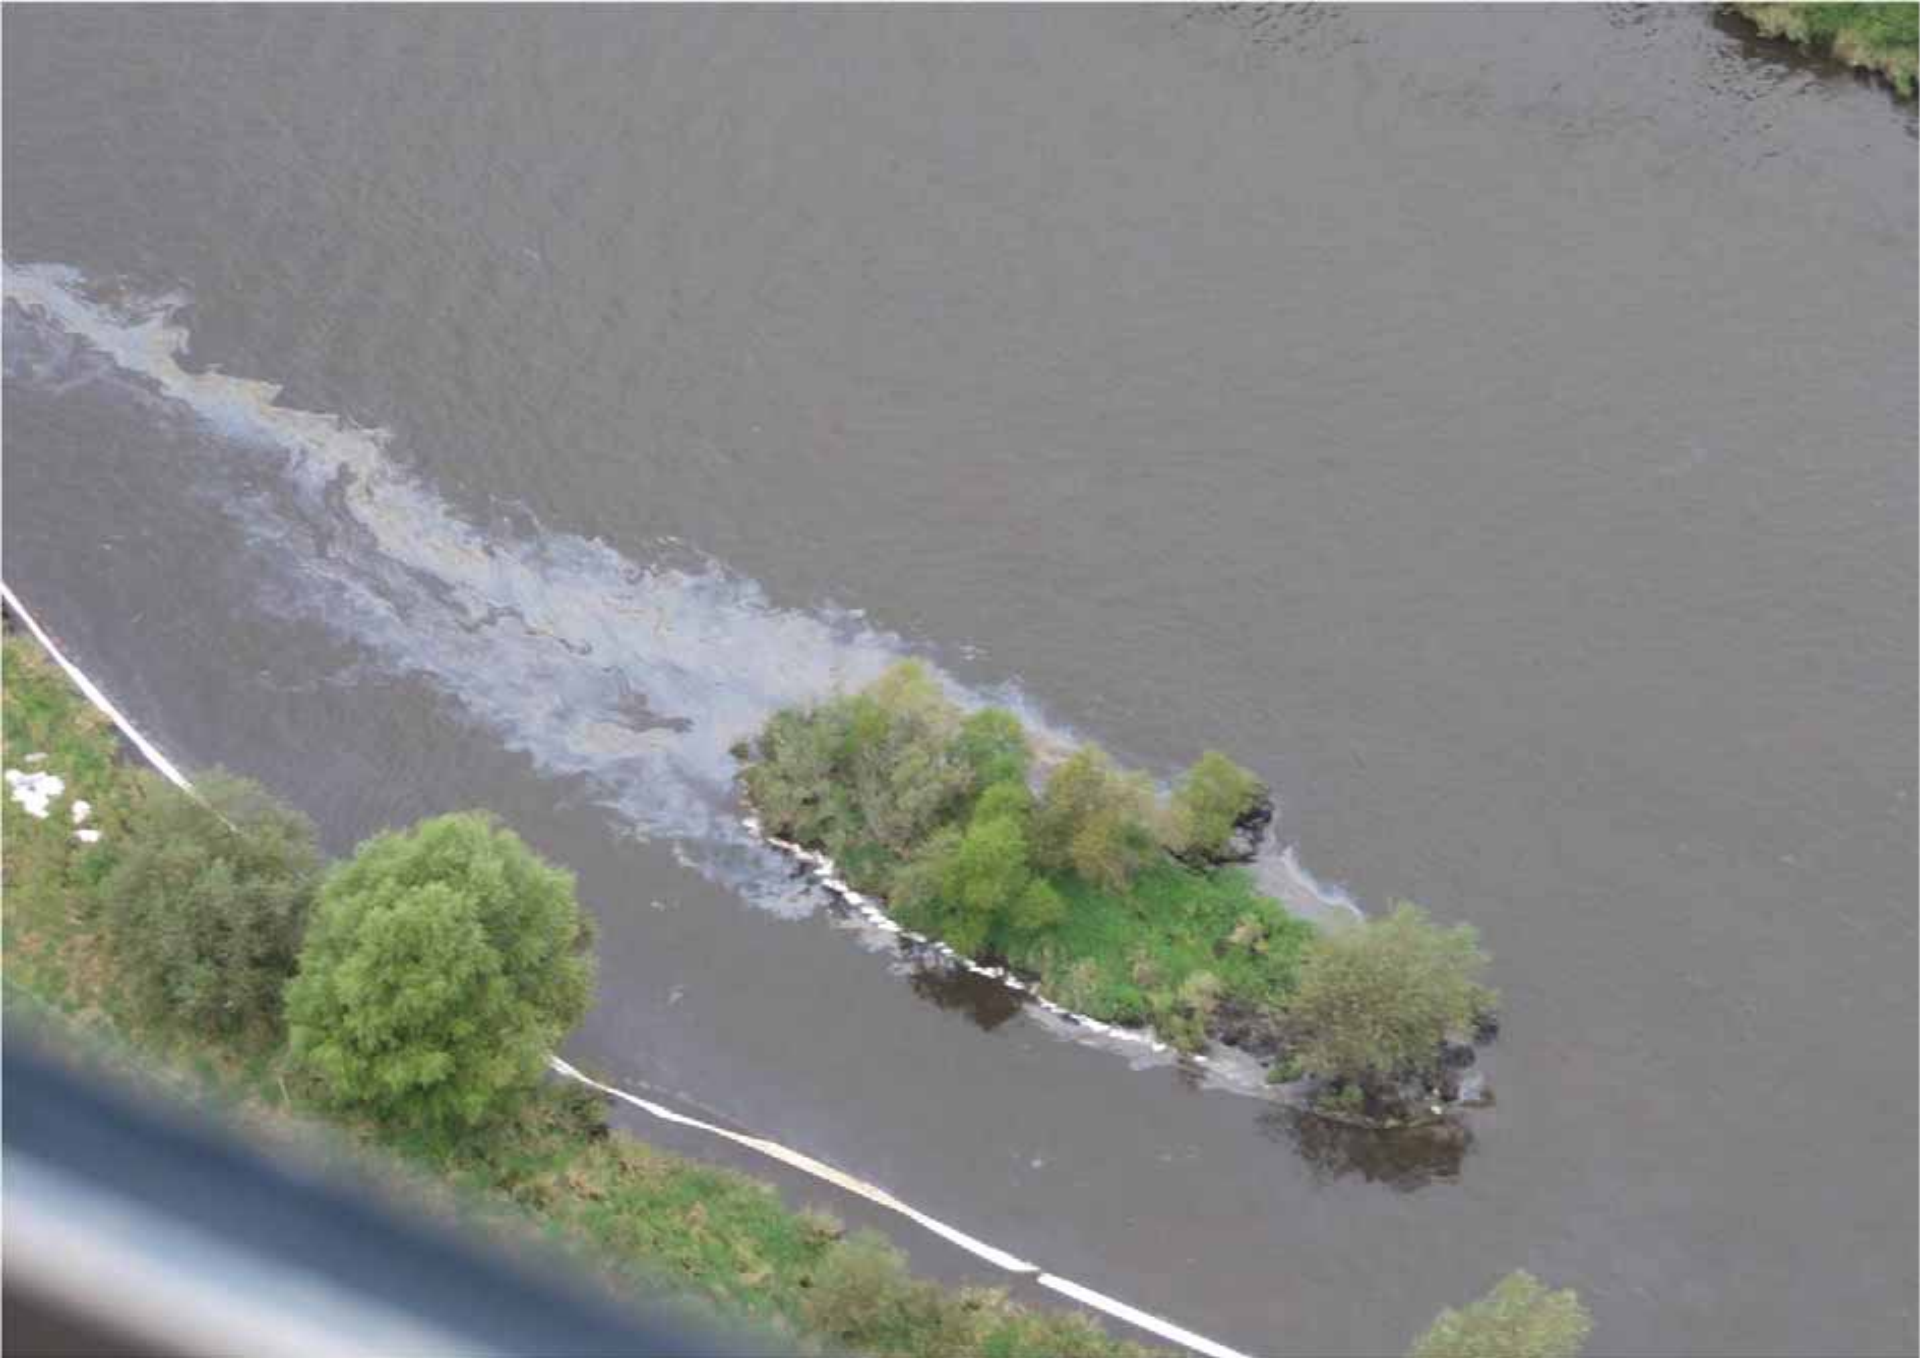
Example of sheening during week two and three of the response.

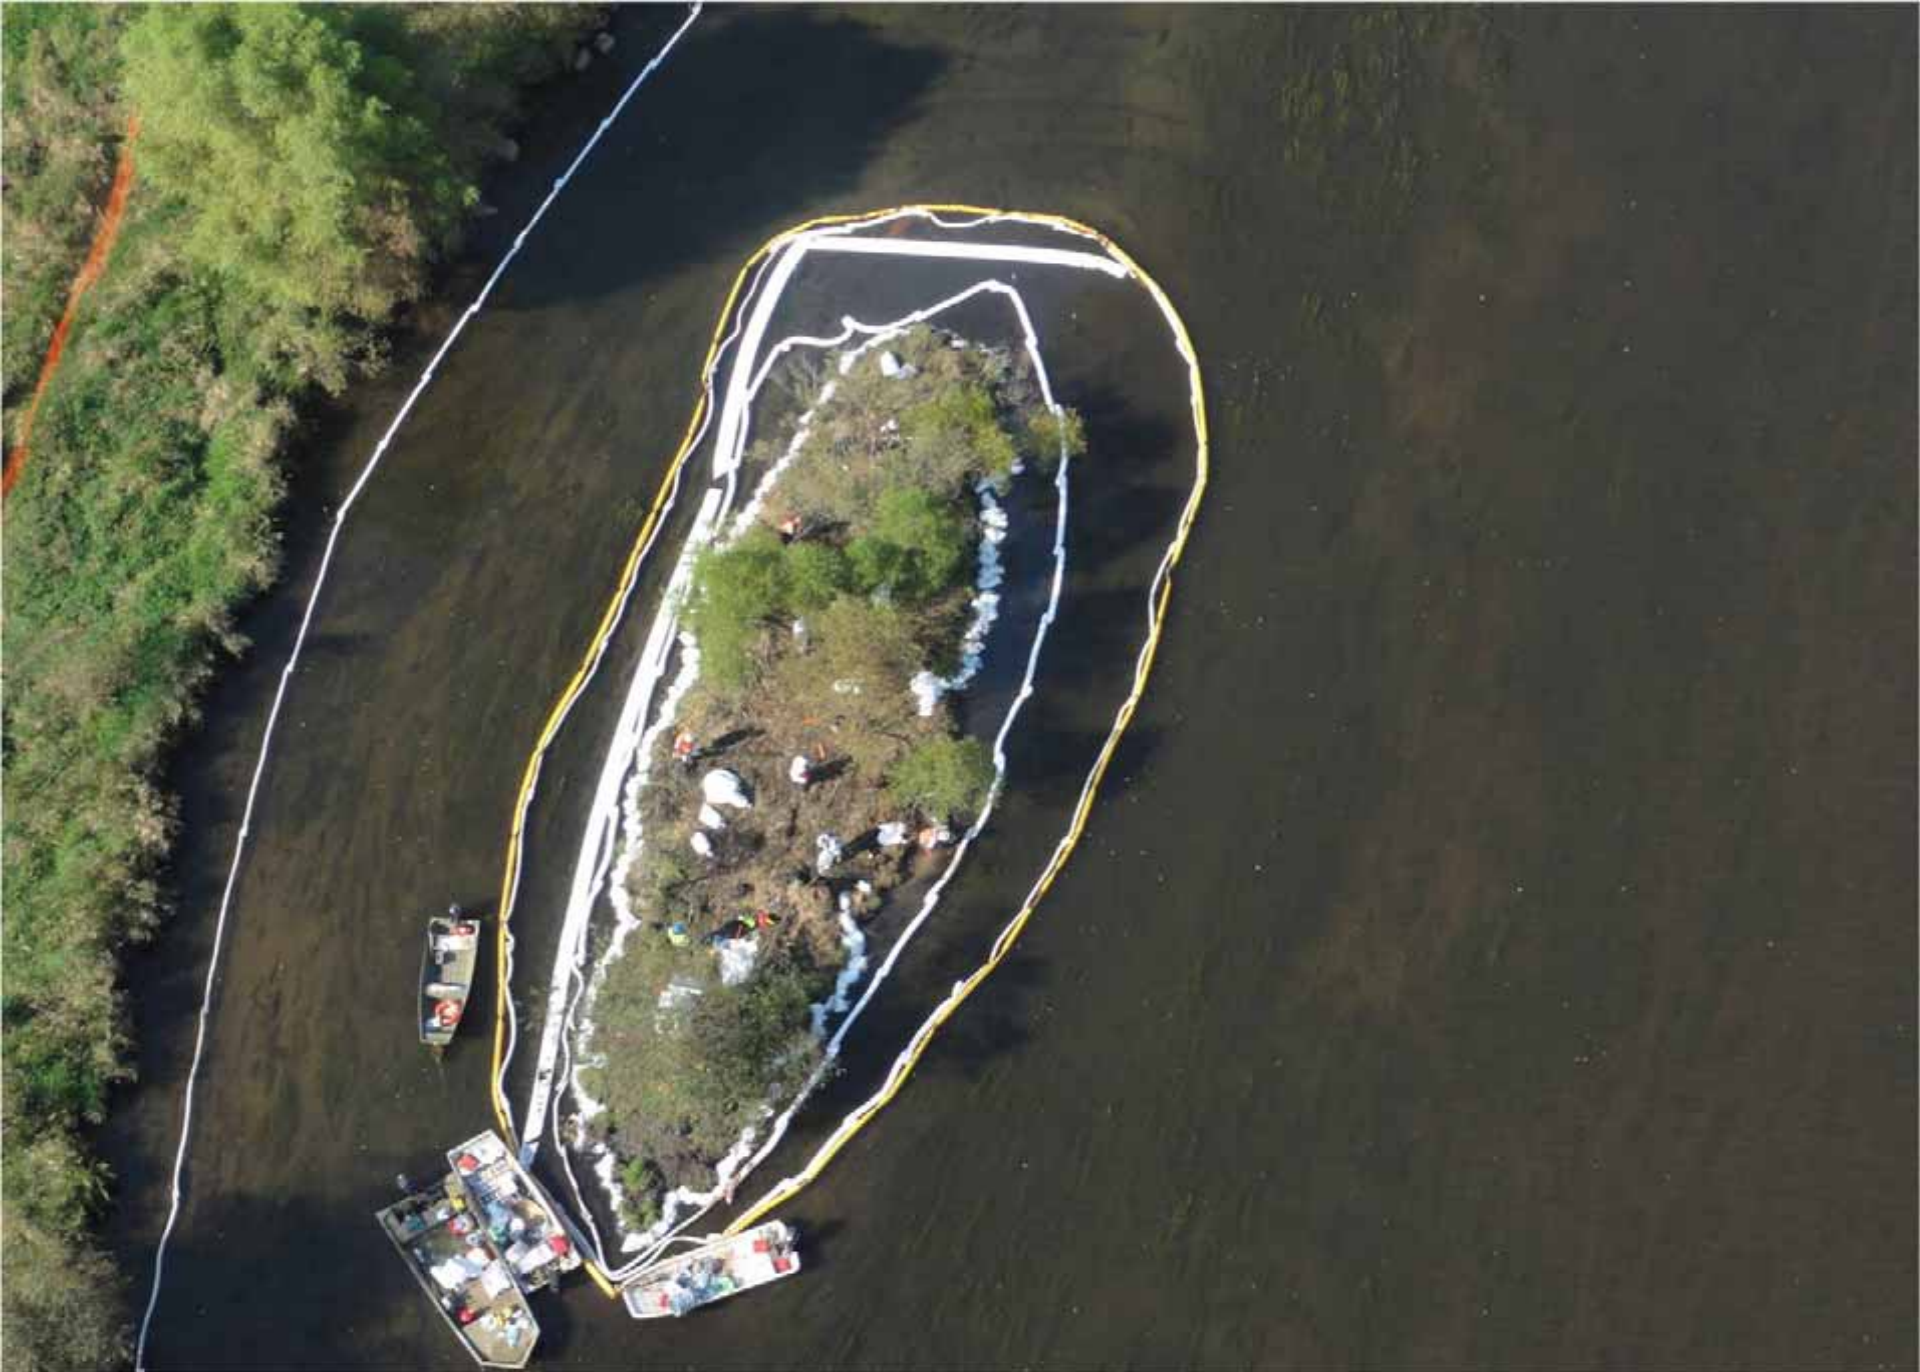
By mid-August, all contaminated islands were contained.

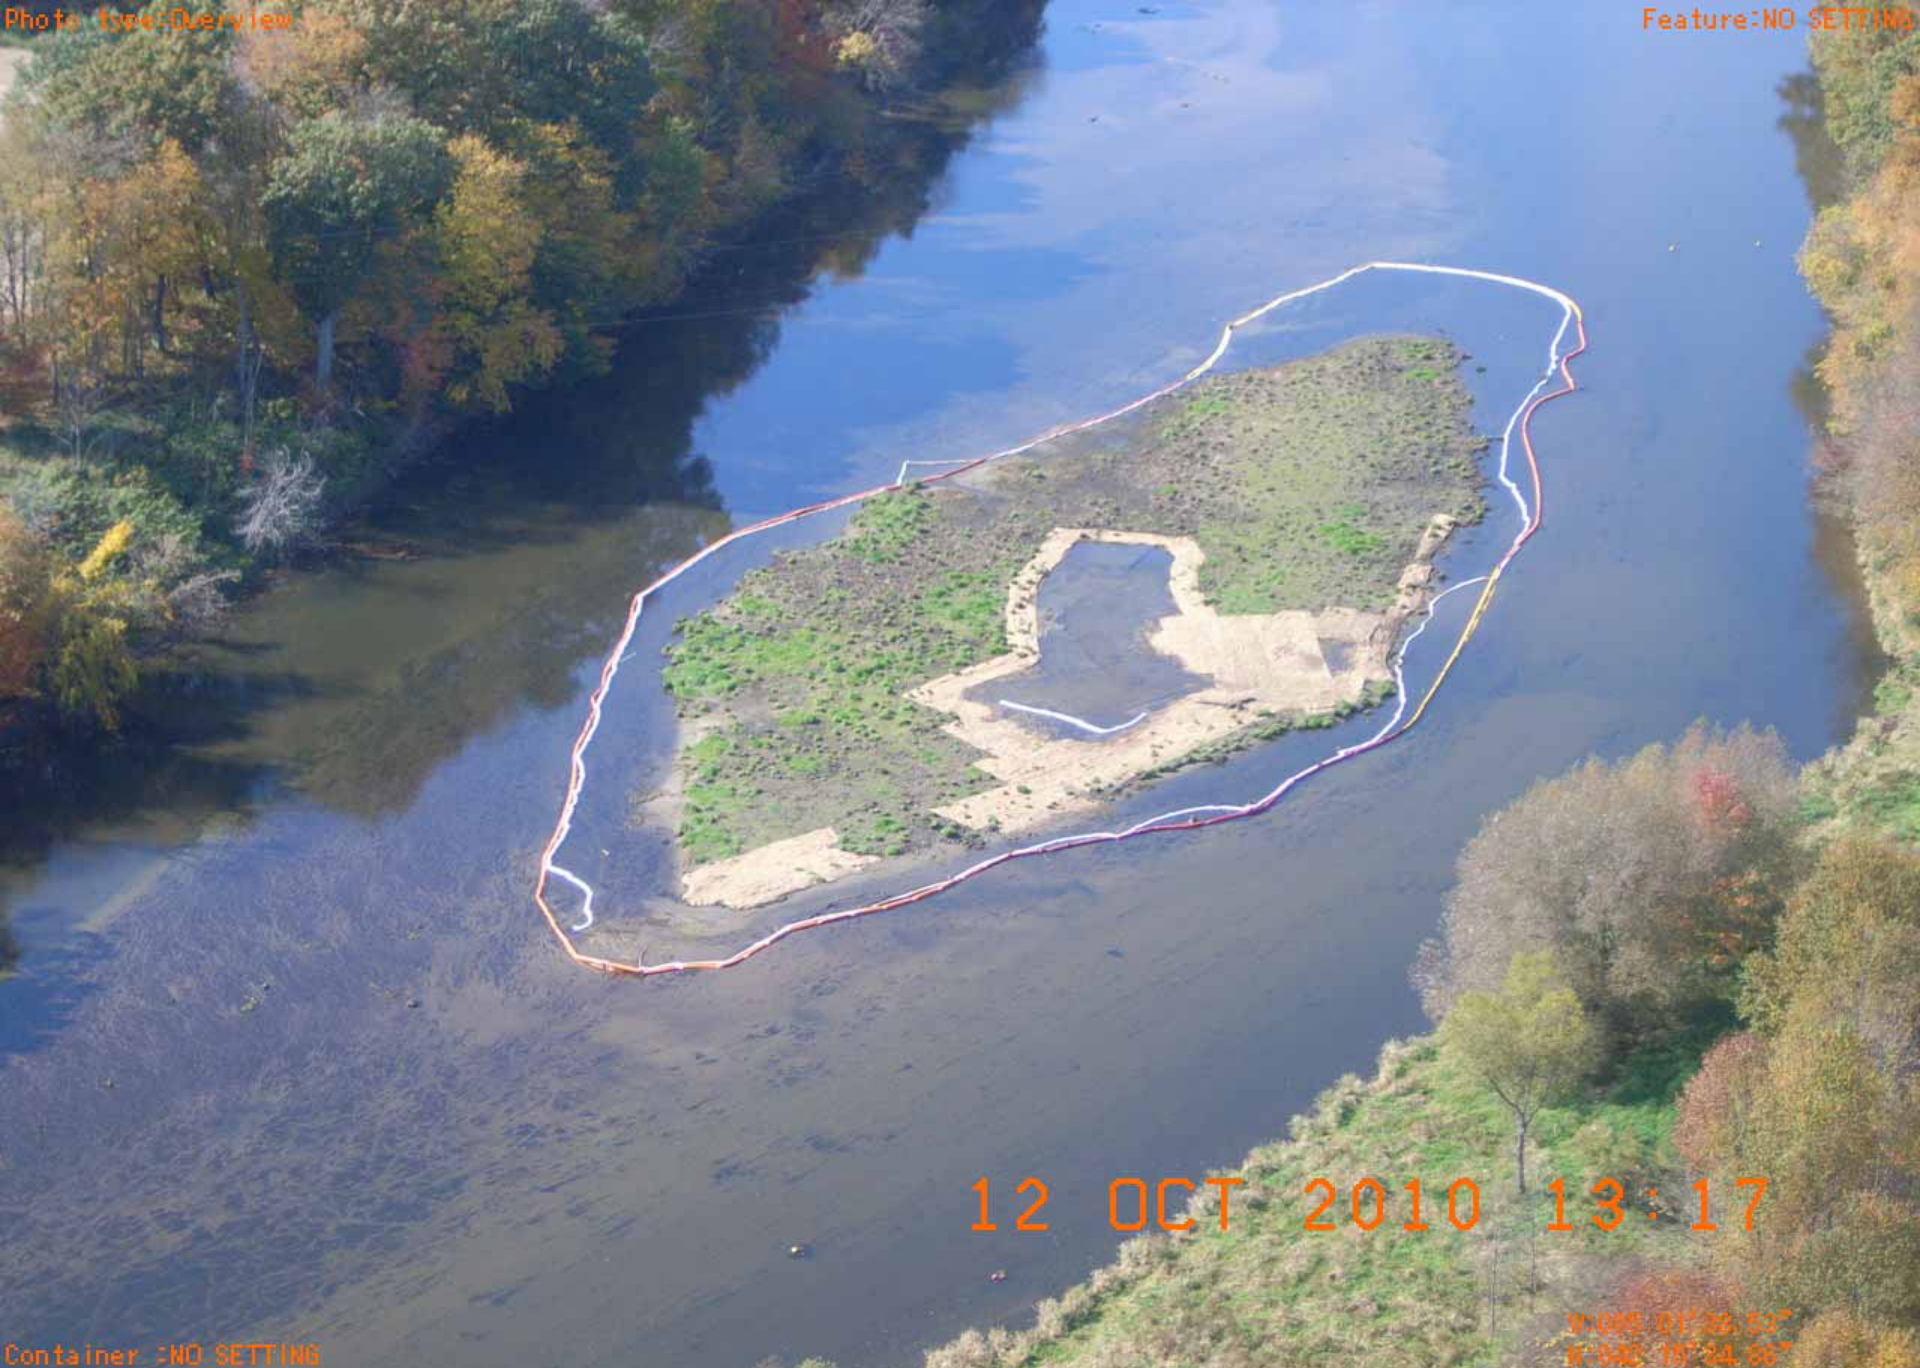
Some islands required soil removal.

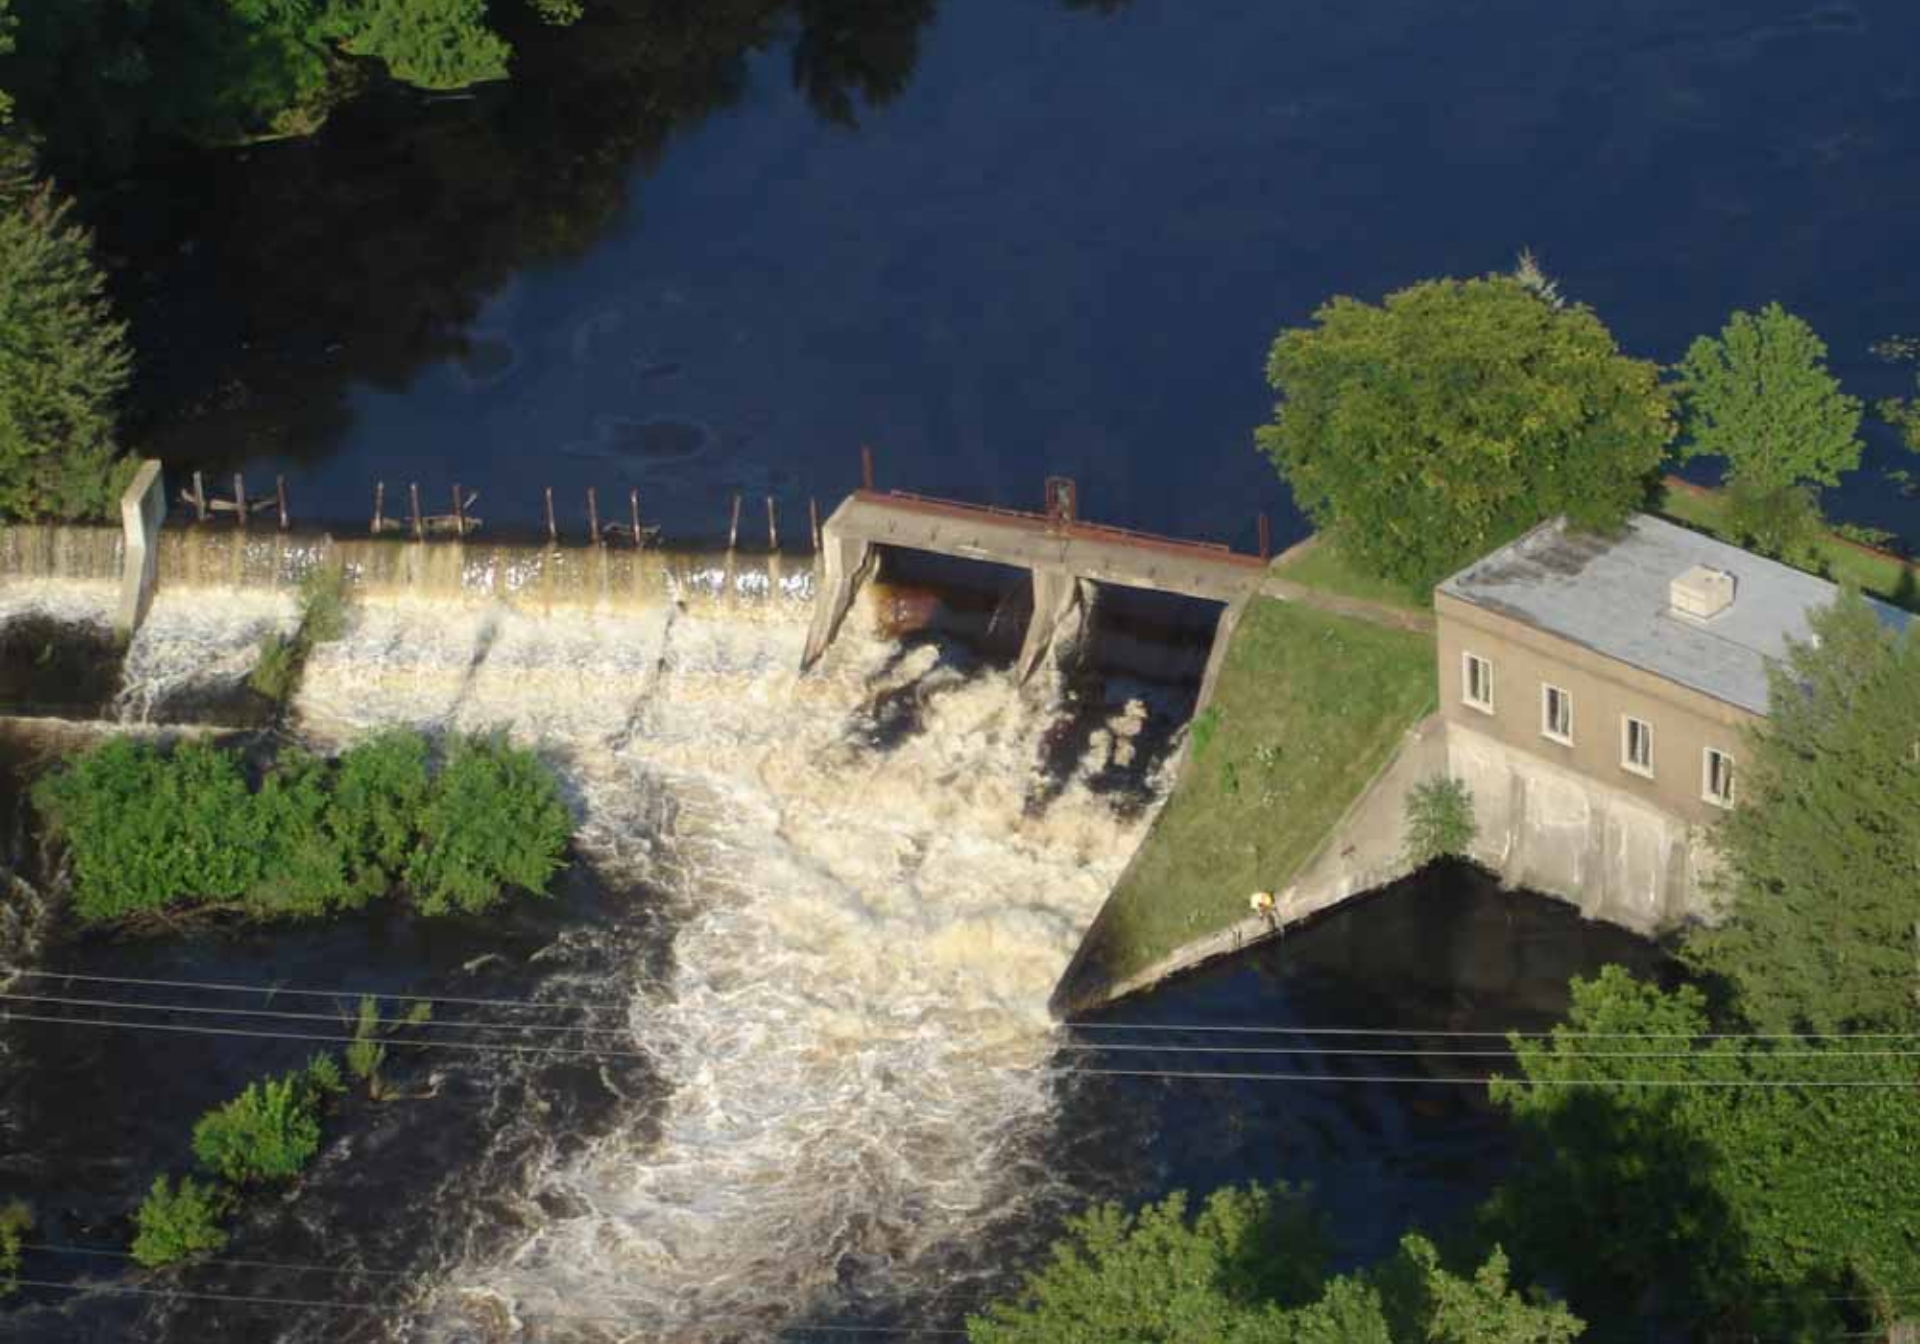
July 26, 2010, Ceresco Dam: note the oil flowing over the dam.
