Enbridge Line 6B Incident

Public Update and Availability Session

October 14, 2010
(Day 81)

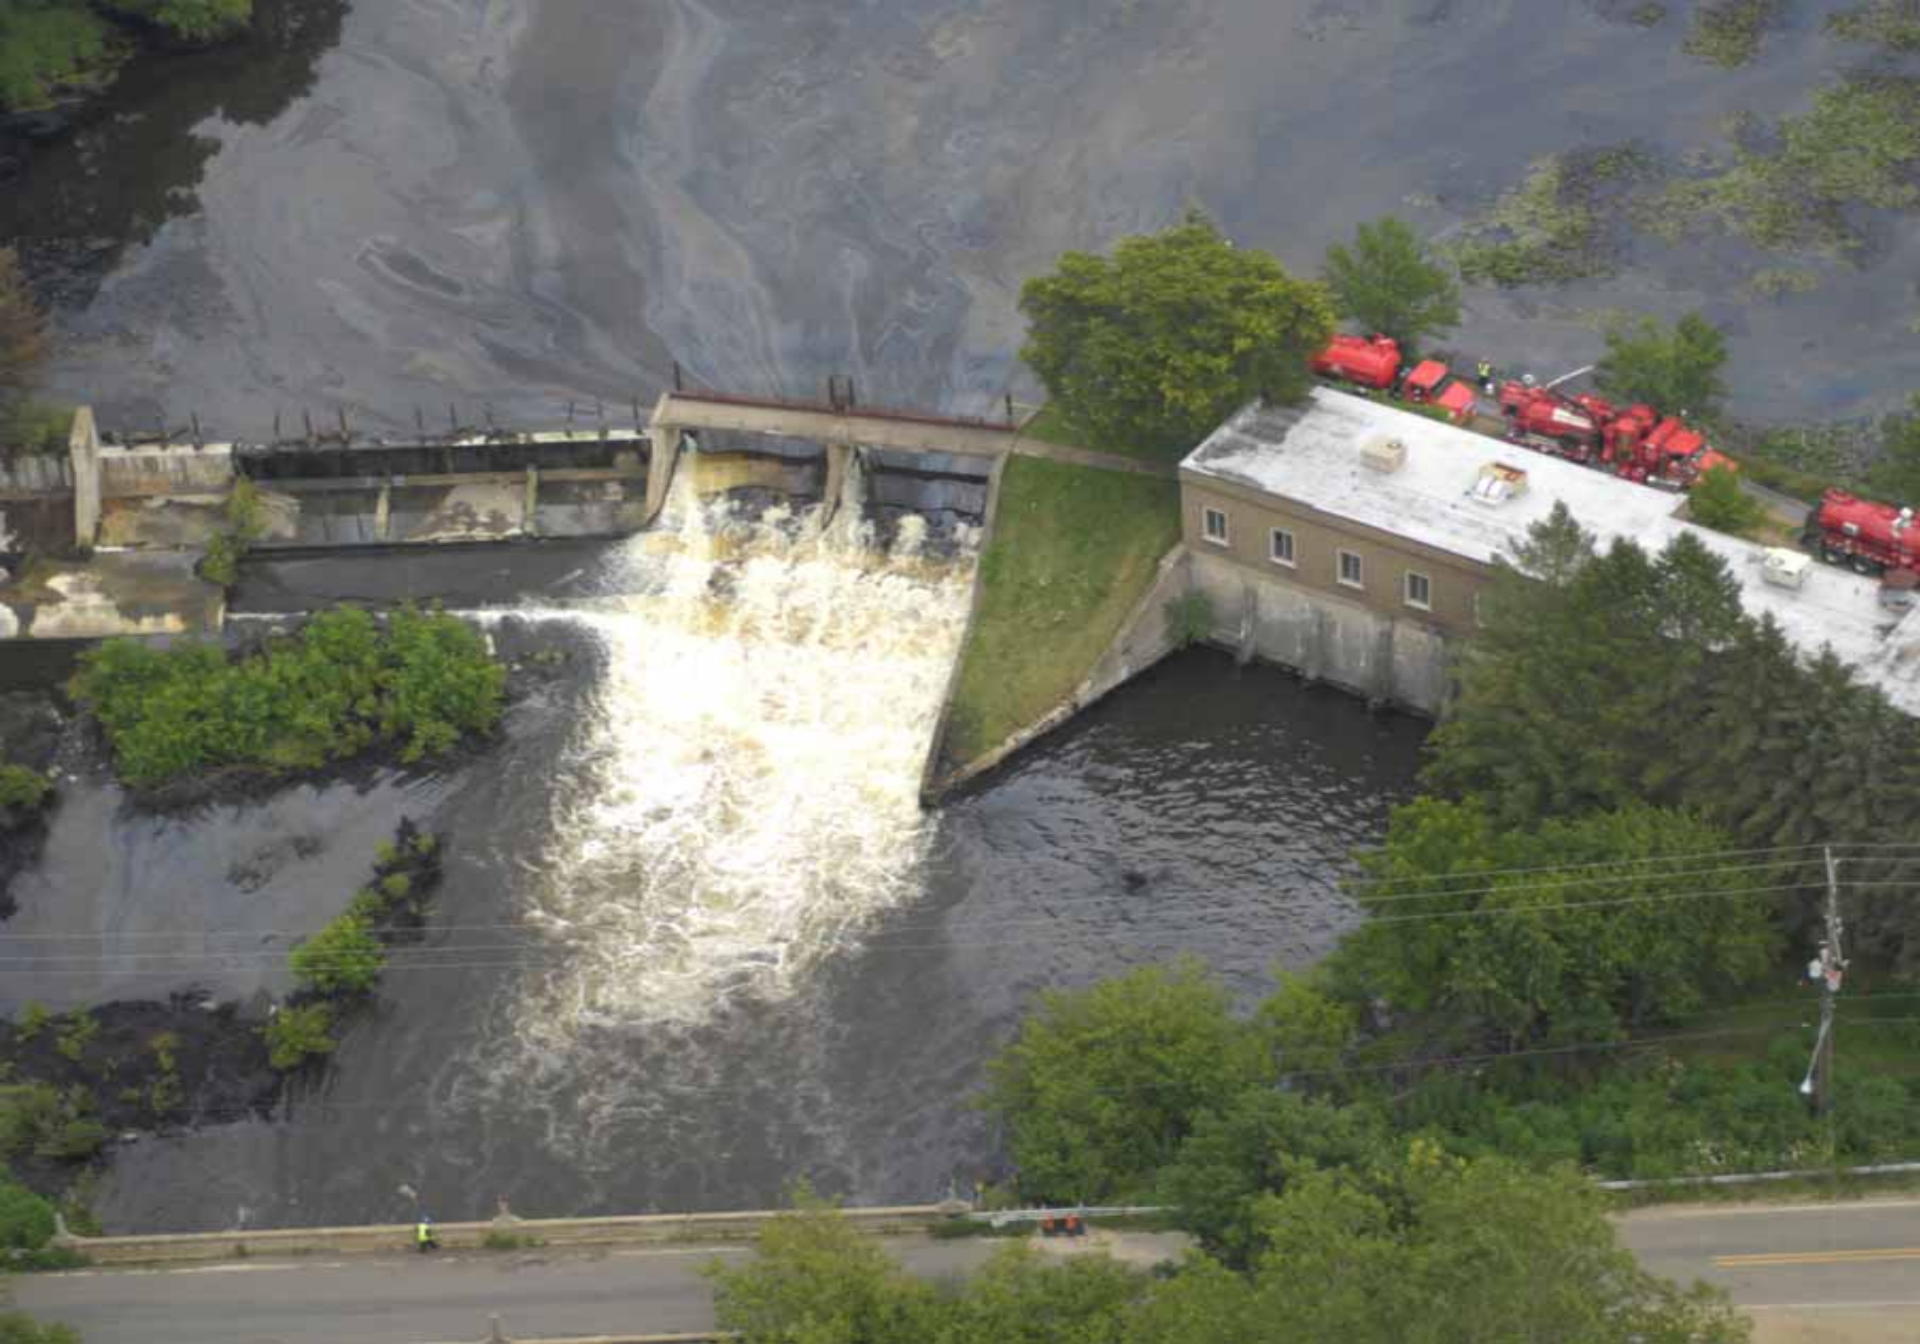
By the end of the first week, oil reduced to a heavy sheen.

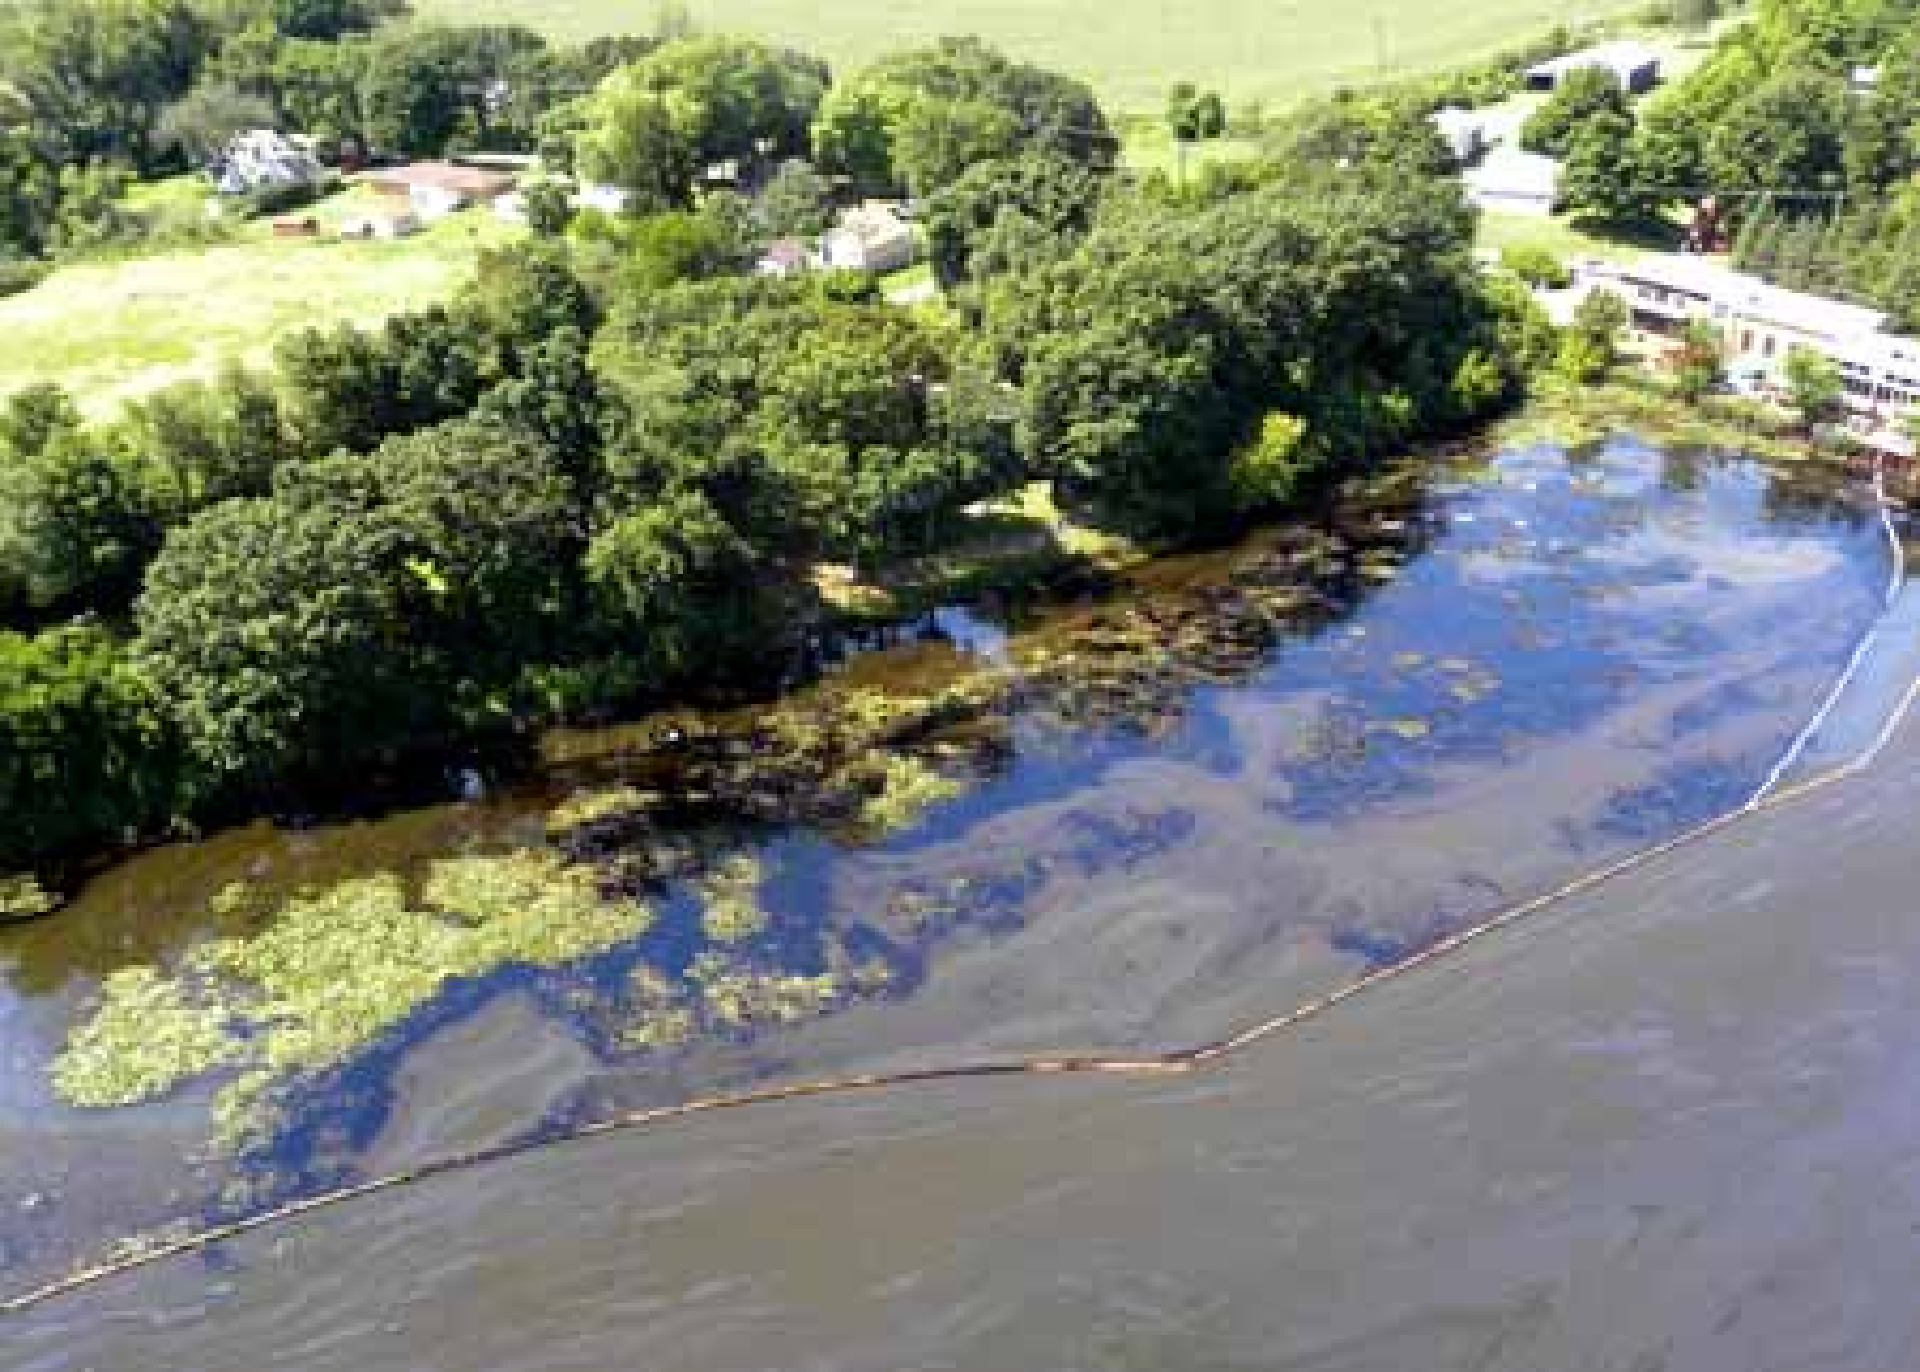
Oil caught in backwater vegetation just upstream from Ceresco Dam.

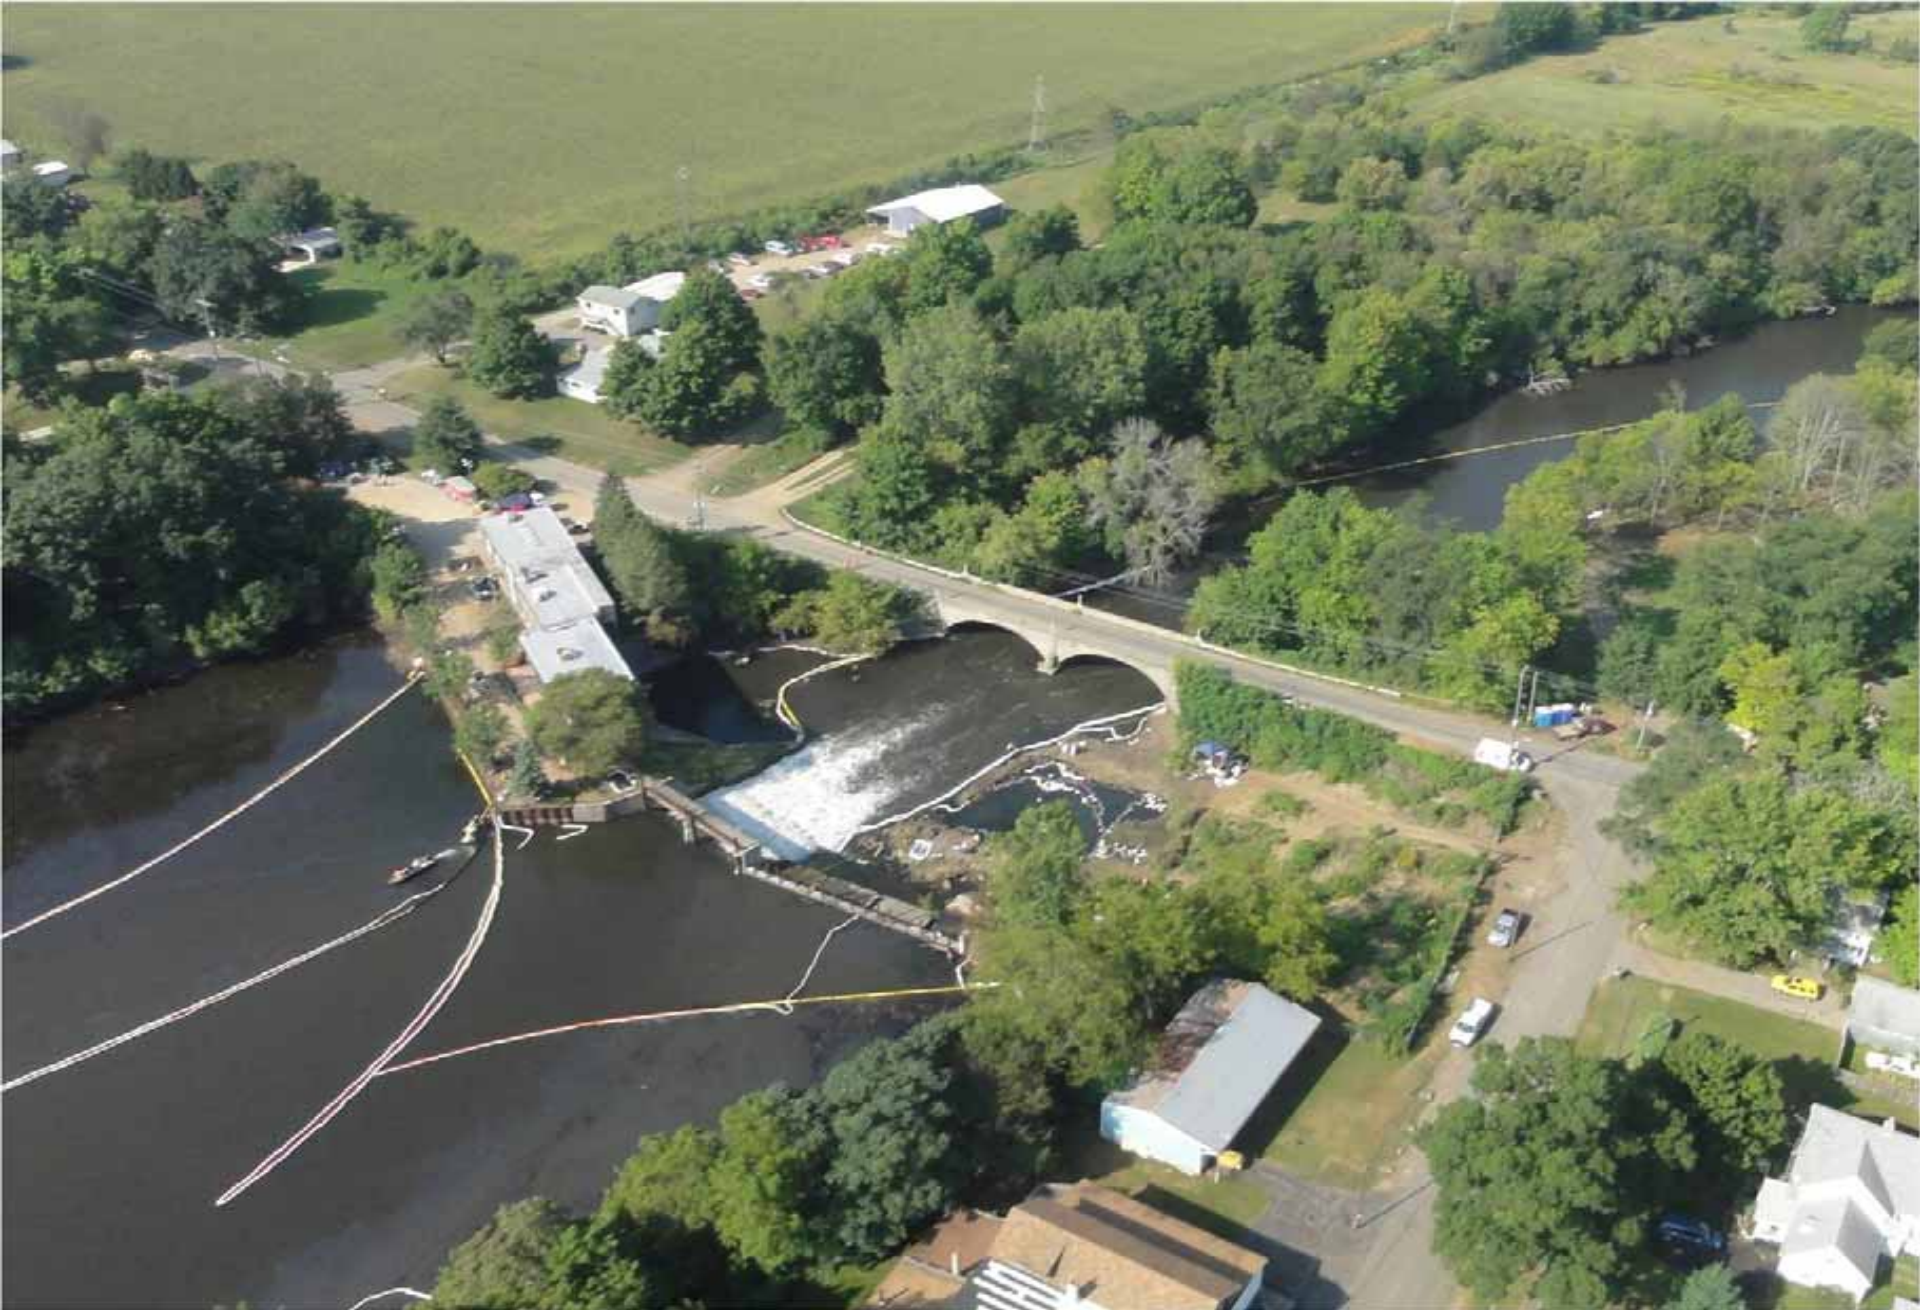
Containment booming established to control vegetation sheening upstream of Ceresco Dam.

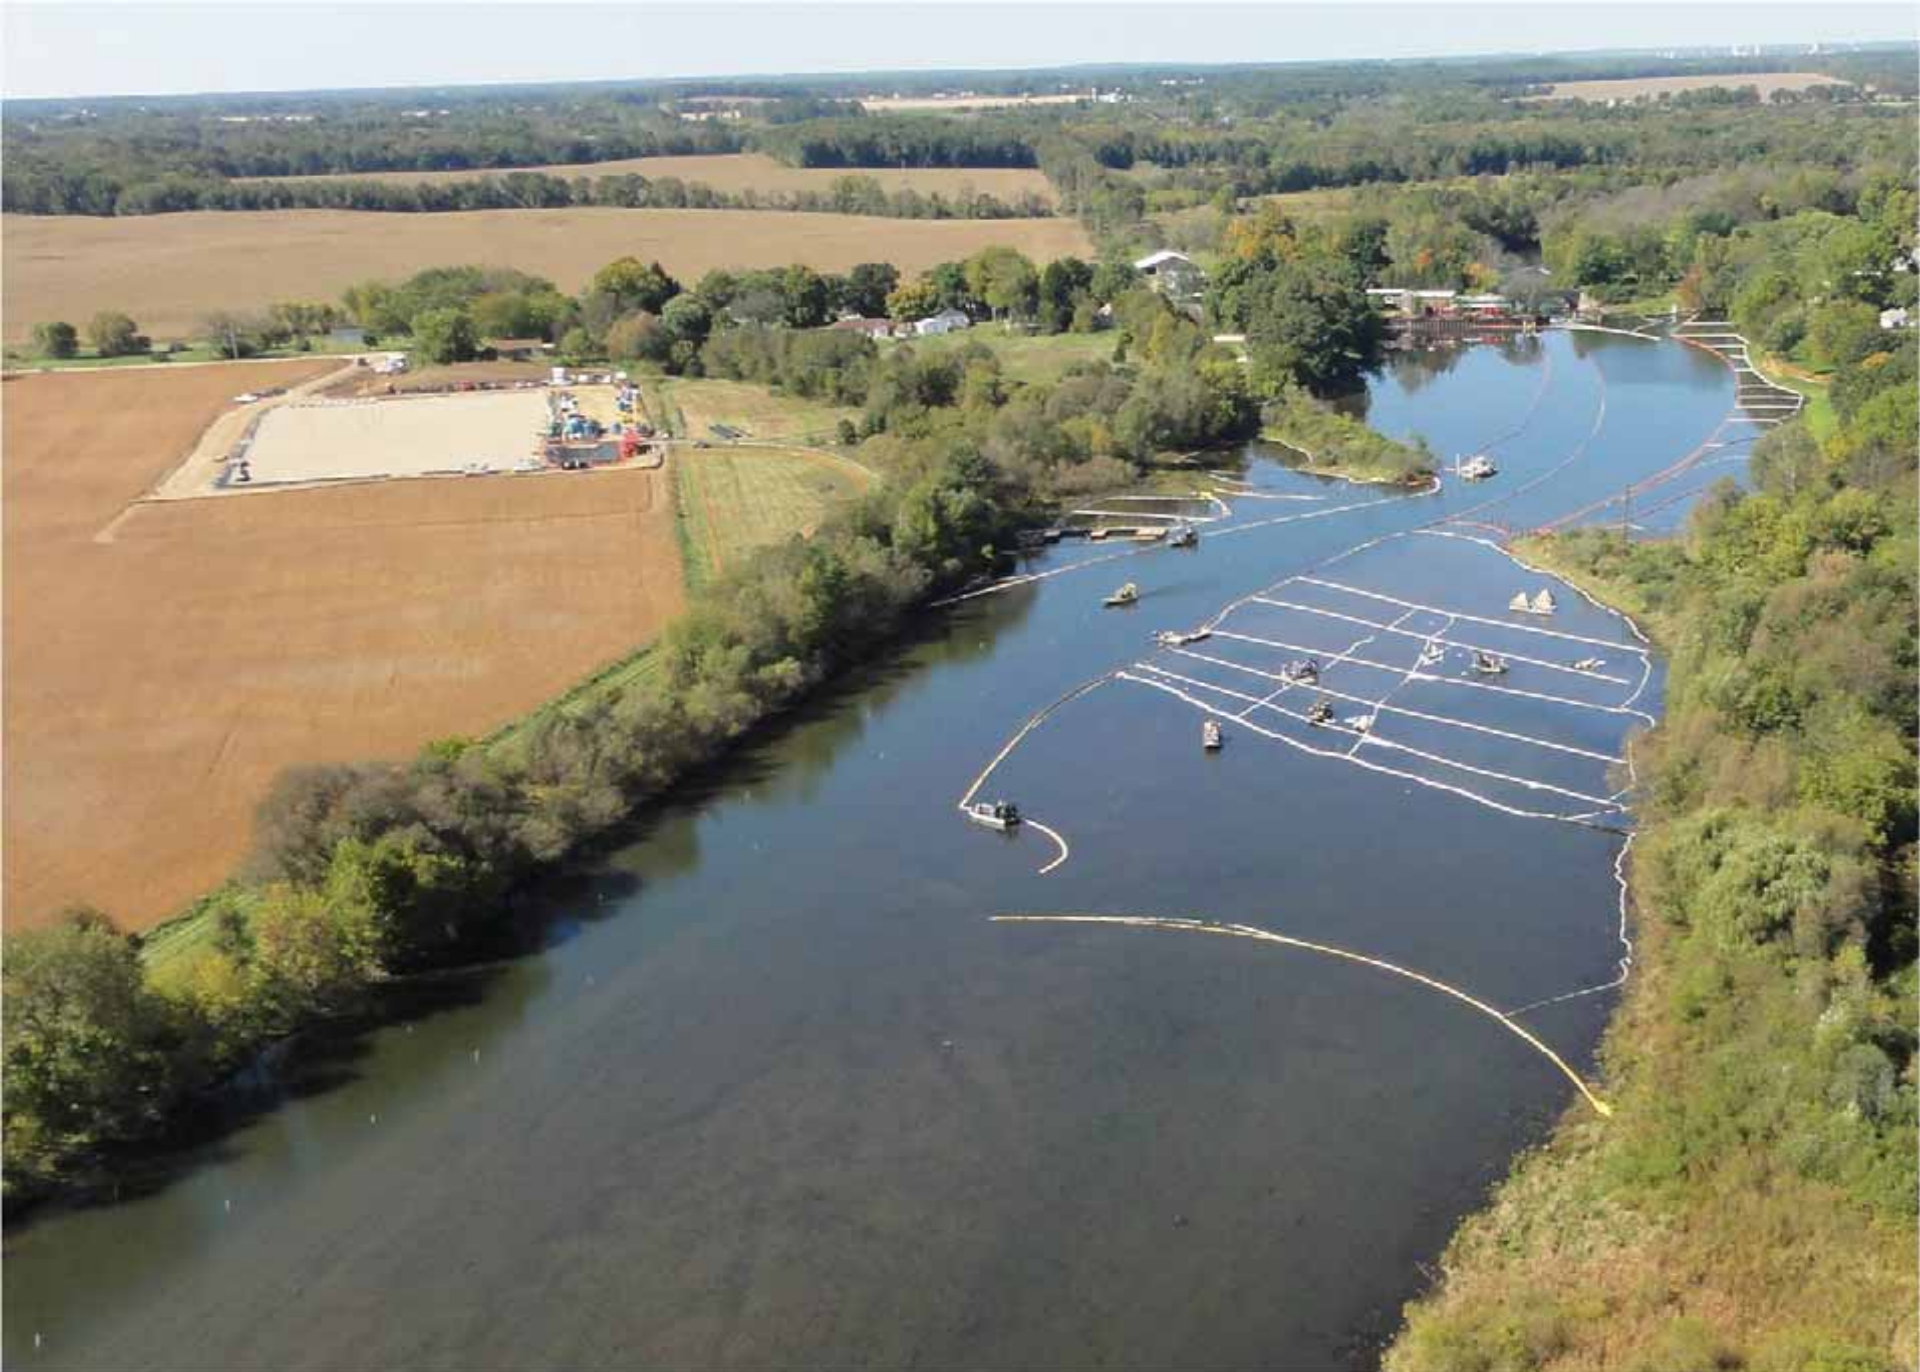
October 2010: submerged oil cleanup started upstream of Ceresco Dam.

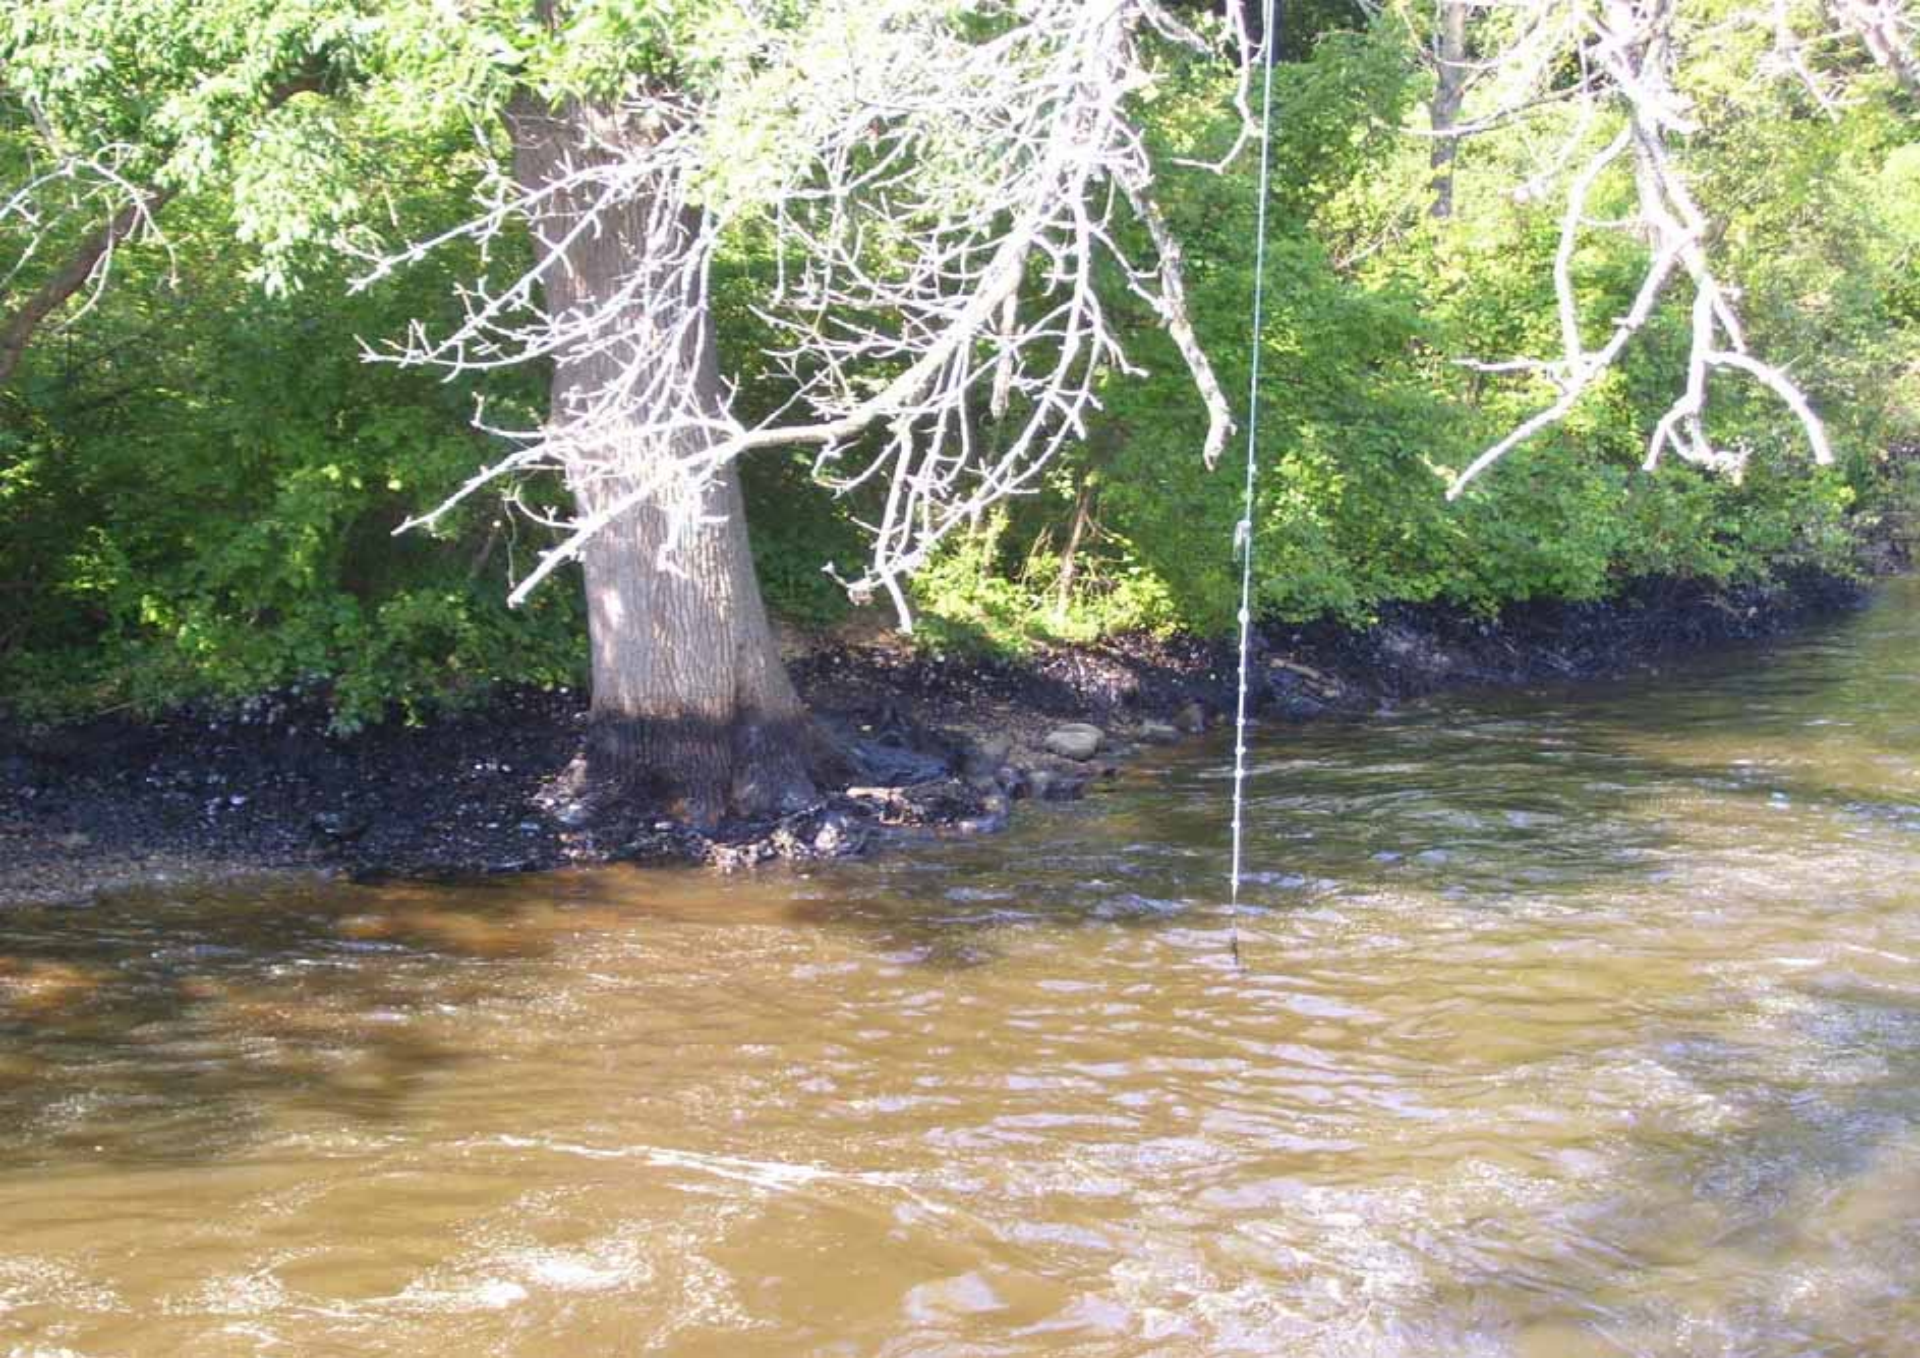
Condition of stream bank just downstream of Ceresco Dam in late July 2010.

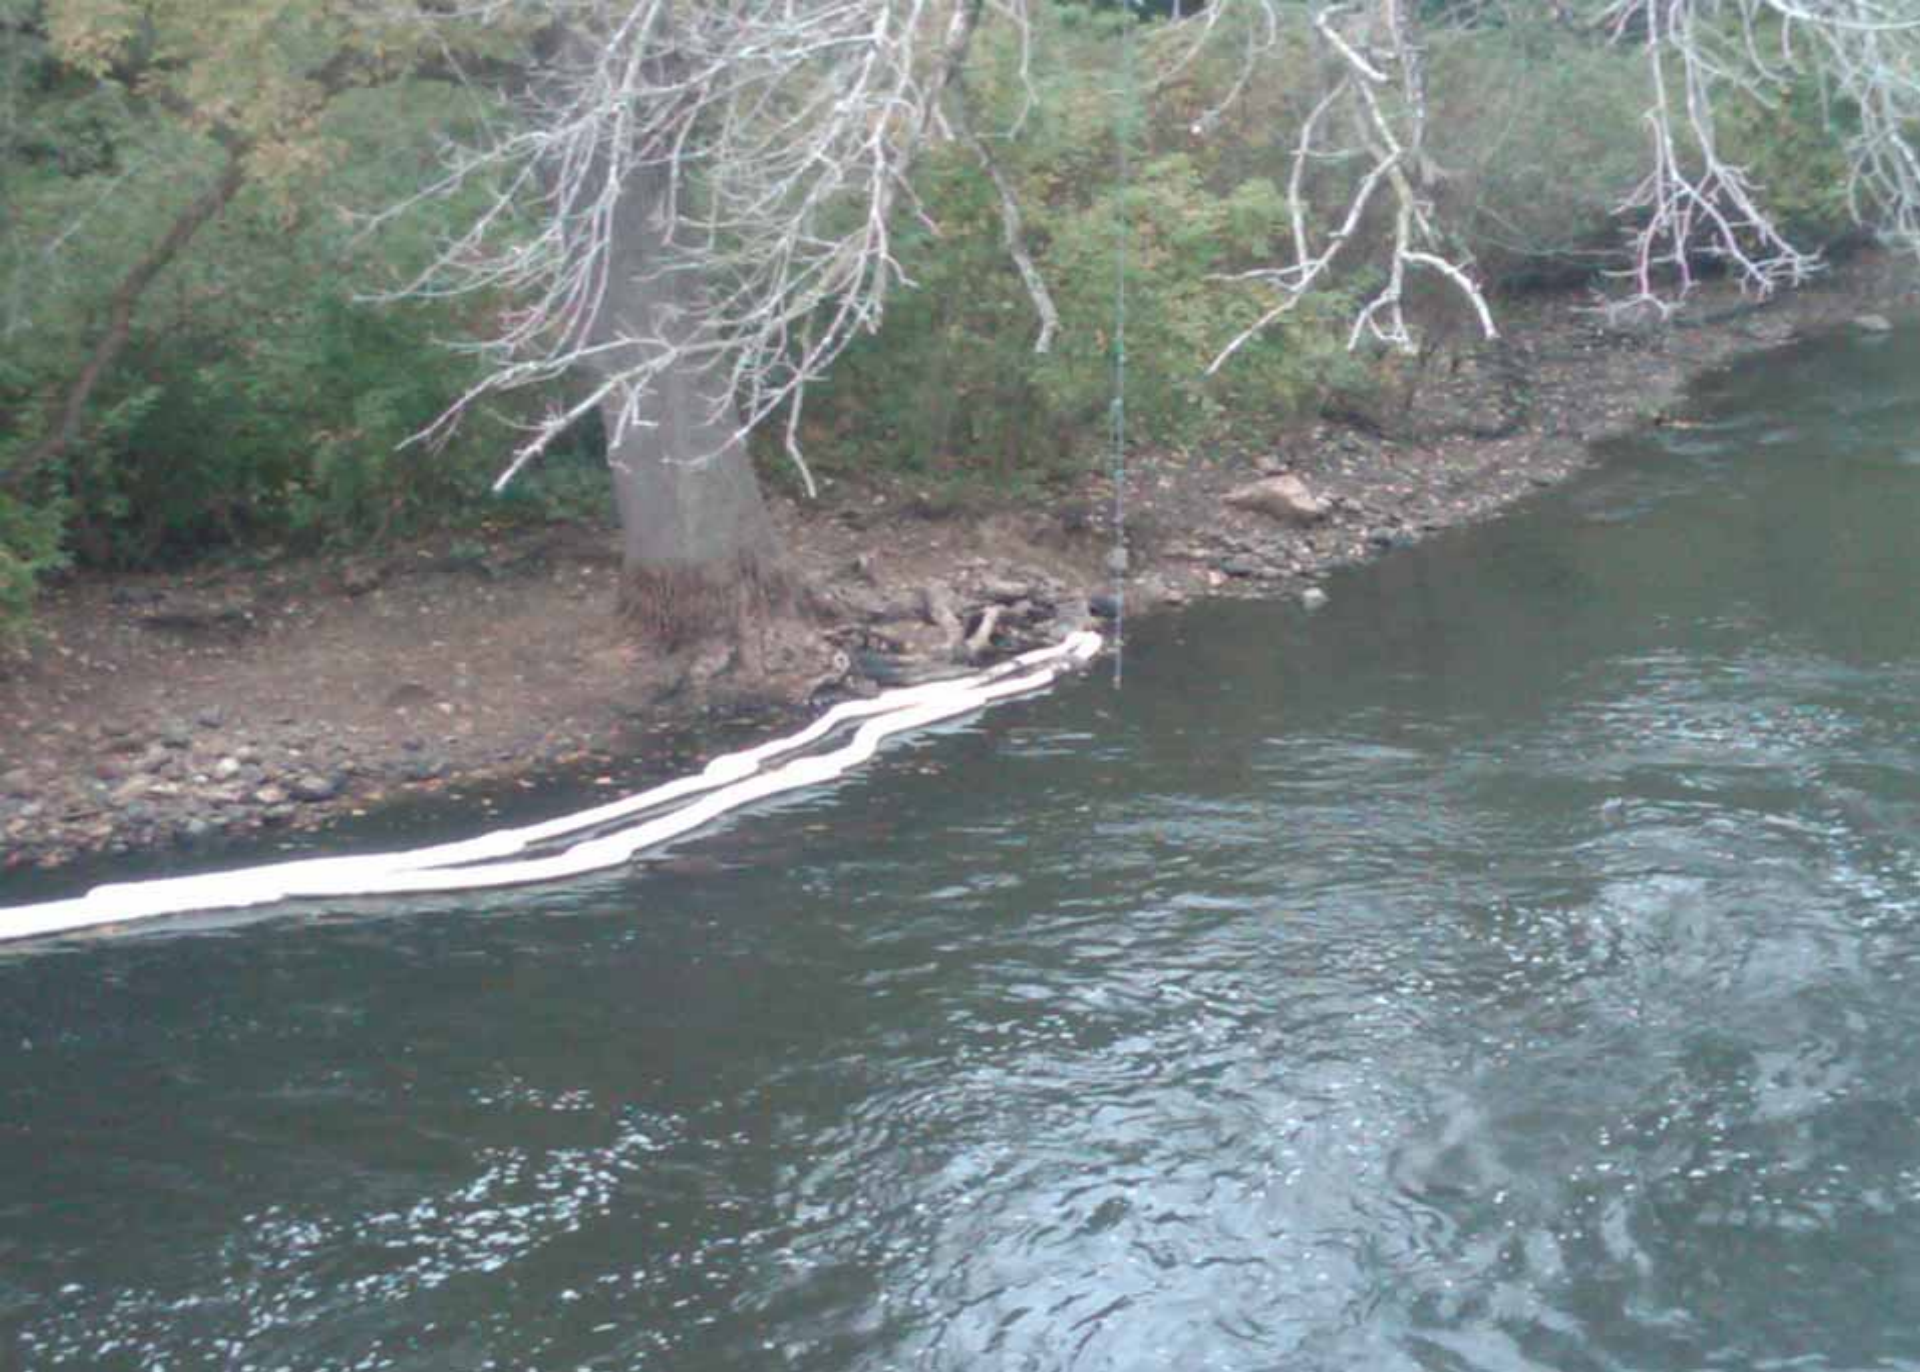
Same location, late September 2010.

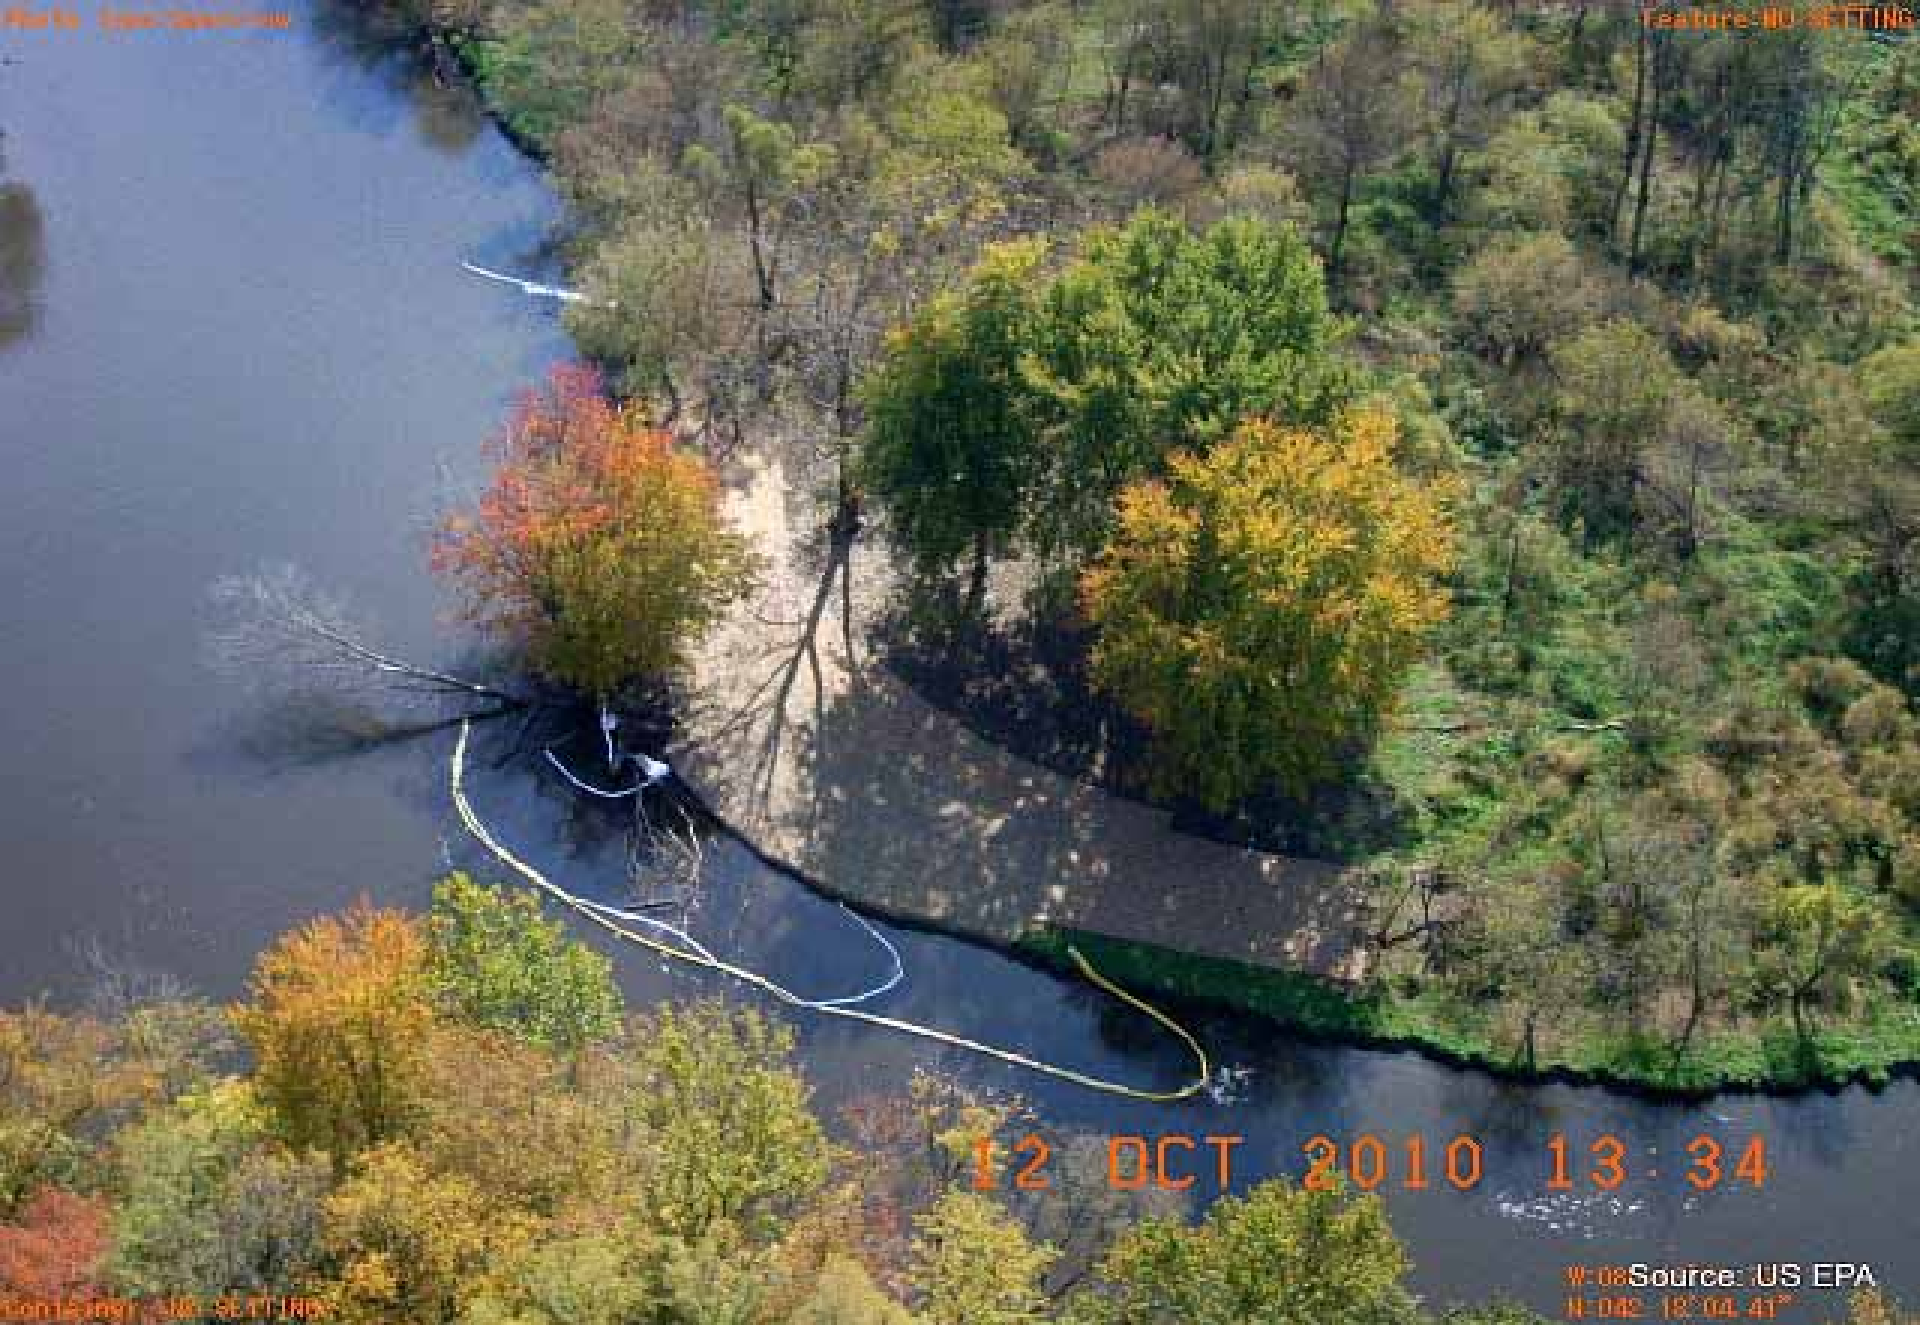
Riverbank restoration and long-term containment . Some areas on river will be monitored over time for potential contamination.

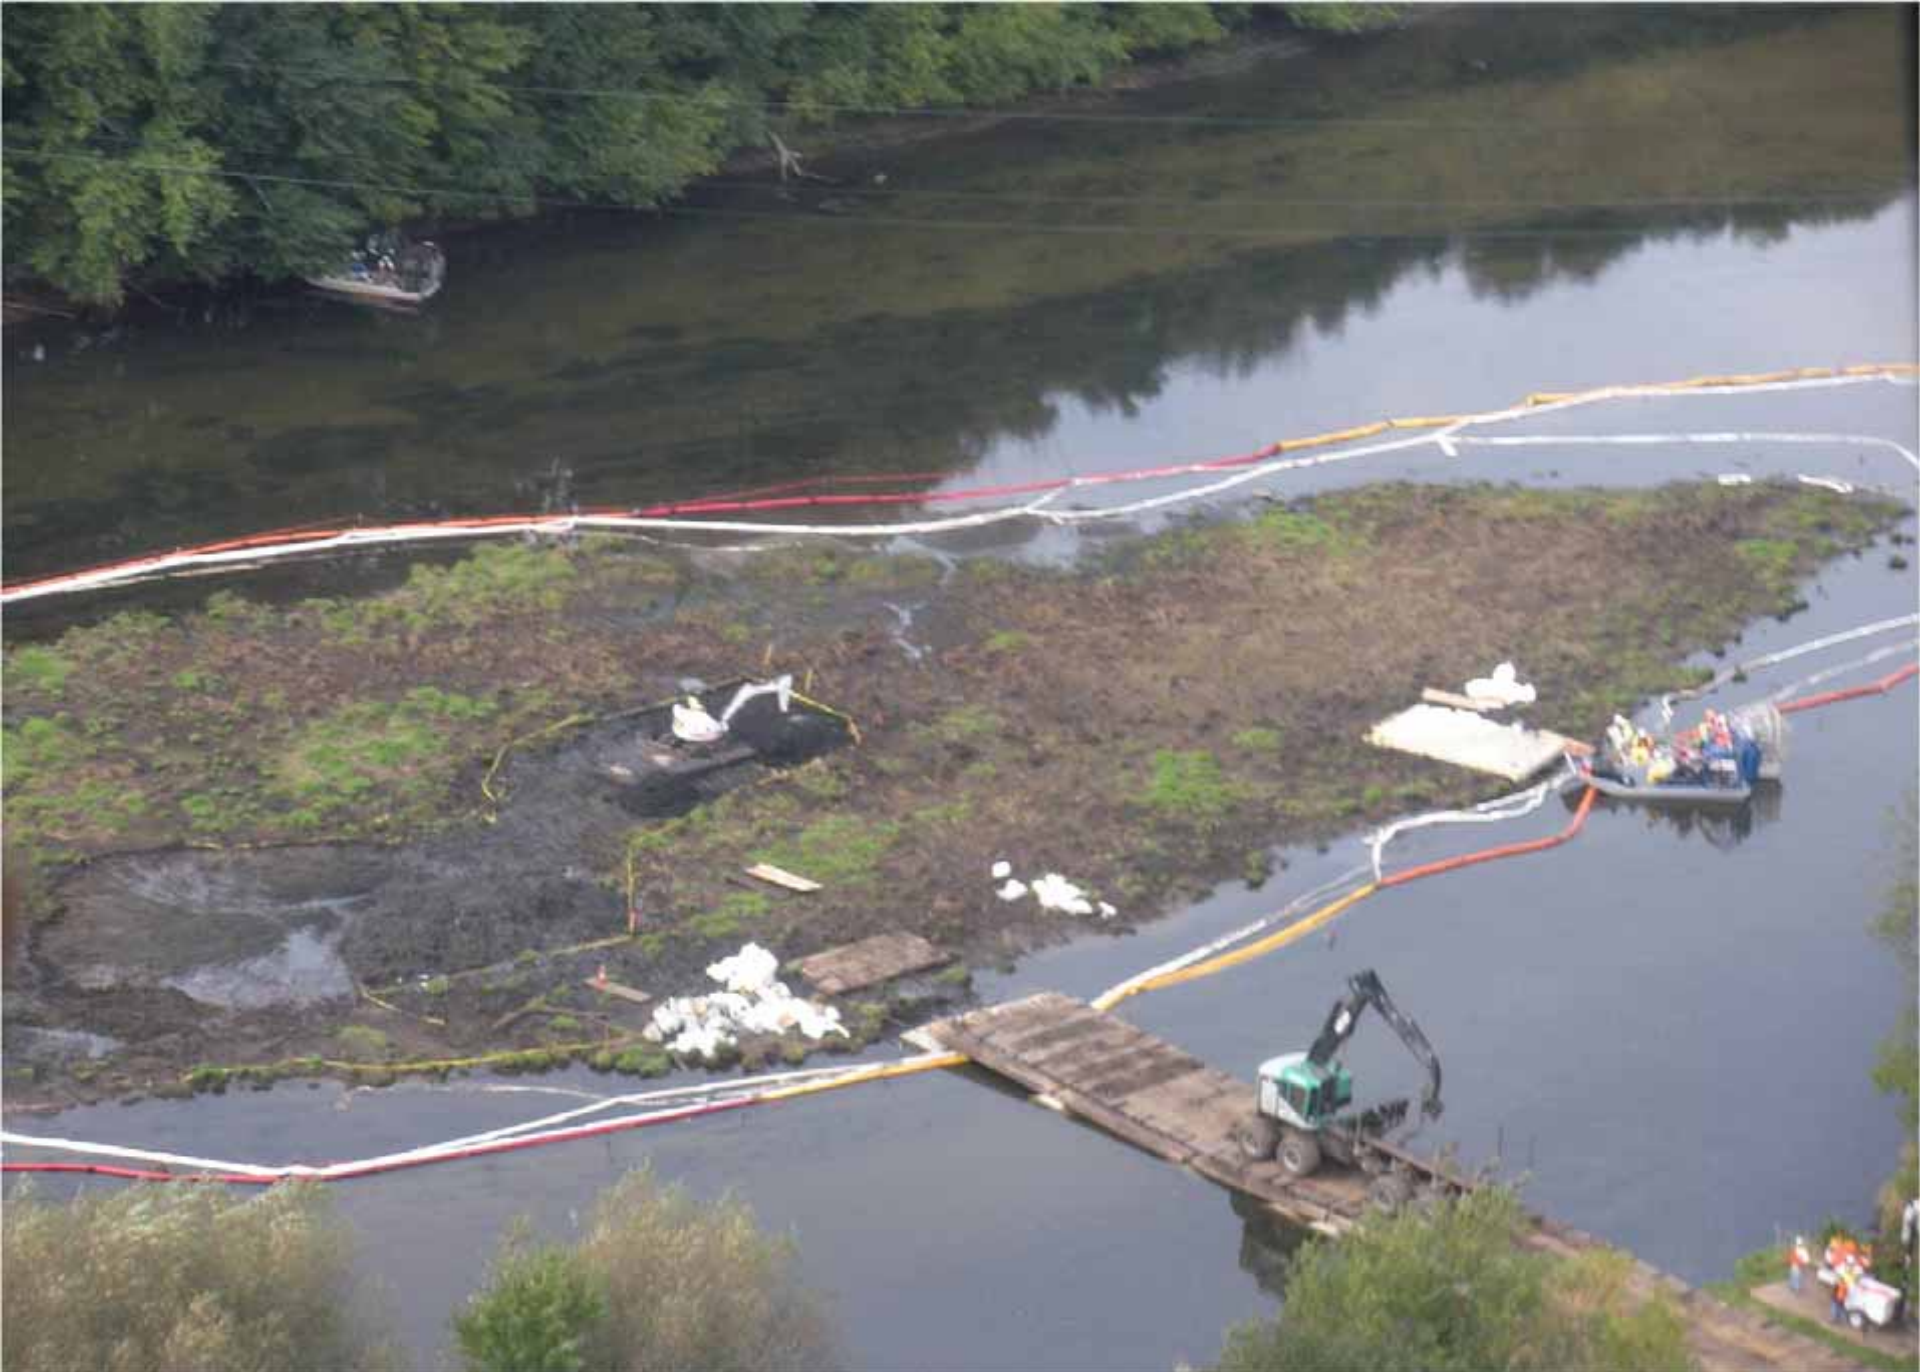
Residual contamination on islands will be monitored over time.

Stains on trees and rocks will fade over time and do not present health or environmental risks.
