Great Lakes Fleet Fuel Facility Spill

04 January – 26 January 2011

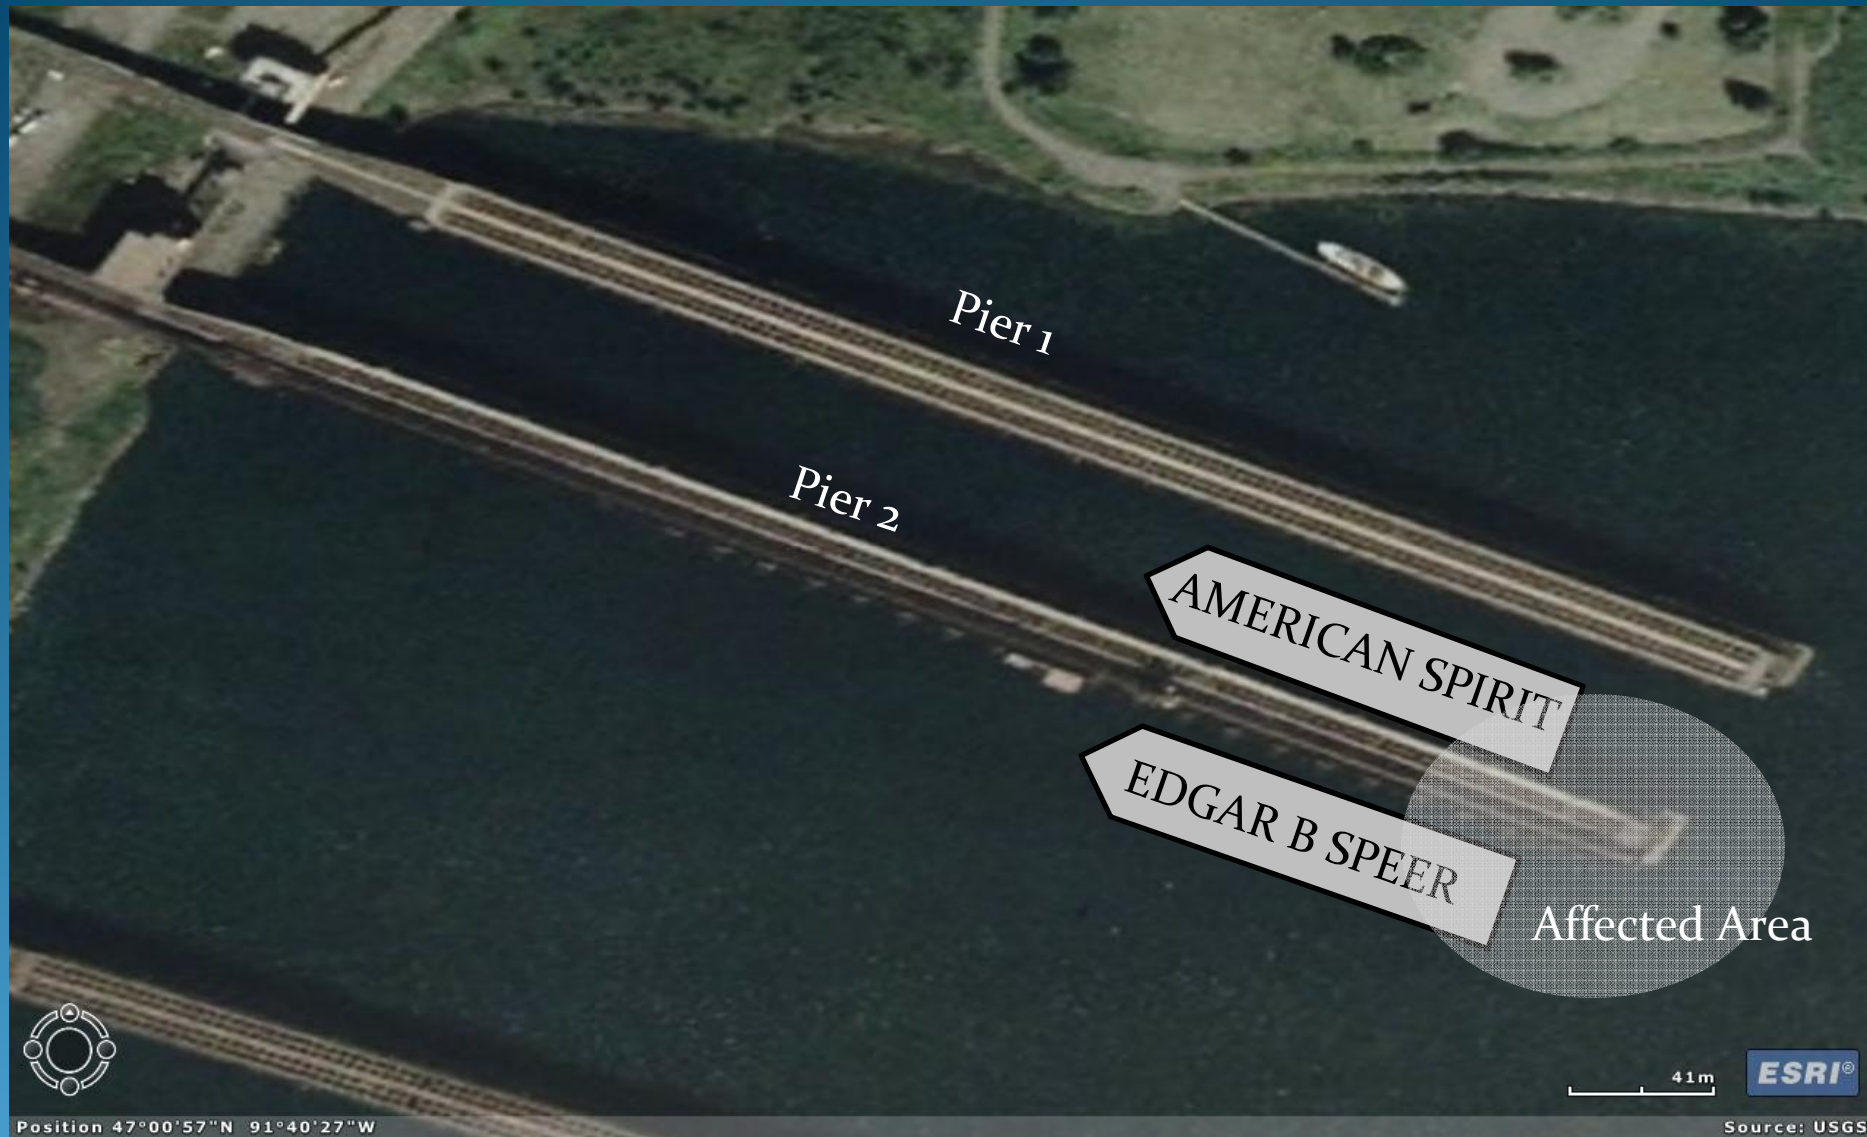
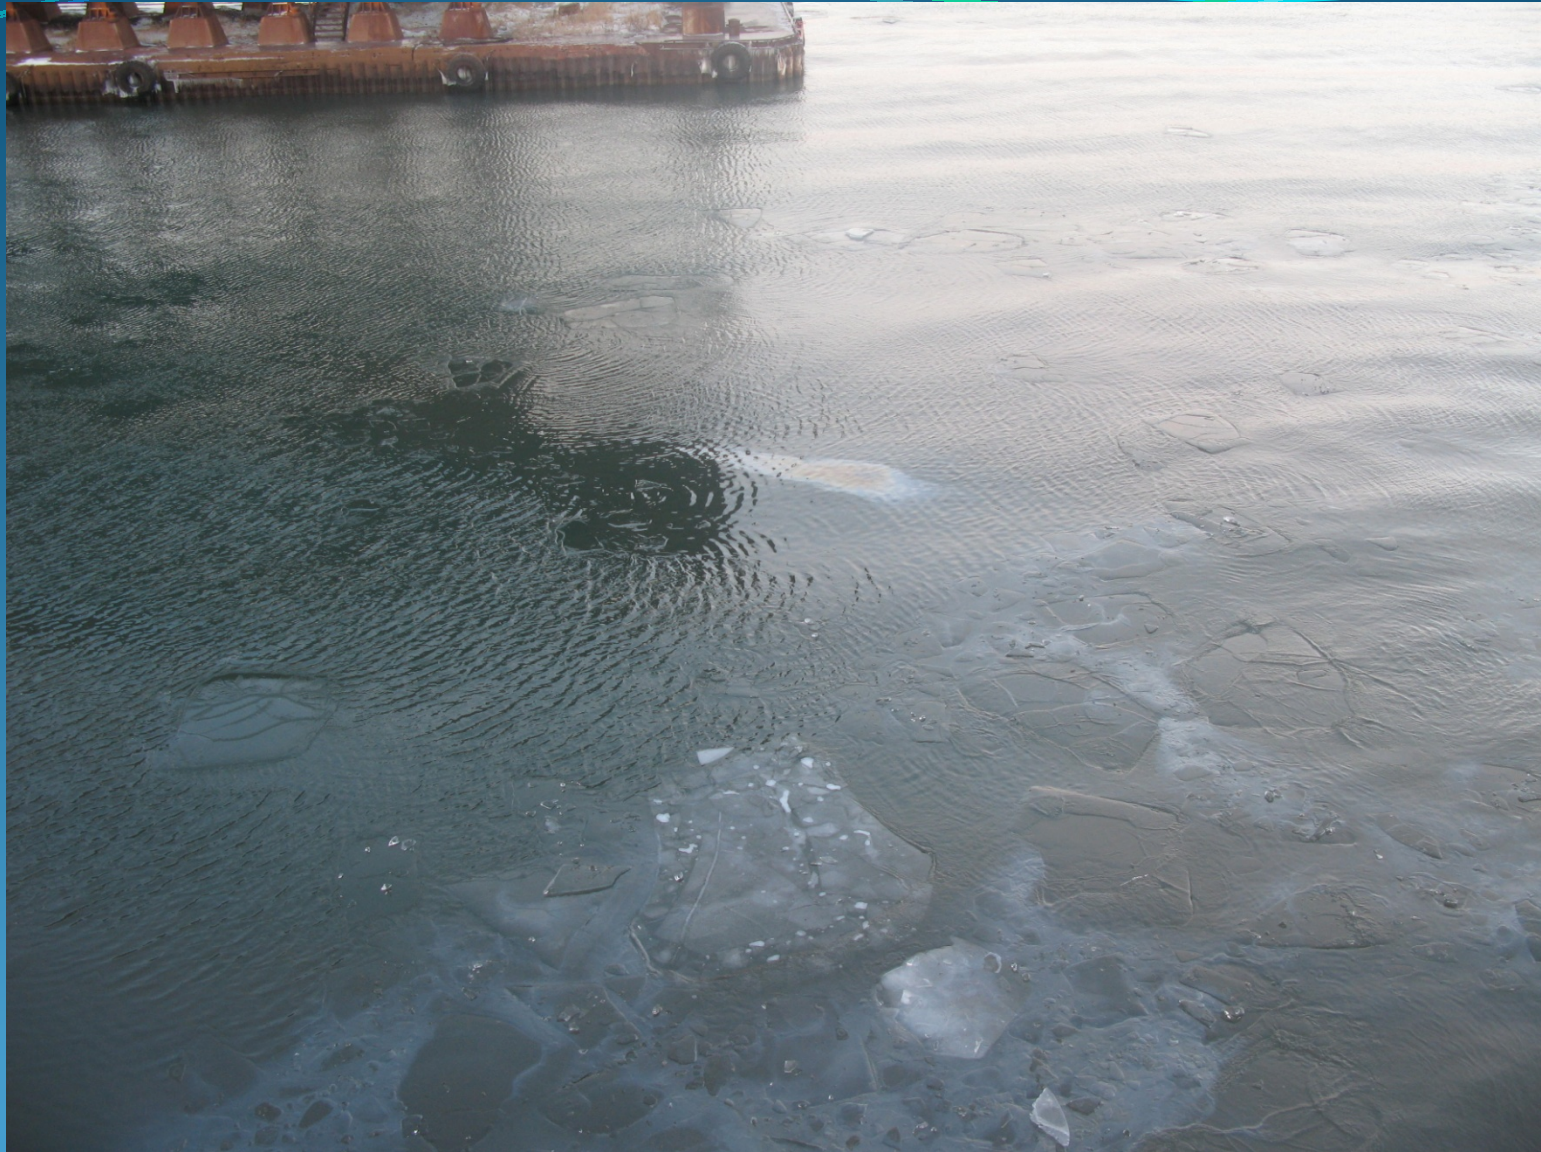
The PIs observed sheen on the water, two vessels on scene, and both vessel's crews conducting clean up.

Wind: 15 mph NNW

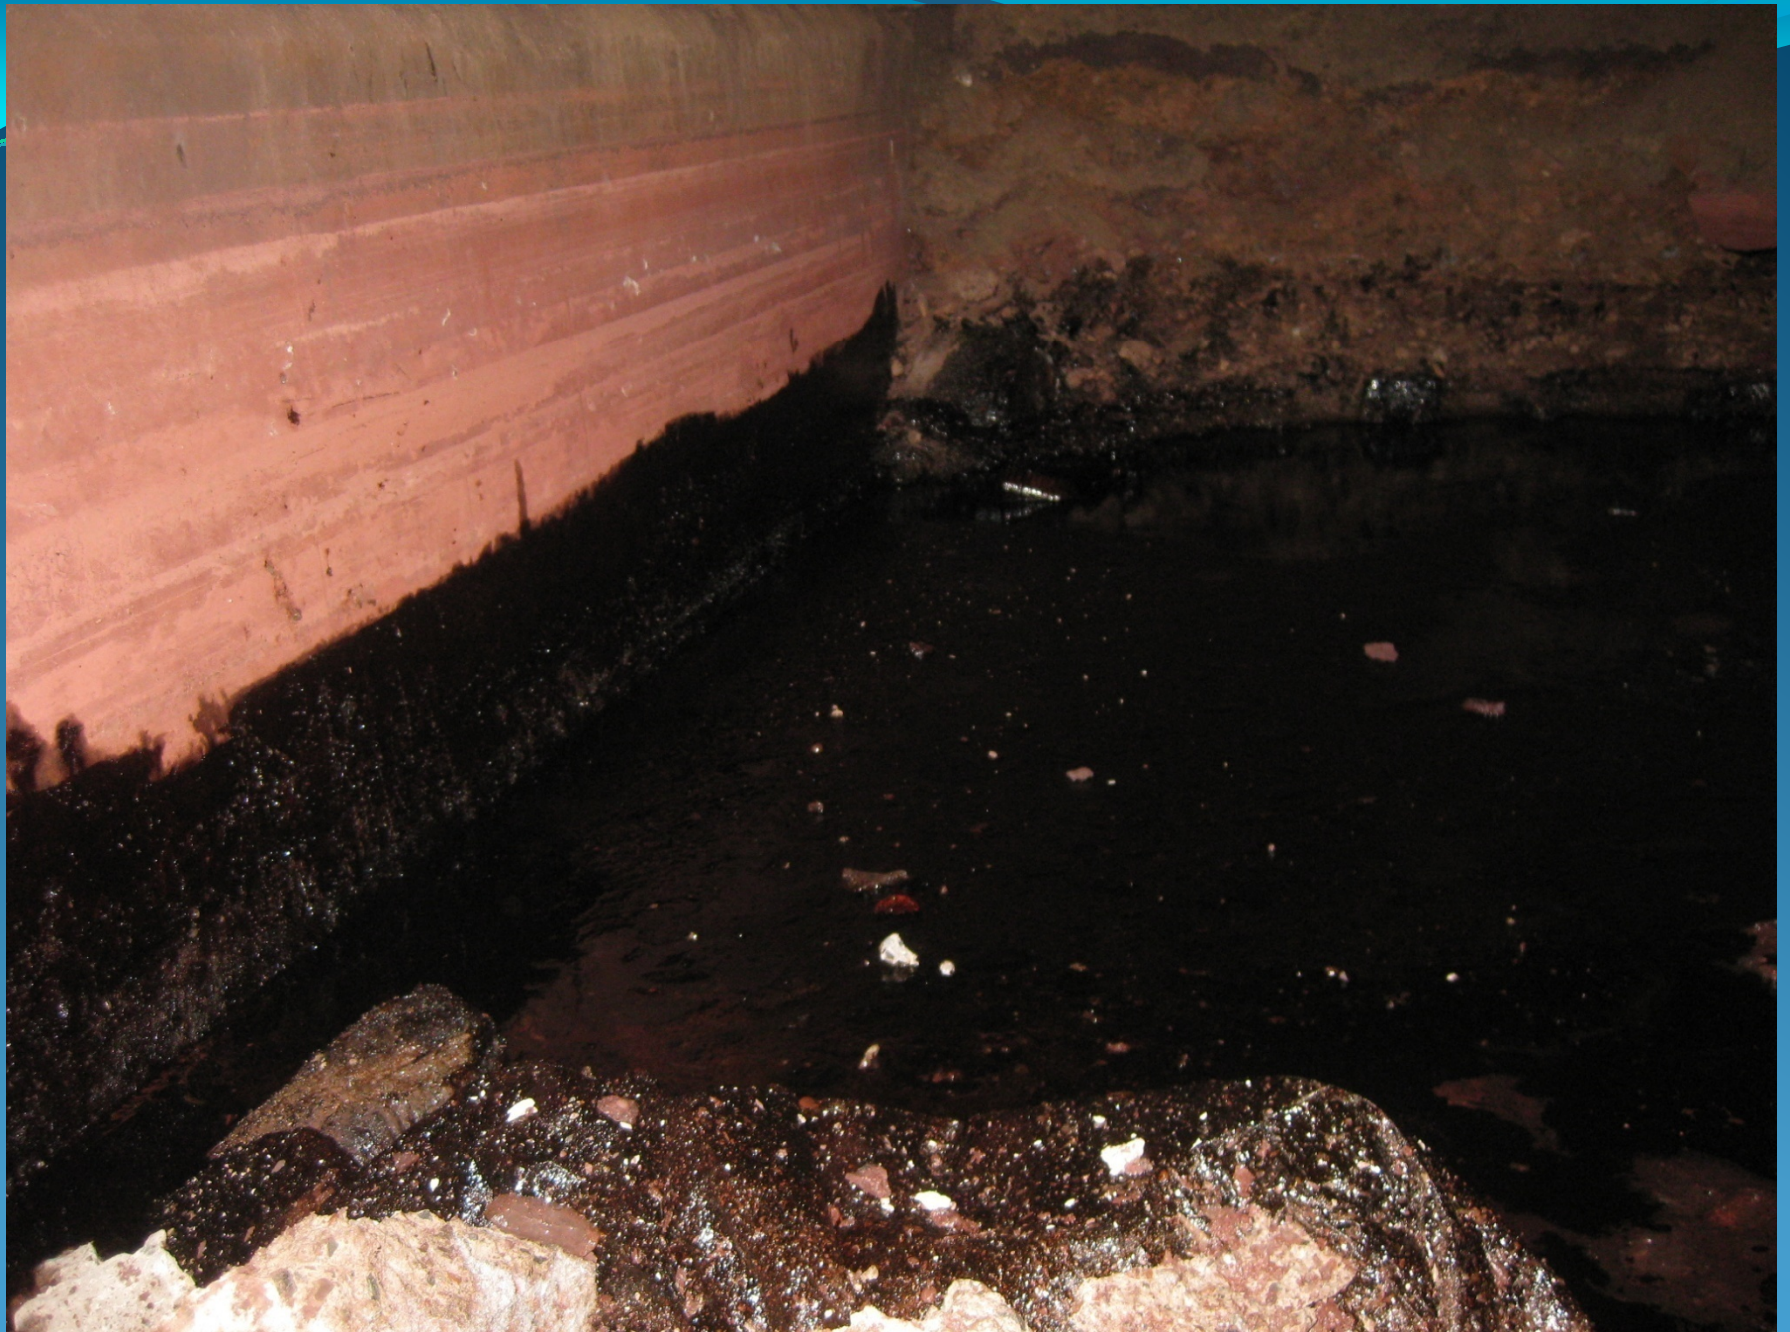
Further investigation of the fuel oil spill from the month before led to the discovery of a hole in the deck of the pier.

After removing the layer of ice covering the hole, oil was observed in the cavity below the pier.

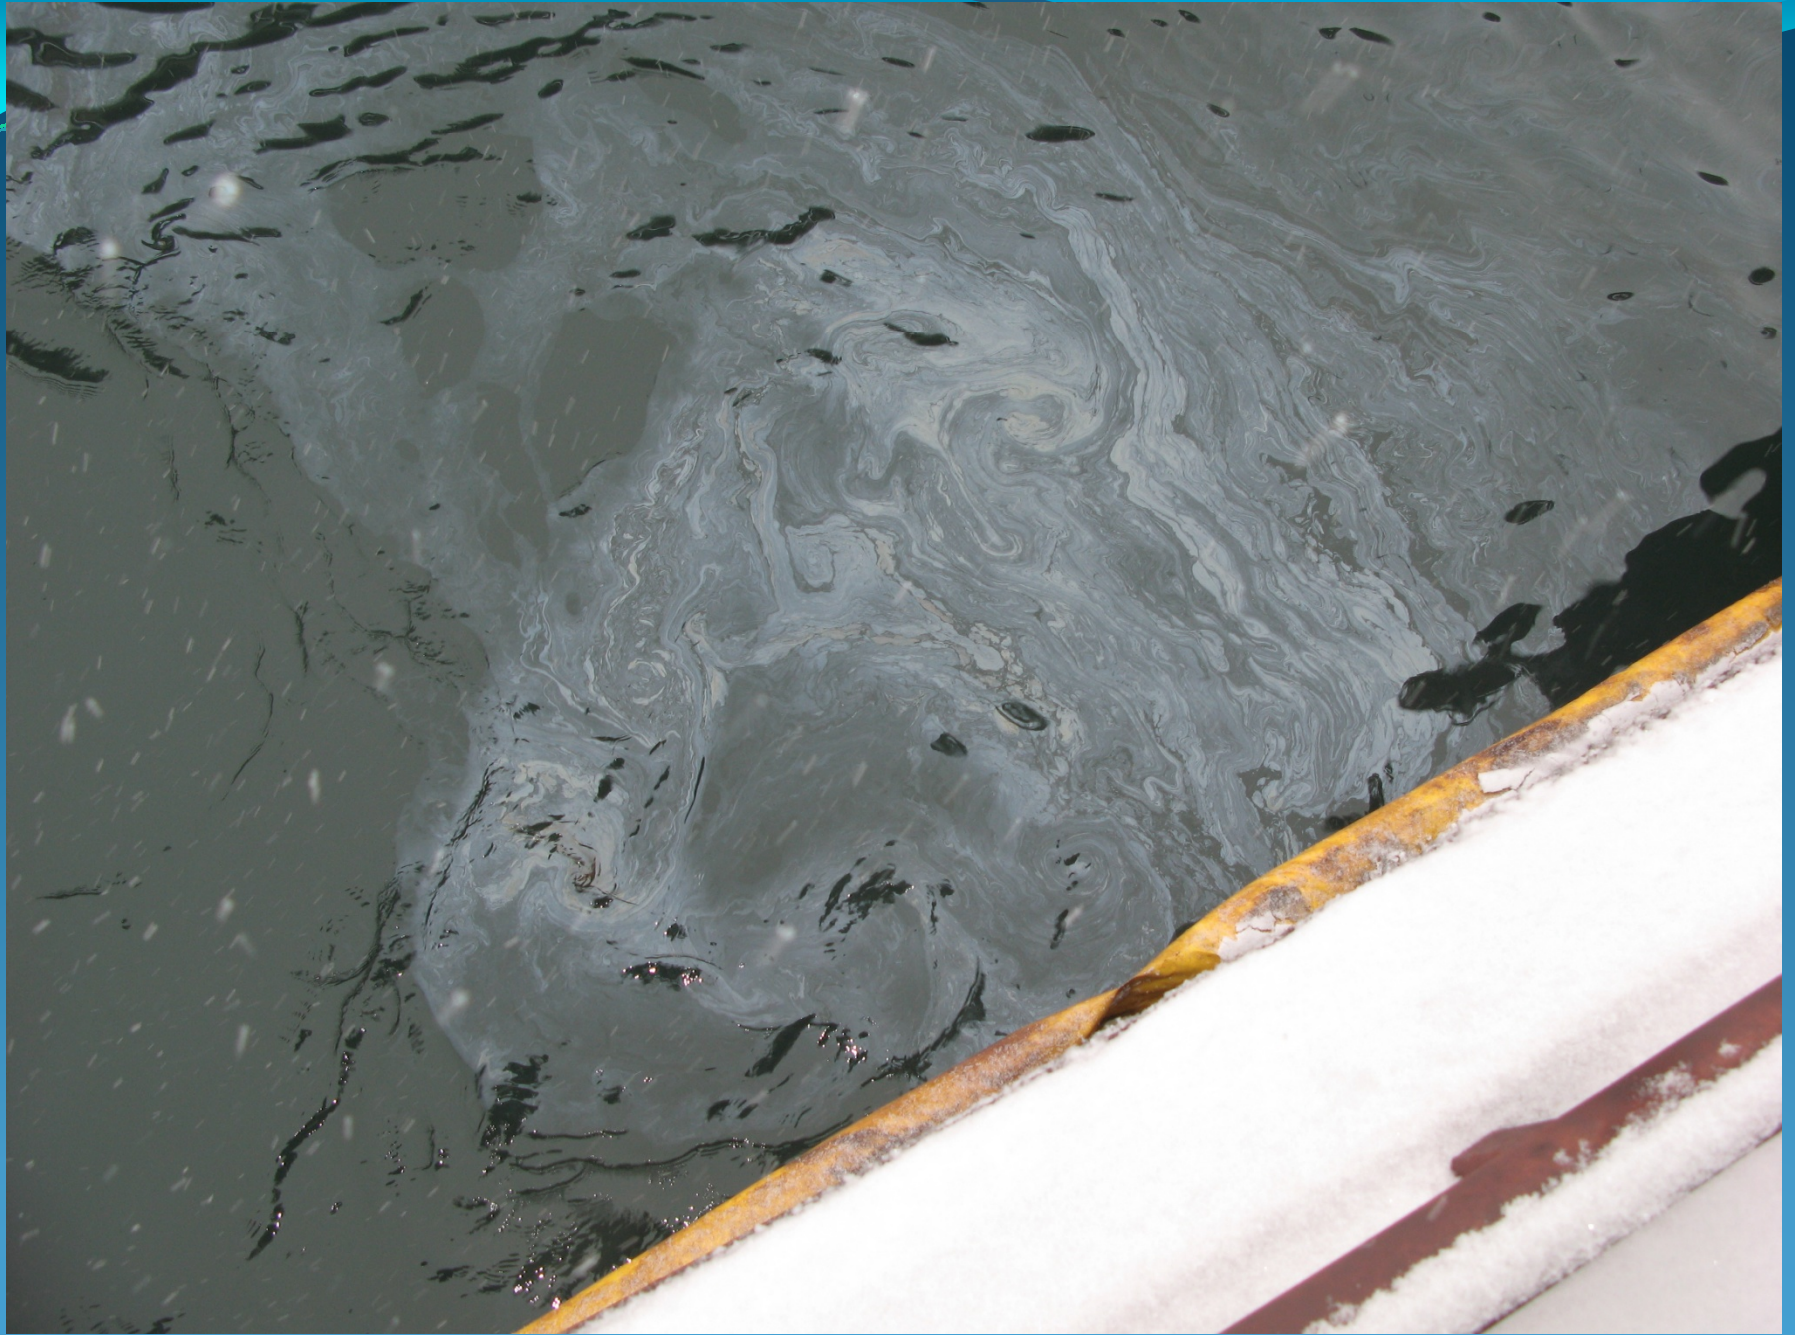
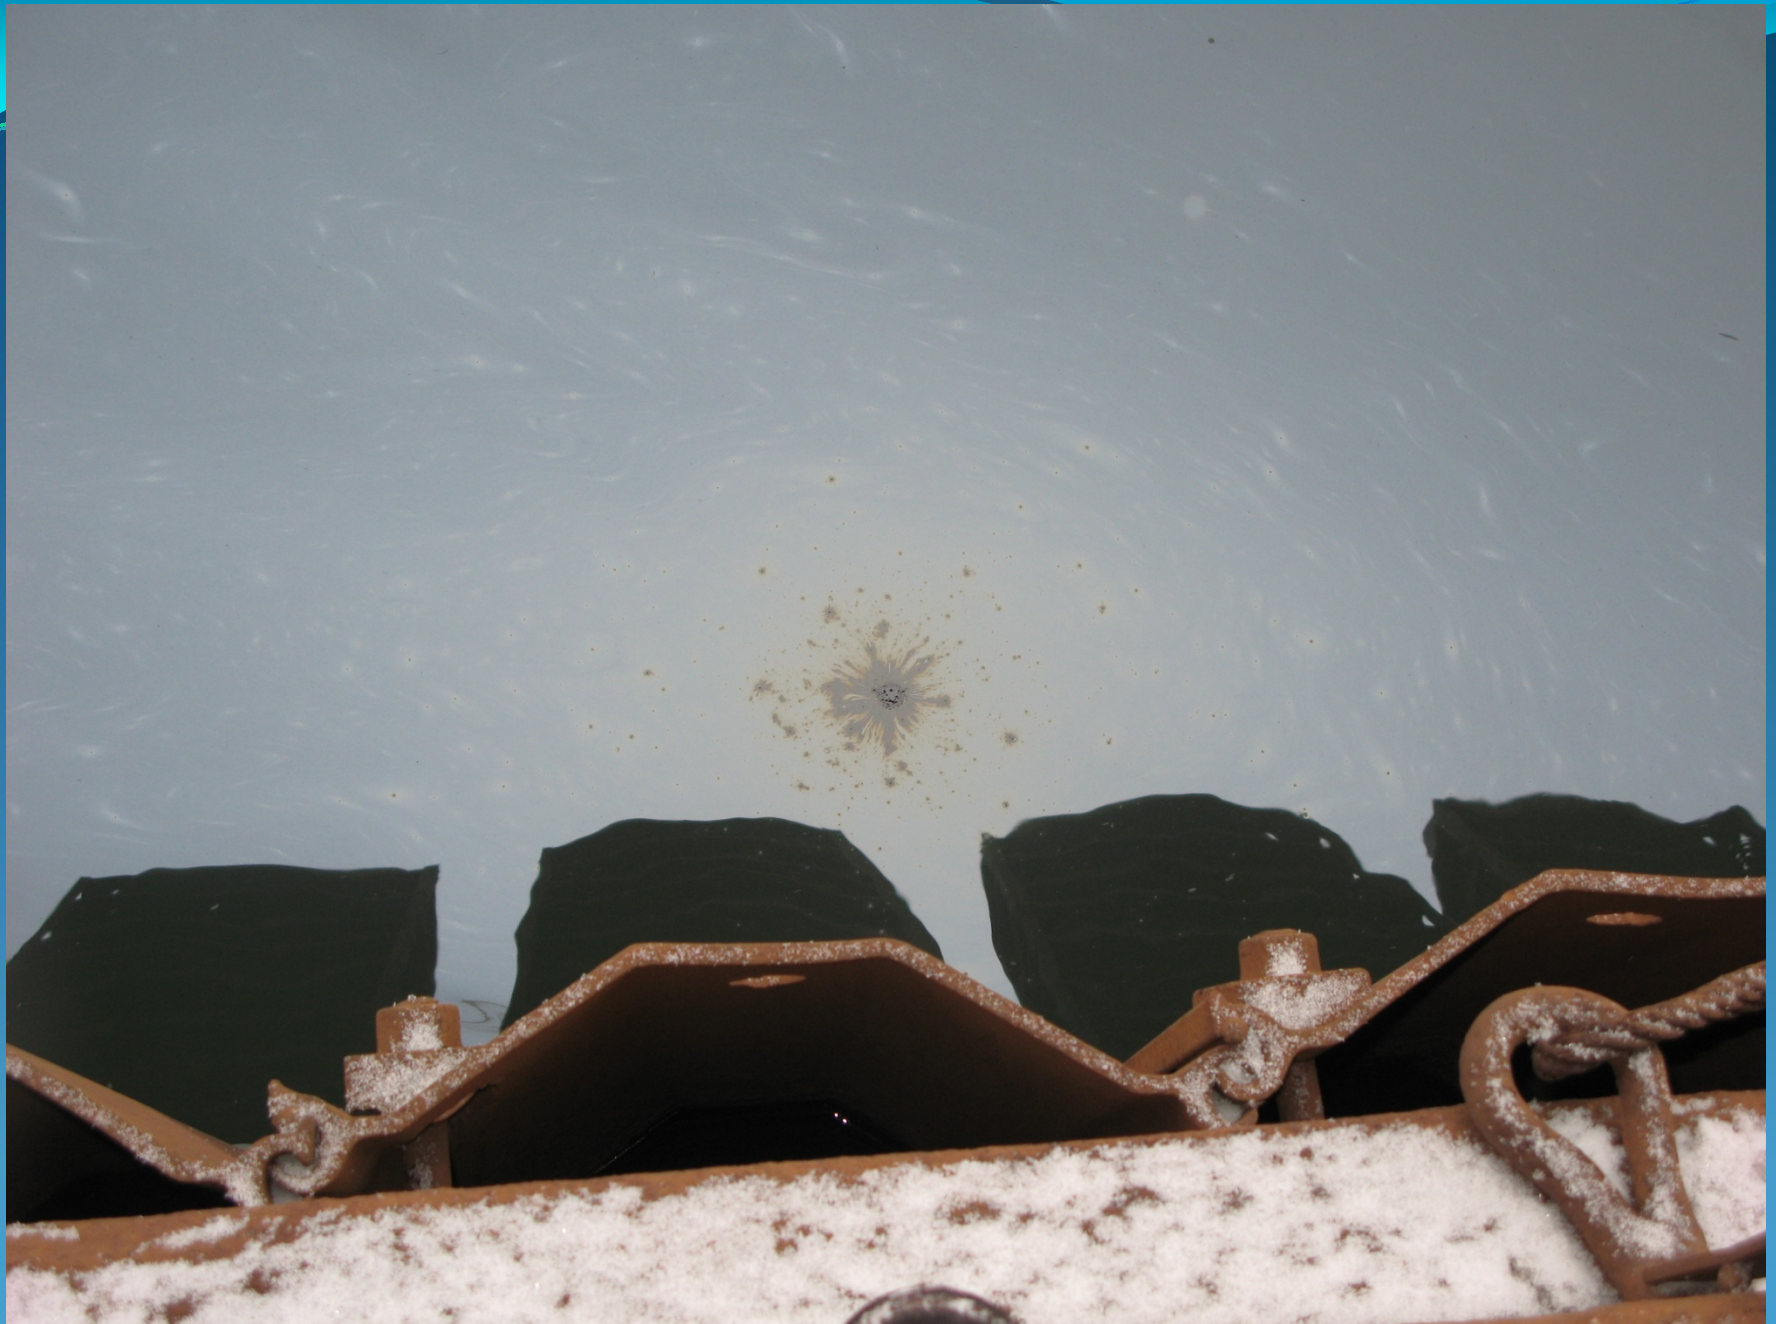
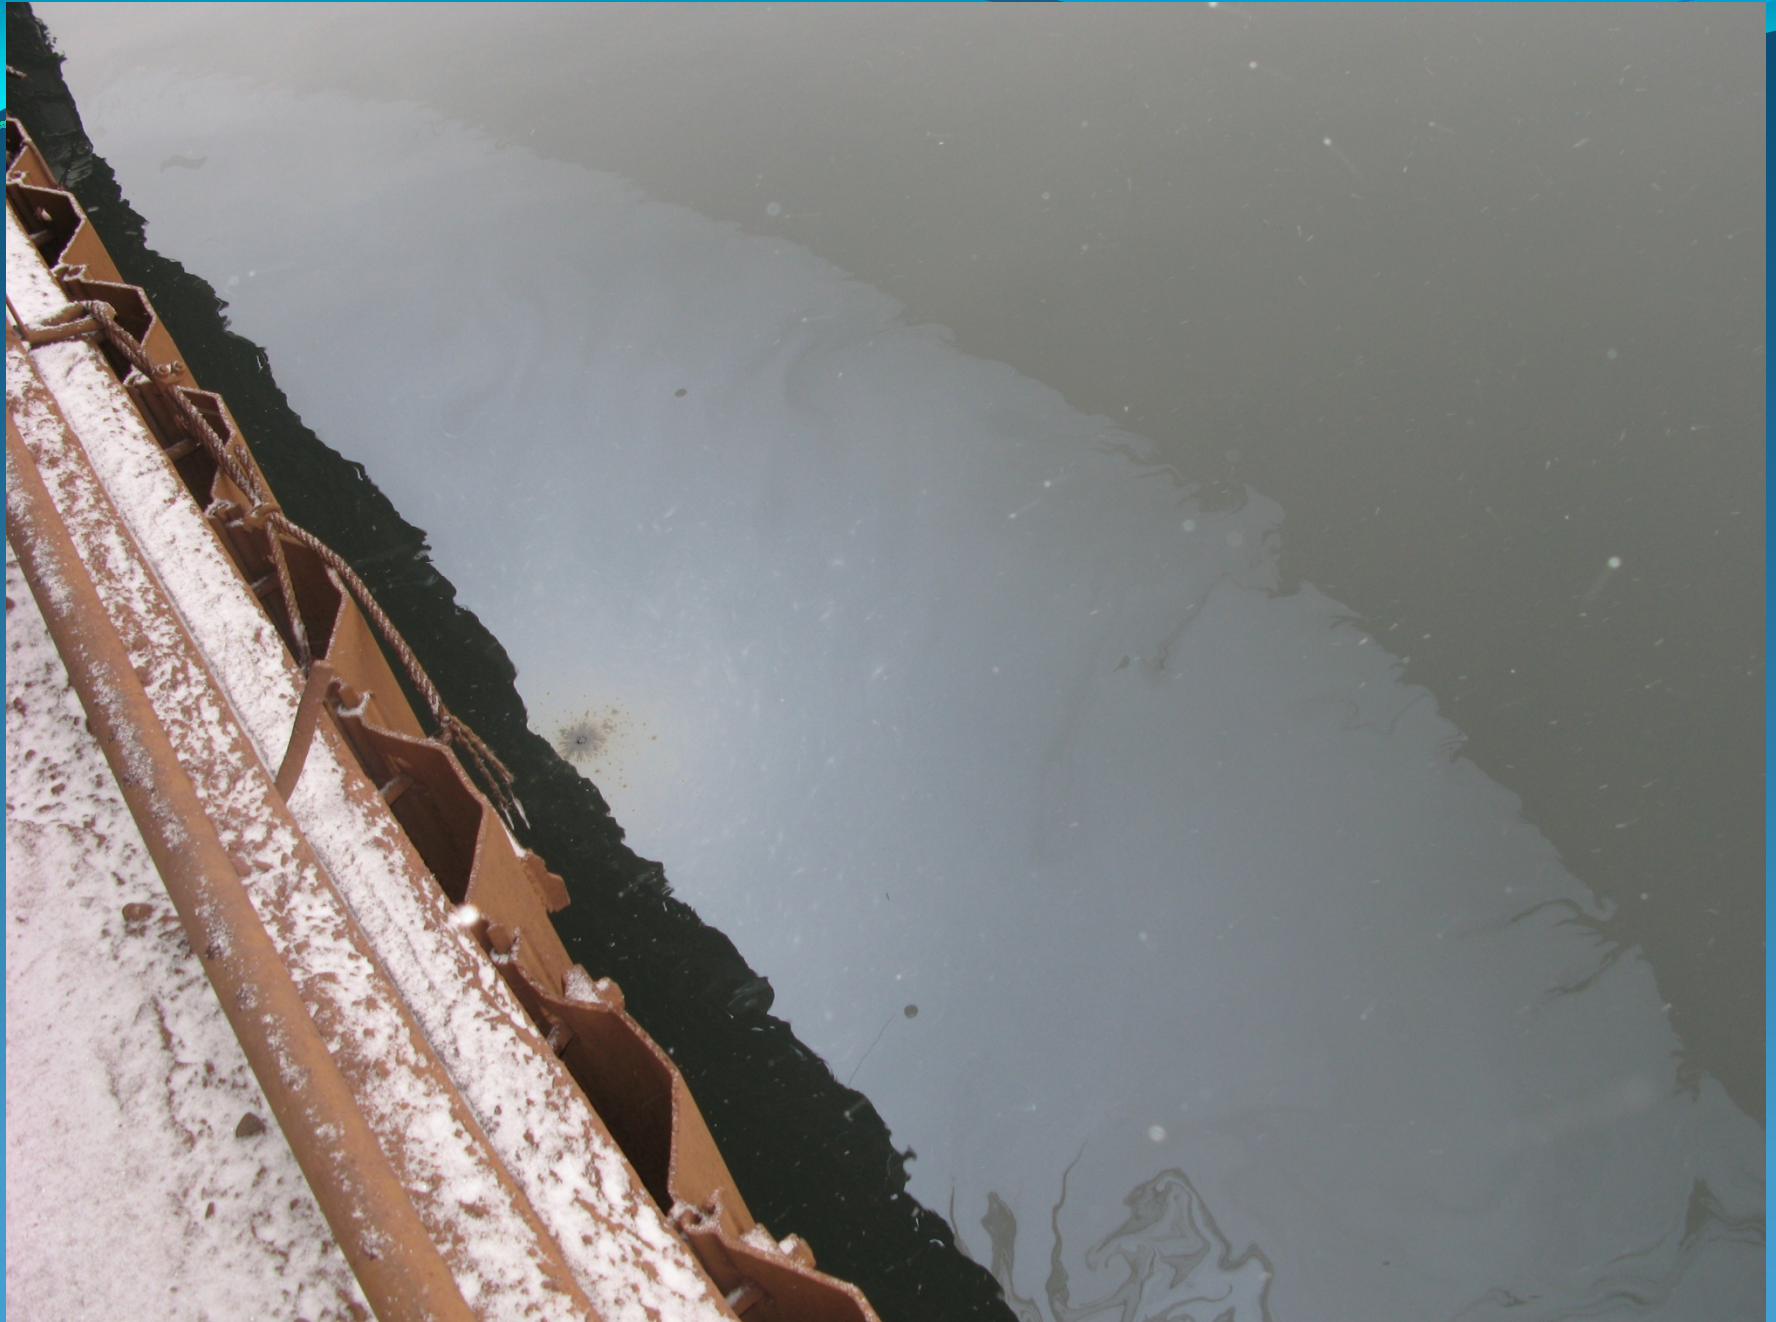
During the clean up small sheens and tar balls appeared sporadically, especially during and shortly after vessel movement around the piers.

It became apparent that there was a hole in the bulkhead that was allowing water to surge into and out of the cavity under the pier, carrying the oil with it.

Facility personnel began cutting open the pier to gain access to the cavity below in order to conduct clean up.

However, due to the lack of proper data, the opening was not fully expanded for a week, once the engineers determined that doing so would not create structural instability of the pier.

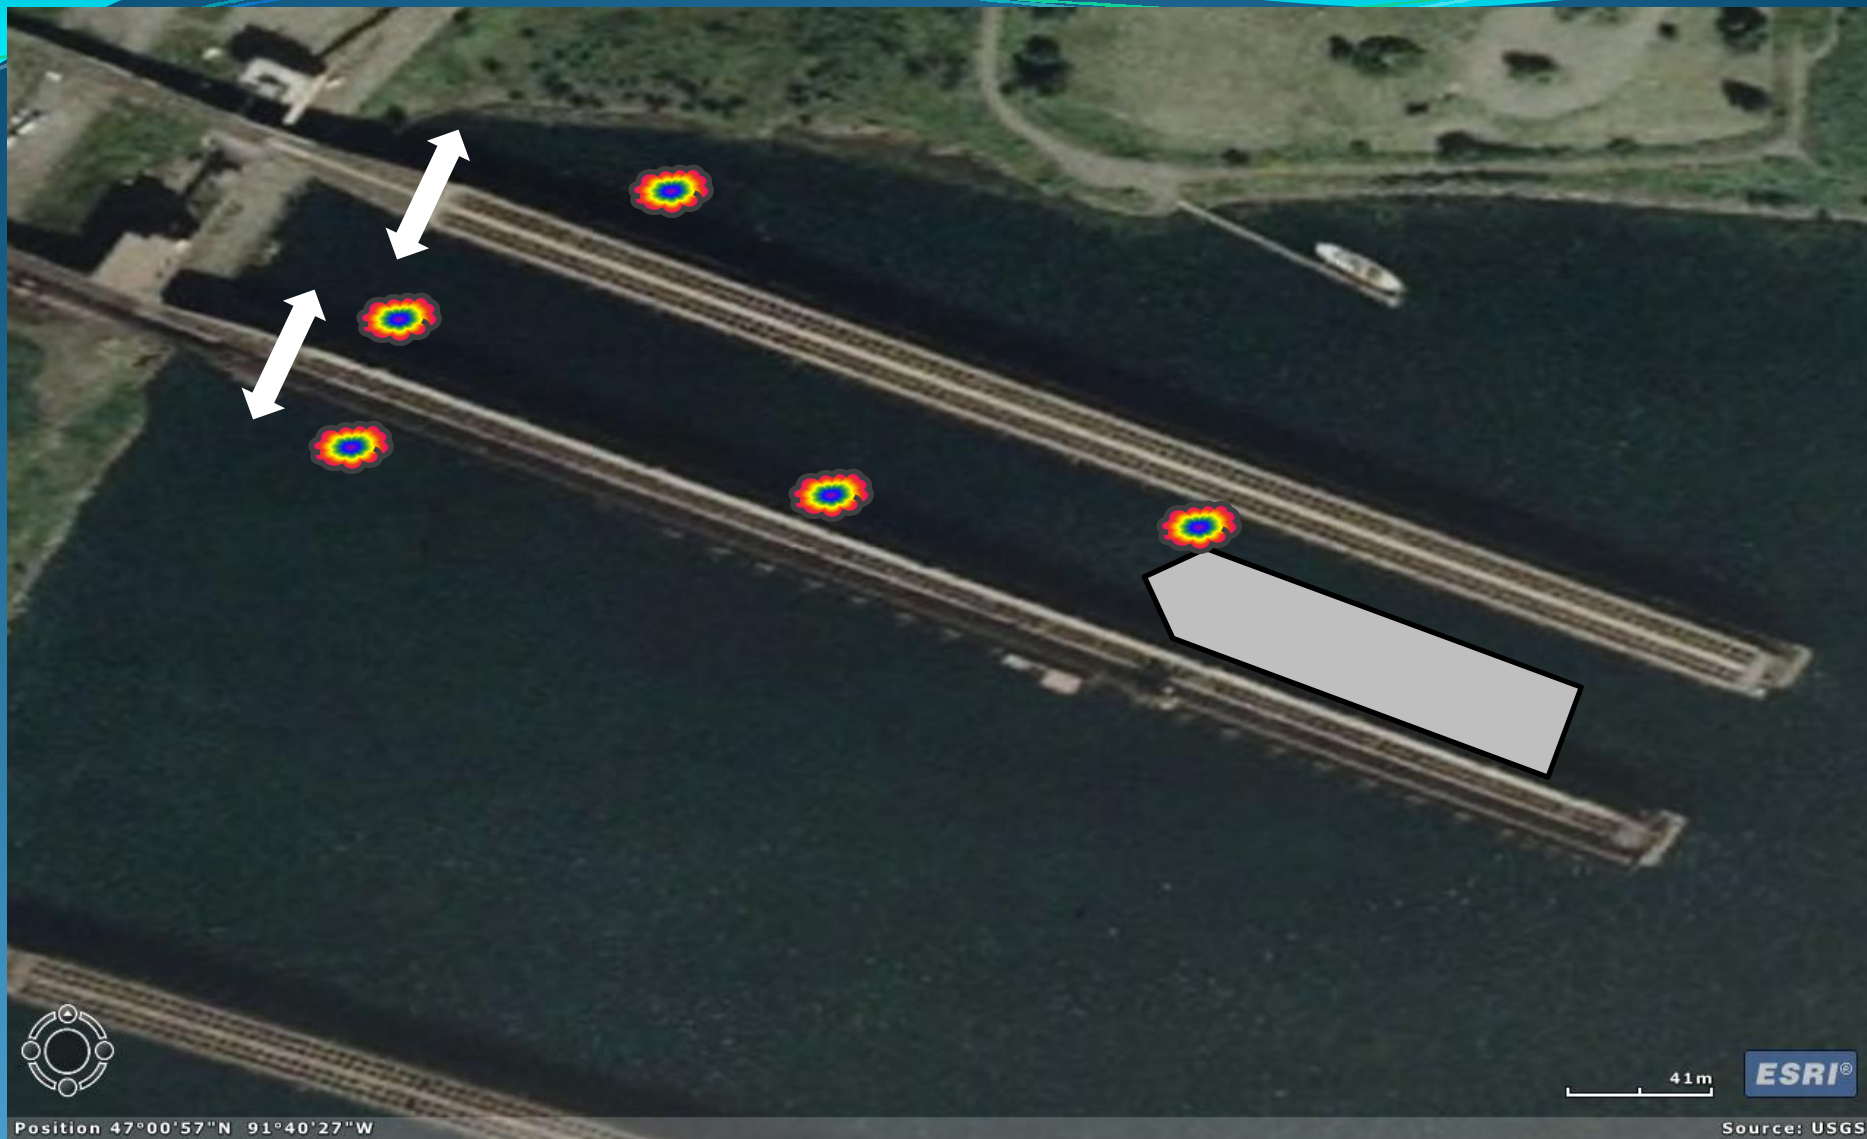
As pollution responders were departing the scene, additional oil was observed surfacing deeper in the slips after the M/V JOSEPH L. BLOCK shifted.

Divers from Indiana arrived on scene and began to deploy sediment curtain to catch tar balls as they emerged from bulkhead.

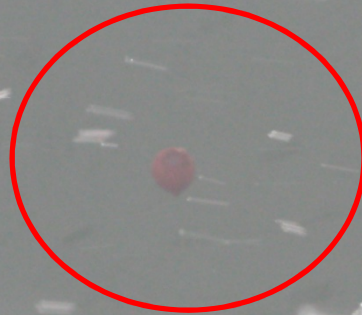
Ping Pong Ball sized tar ball just underneath the surface moving deeper into the slip after the M/V JOSEPH L. BLOCK shifted.

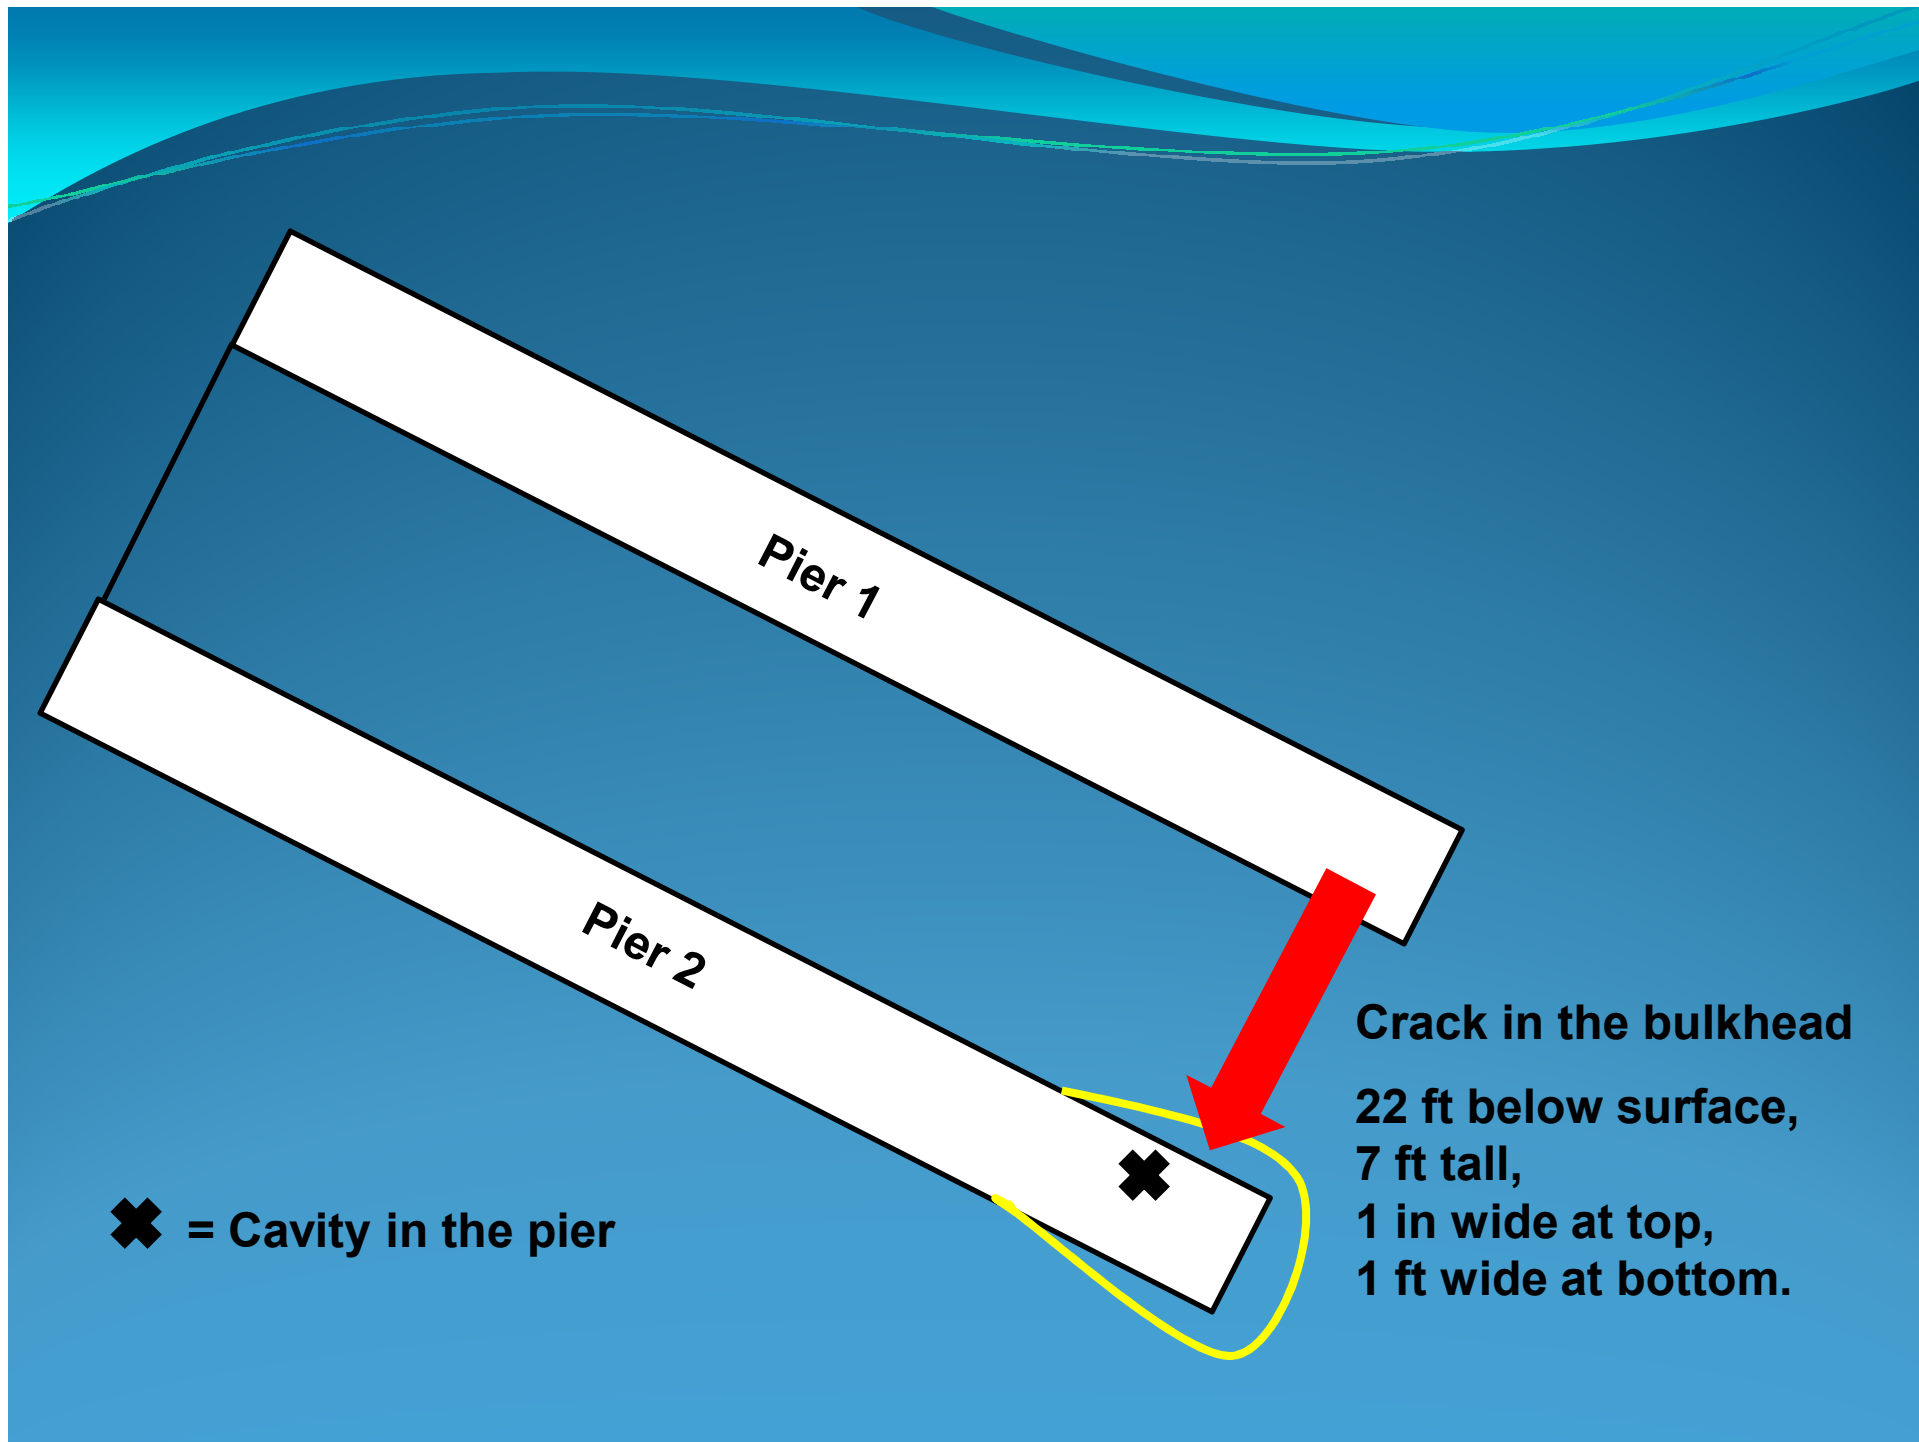
While inspecting the bulkhead, the divers found a crack on the north side of Pier 2.

The divers blew compressed air into the crack in the bulkhead which forced approximately one gallon of oil into the cavity under the pier, which was recovered with sorbent material.

This process was repeated several times per day until no more oil was entering the cavity. (16 January 2011)

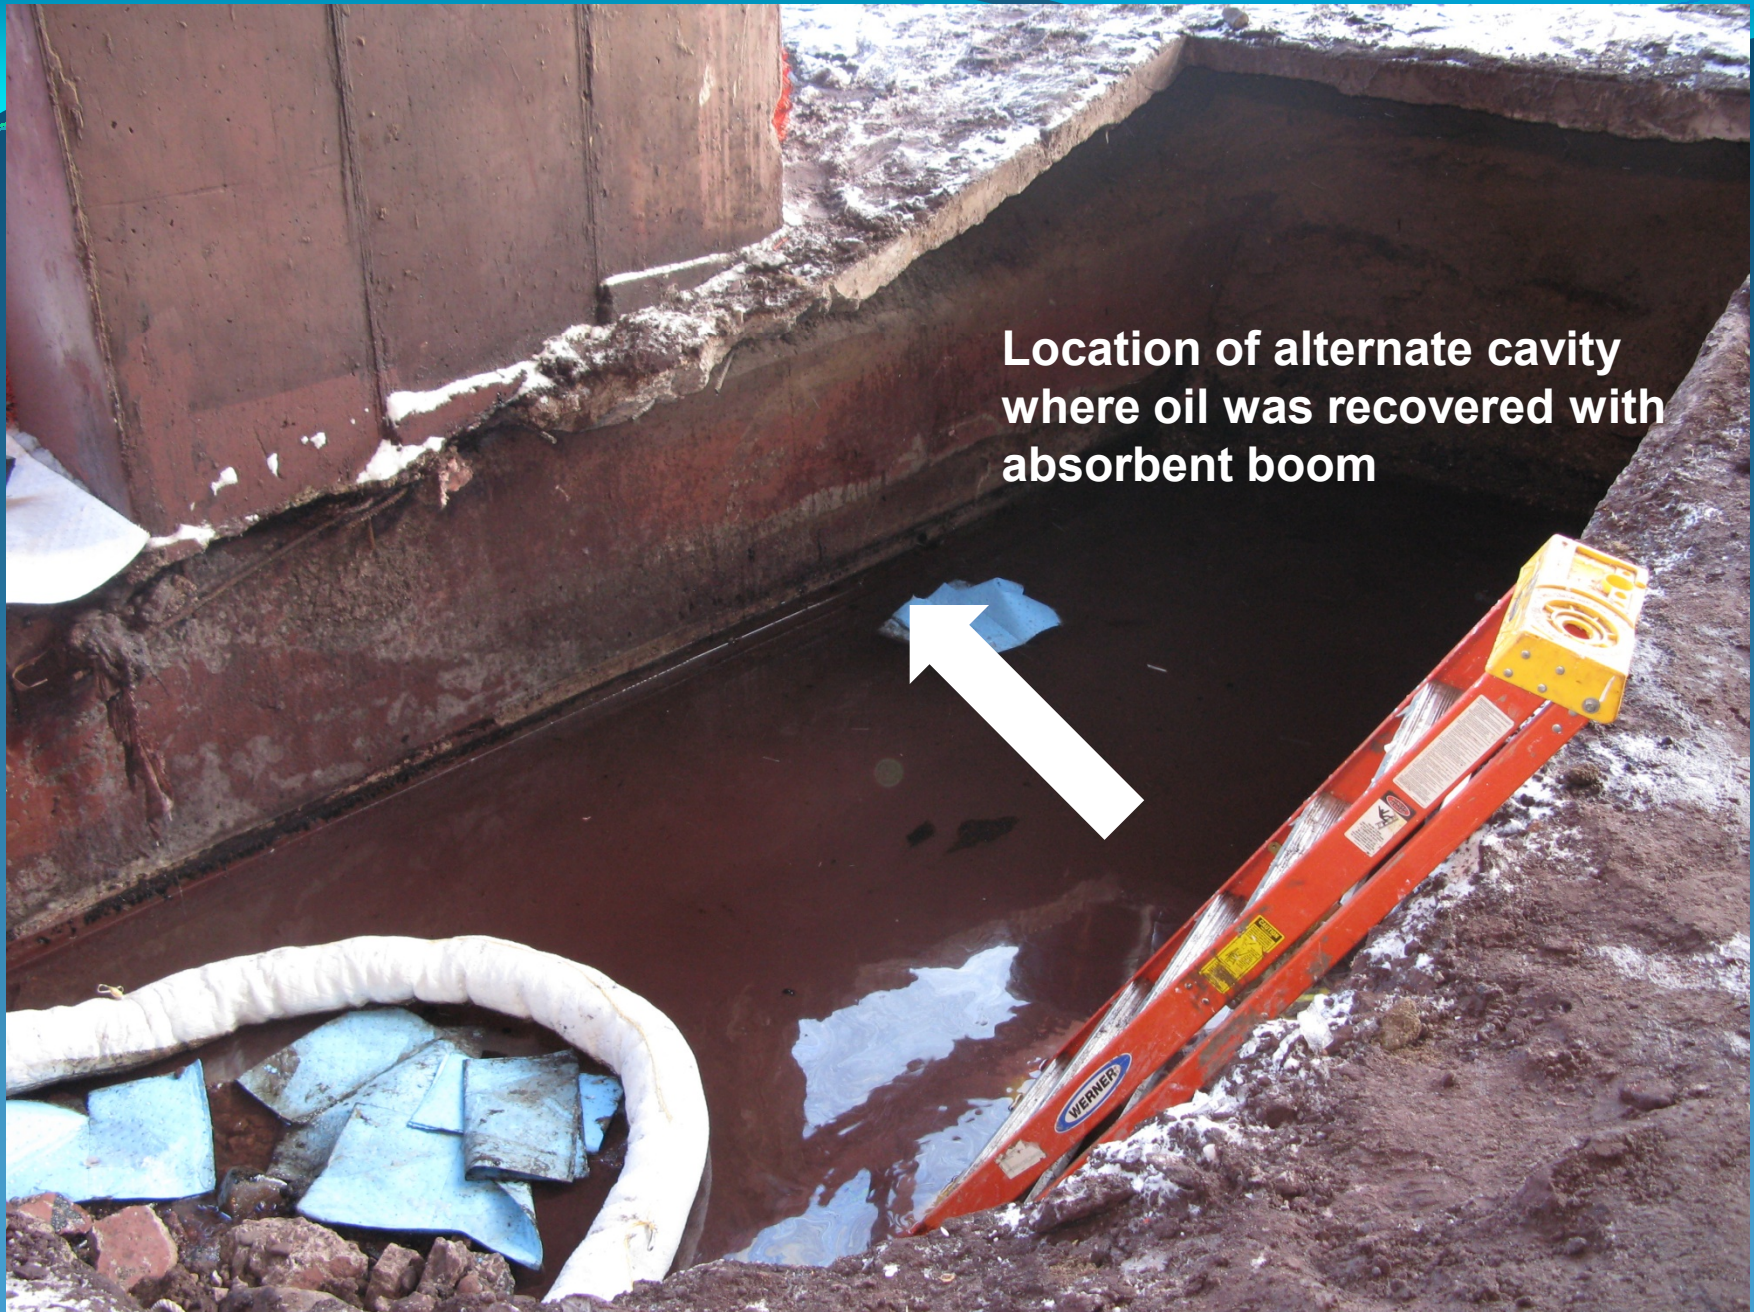
One of the divers deployed a camera into a submerged cavity to the north of the opened cavity and found approximately six pea sized tar balls and one ping pong ball sized tar ball.

**Location of alternate cavity
where oil was recovered with
absorbent boom**

Sorbent boom was stuffed into the cavity to recover this oil.
