OSWEGO HARBOR POWER #6 OIL SPILL

OSWEGO, NY MARCH 8, 2022 – AUGUST 10, 2022

LT IAN JOHNS & LTJG JOSHUA WELSH SECTOR BUFFALO / ATLANTIC STRIKE TEAM

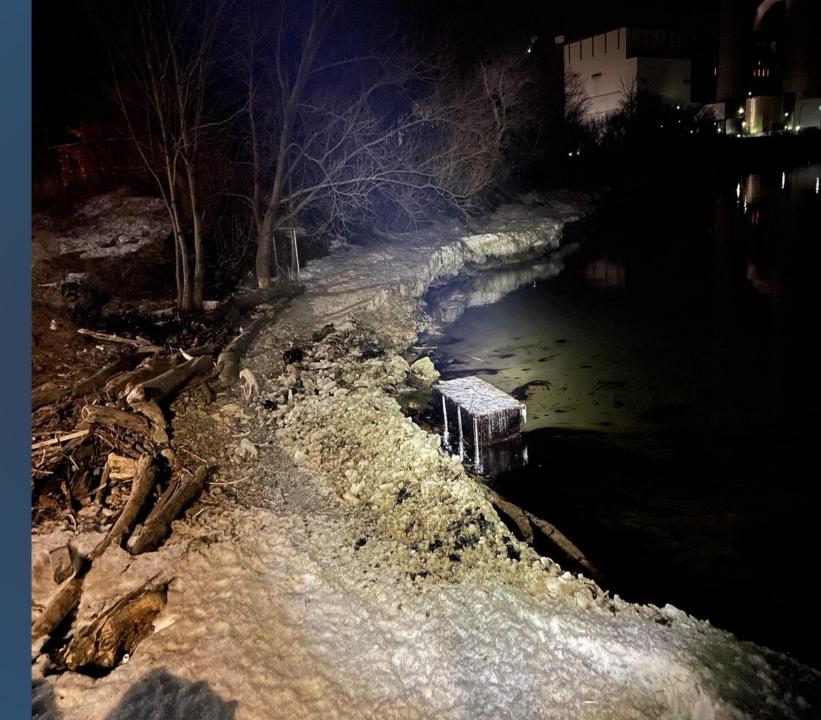
07MAR2022 2100LT: INITIAL INVESTIGATION REVEALED A THICK BLACK SHEEN IN THE SOUTHWEST CORNER OF BREITBECK PARK.

A BLACK 5'X3' CONTAINER FLOATING IN THE OIL WAS THOUGHT TO BE THE PROBABLE SOURCE OF THE OIL.

AT APPROXIMATELY 0400 A 600' SECTION OF OSWEGO HARBOR WAS CONTAINED AND THE CONTAINER WAS REMOVED. OIL RECOVERY BEGAN.

NY DEC HIRED AN OSRO IMMEDIATELY AFTER ARRIVING ON SCENE TO CONTAIN THE OIL AND RECOVER THE BLACK CONTAINER.

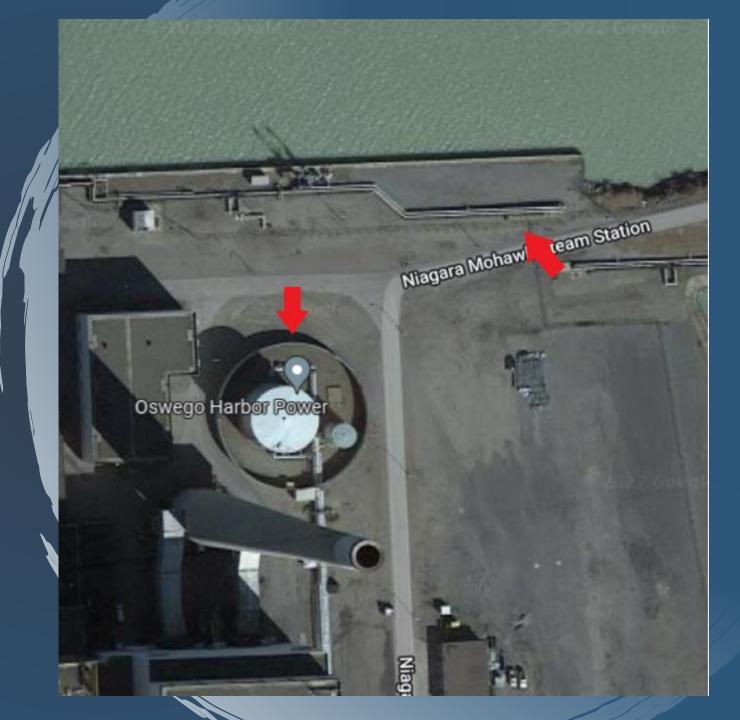
THE FIRST TWO MANHOLES SEARCHED PRODUCED STRONG PETROLEUM ODORS AND BLACK OIL WAS VISIBLE IN EACH.

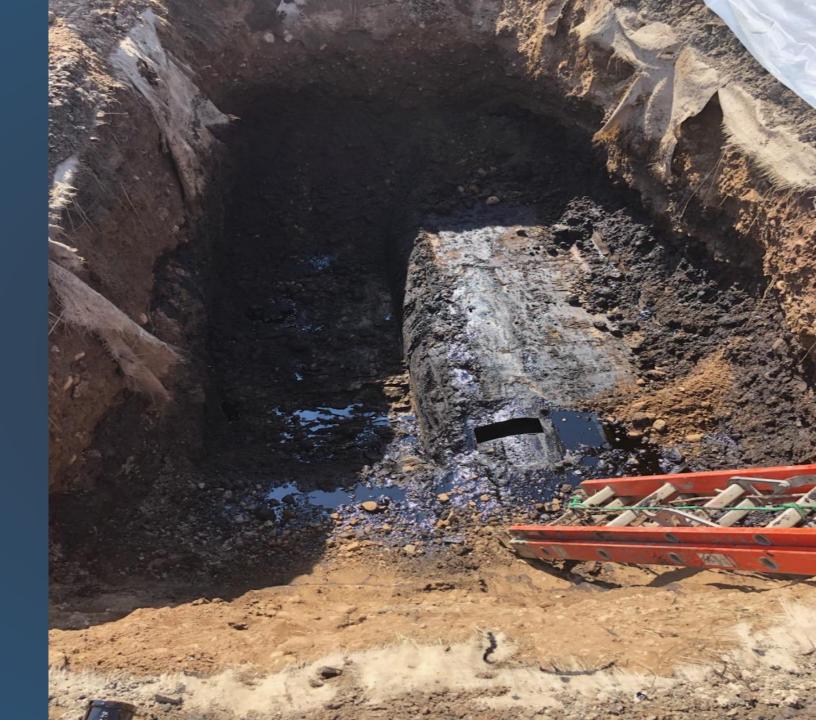
INITIAL DIGGING ALONG UNDERGROUND #6 OIL TRANSFER PIPELINE REVEALED HEAVILY OILED SOIL THE COMPLETE LENGTH OF THE PIPELINE.

THE 100+' OF PIPING WAS INSTALLED IN THE 1950S AND SHOWED SIGNS OF HEAVY PITTING.

OIL PIPELINE OVERLAPPED WITH CONCRETE STORM WATER LINES WHICH DISCHARGED INTO LAKE ONTARIO.

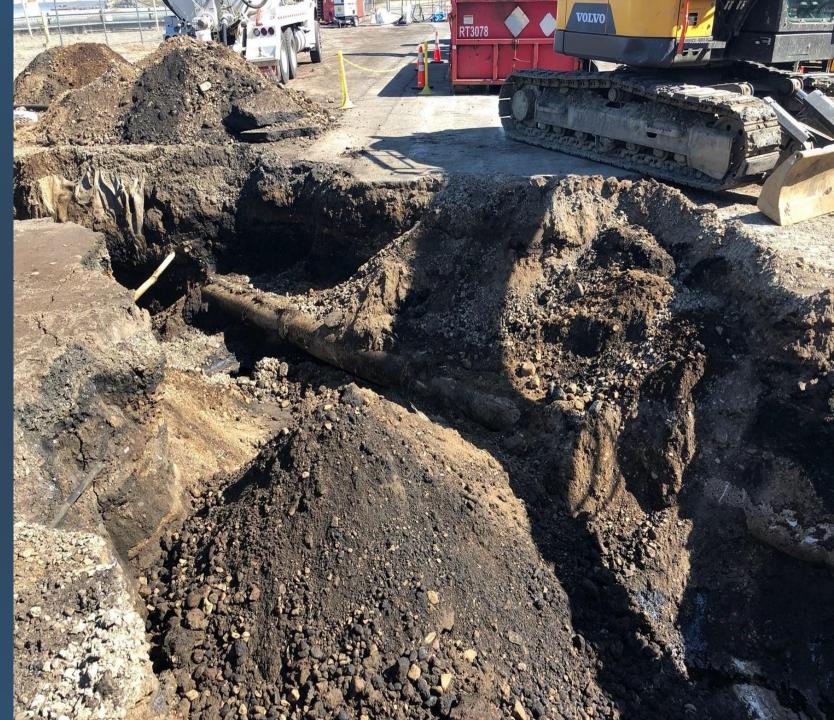
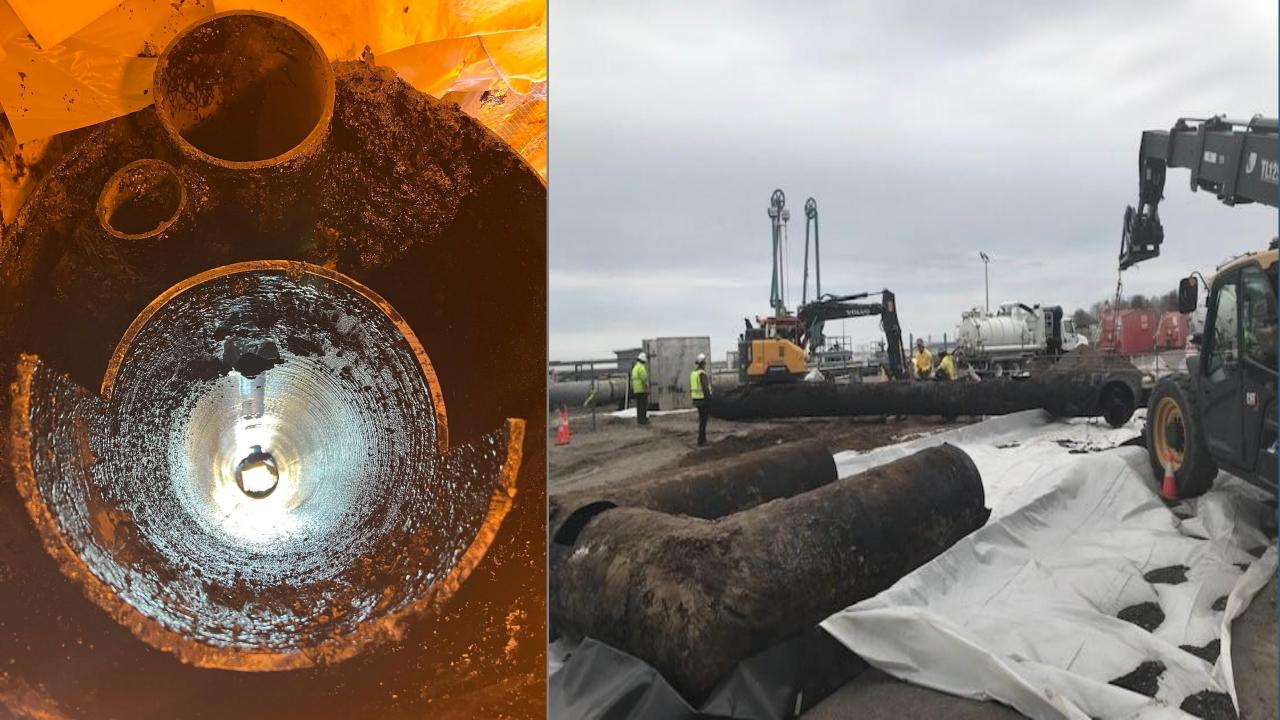
PIPING WAS JACKETED ALONG WITH A STEAM LINE. BOTH PIPES WERE COATED WITH AN ASBESTOS CONTAINING PROTECTANT.

THE LINE WAS ORIGINALLY INSTALLED JUST ABOVE THE GROUND WATER LINE WHICH WAS STRUCK MULTIPLE TIMES CAUSING THE EXCAVATION SITE TO FILL WITH WATER.

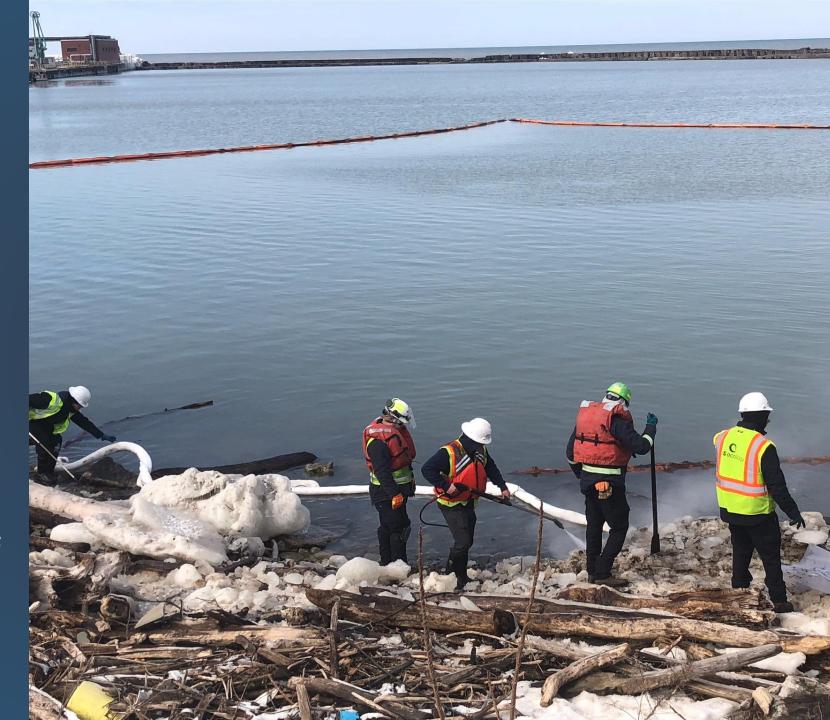
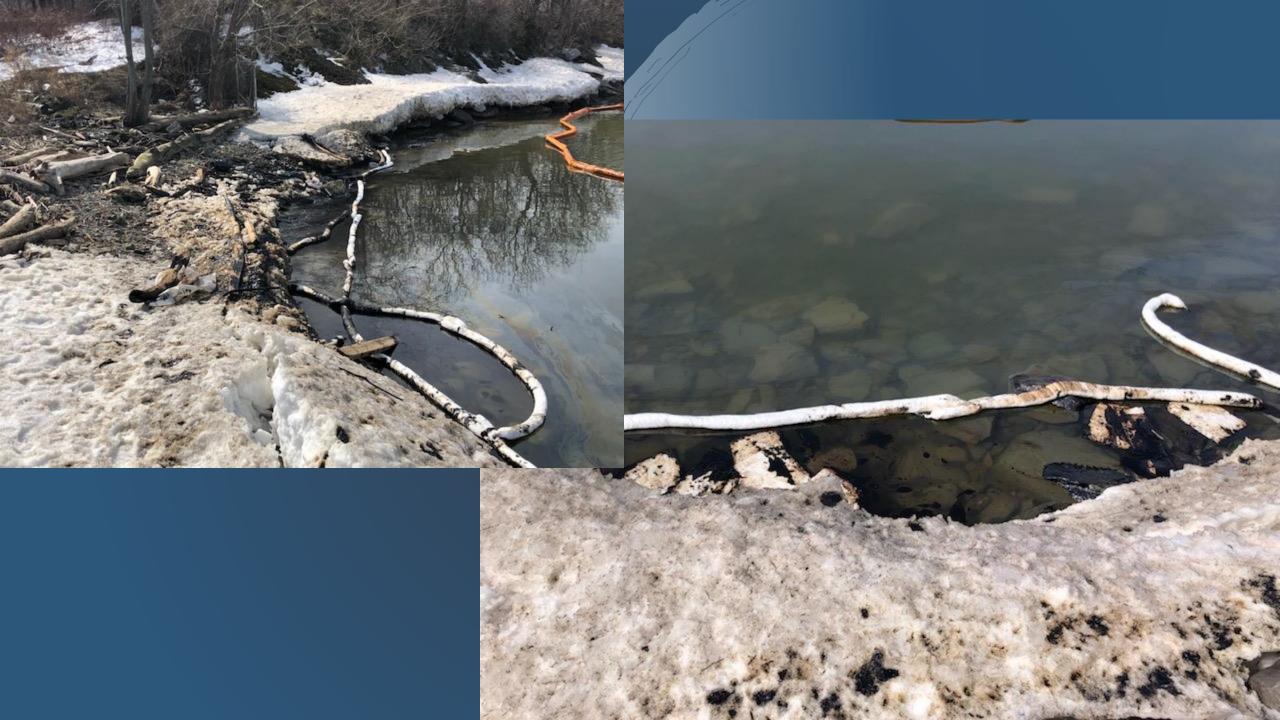
ON-WATER RECOVERY PROVED CHALLENGING DUE TO RIPRAP SHORELINE HEAVILY ICED OVER. MUCH OF THE OIL BECAME TRAPPED UNDER SNOW AND DEBRIS.

OSROS SPENT WEEKS MELTING ICE & SNOW TO REVEAL HEAVY POCKETS OF #6 OIL.

FROZEN GROUND MADE EXCAVATION OF SOURCE SITE SLOWER THAN EXPECTED.

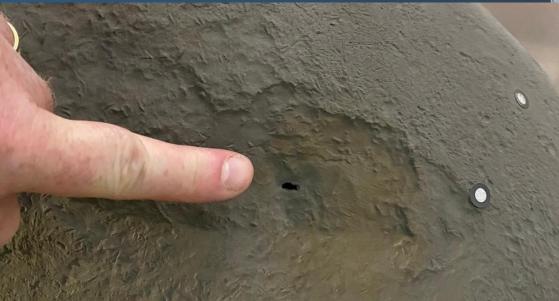
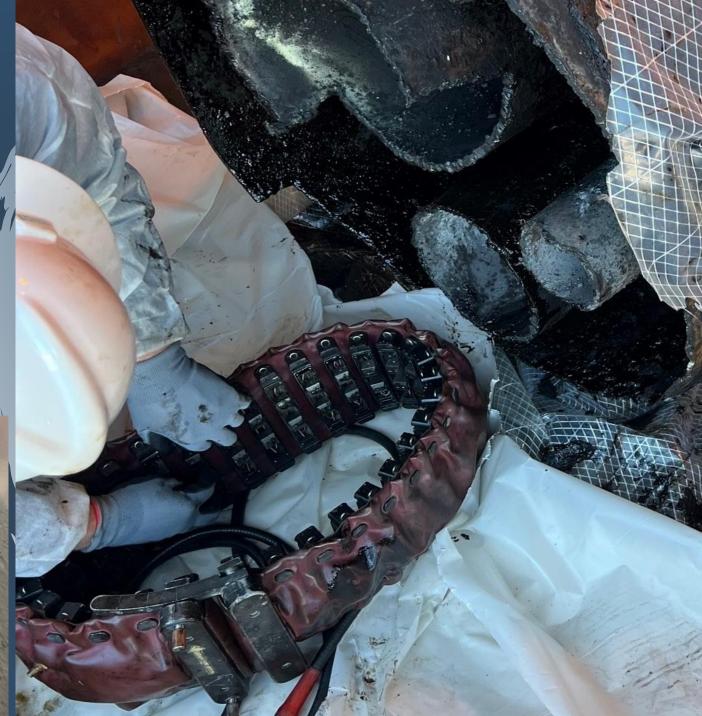
ULTRASONIC TESTS REVEALED DOZENS OF INTEGRITY ISSUES OF THE INTERNAL STRUCTURING ALONG THE 100' OF PIPING THAT WAS REMOVED.

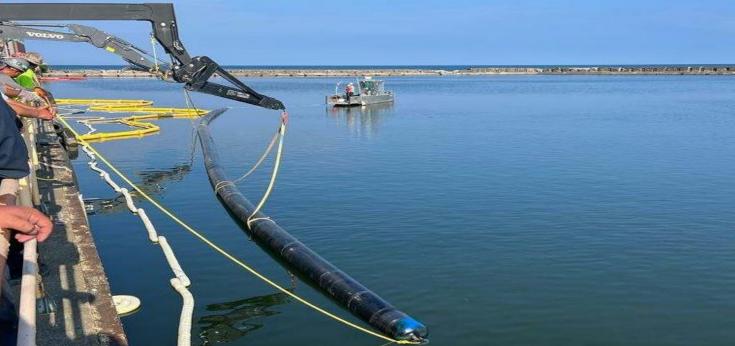
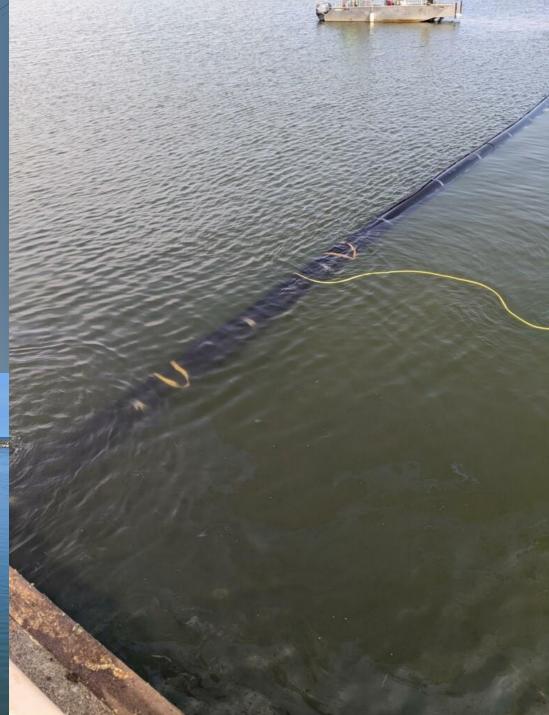
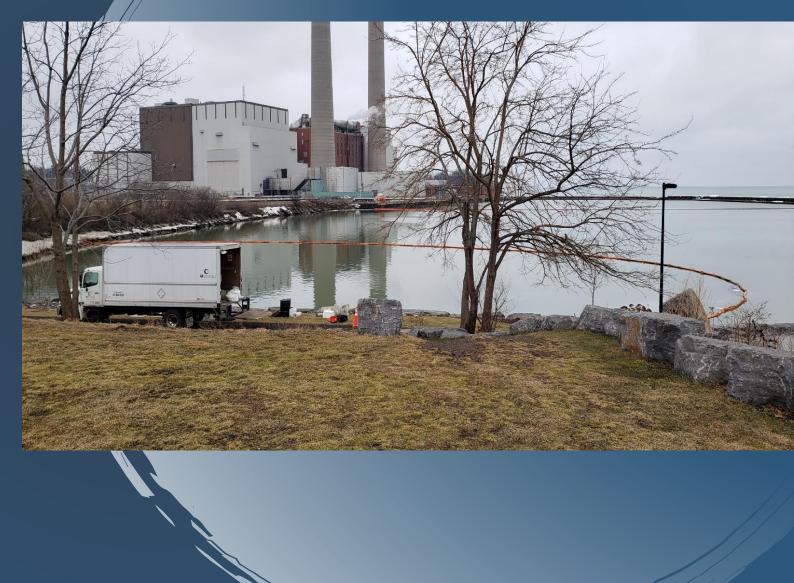
THE ORIGINAL OUTFALL CONCRETE PIPING WAS BROKEN IN MANY PLACES WHICH CAUSED THE OIL TO ENTER THE SYSTEM. INSTEAD OF REPLACING THE WHOLE OUTFALL SYSTEM, USING A SLEEVE WAS APPROVED.

A CUSTOM 120' HDPE PIPE WAS ORDERED AND FUSED TOGETHER ON SITE. THE PIPE WAS INSTALLED USING A VESSEL AND WINCH SYSTEM.
