Case Studies

Examples from Region 5

Region 5 Case Studies

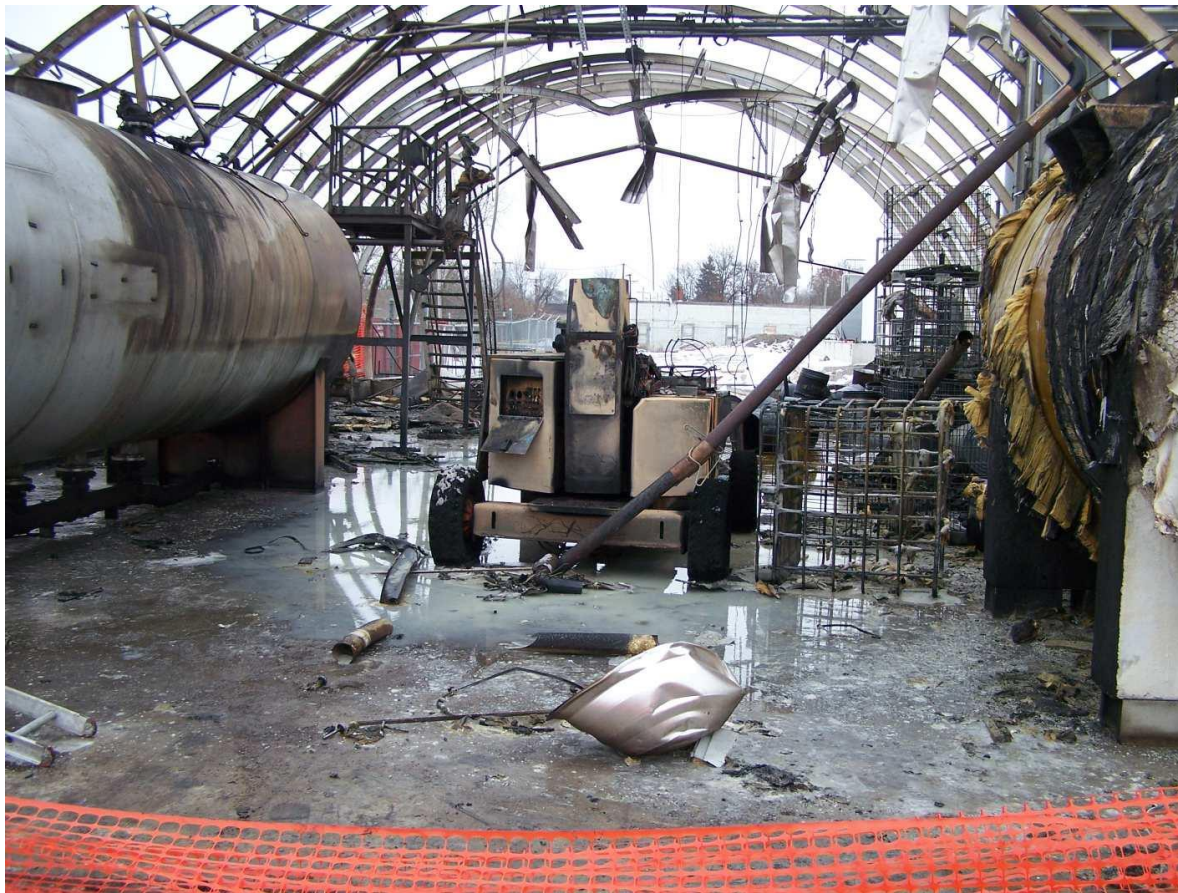
Fire and release point

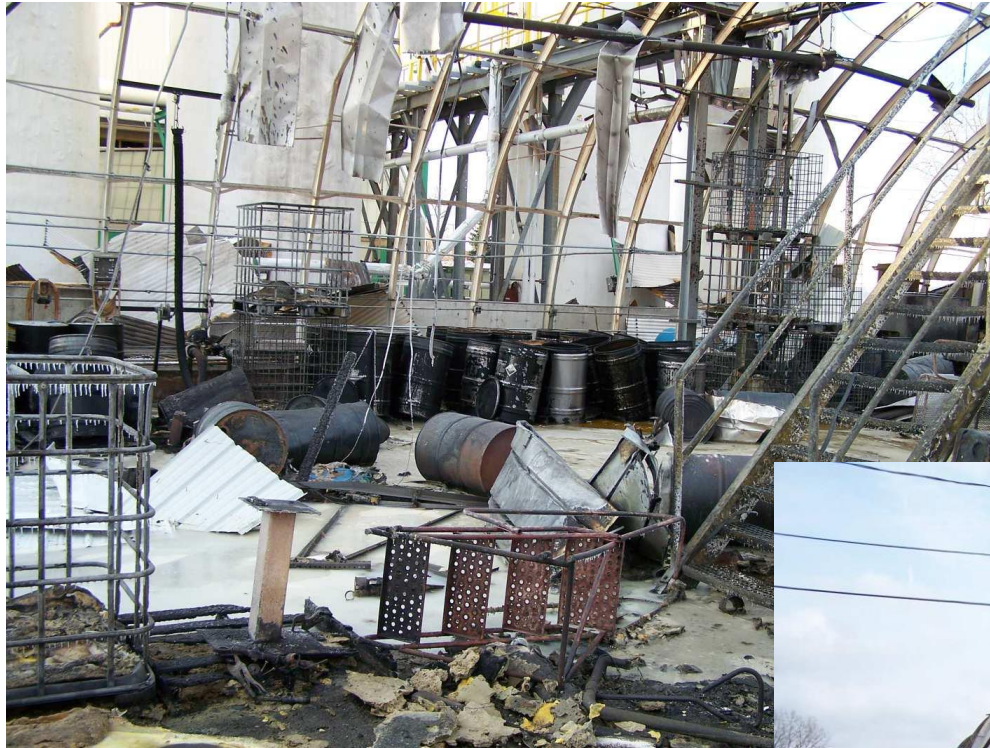
Drums consumed in fire

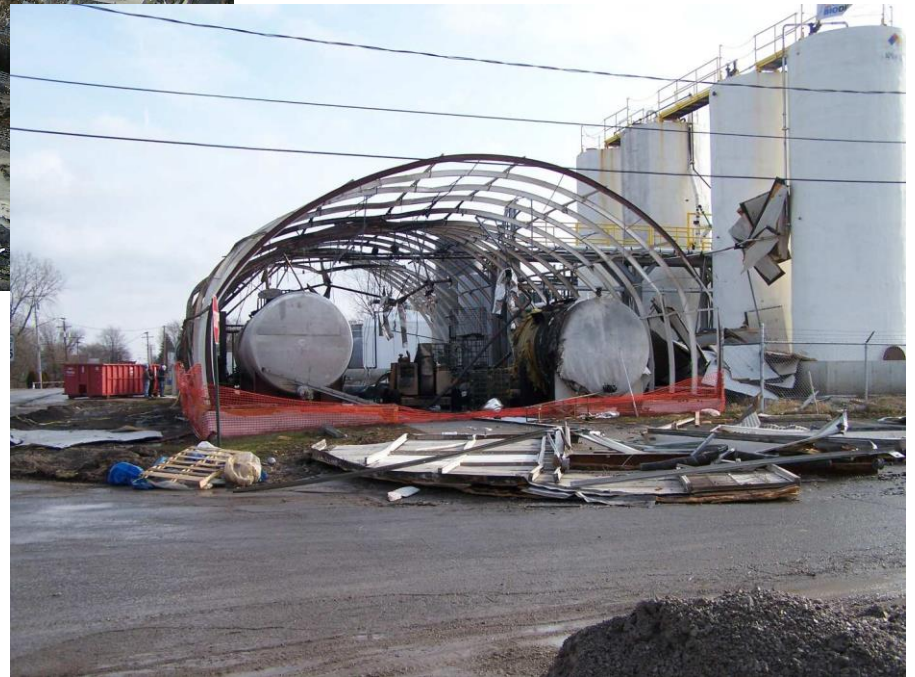
Release came out of structure with
FF water

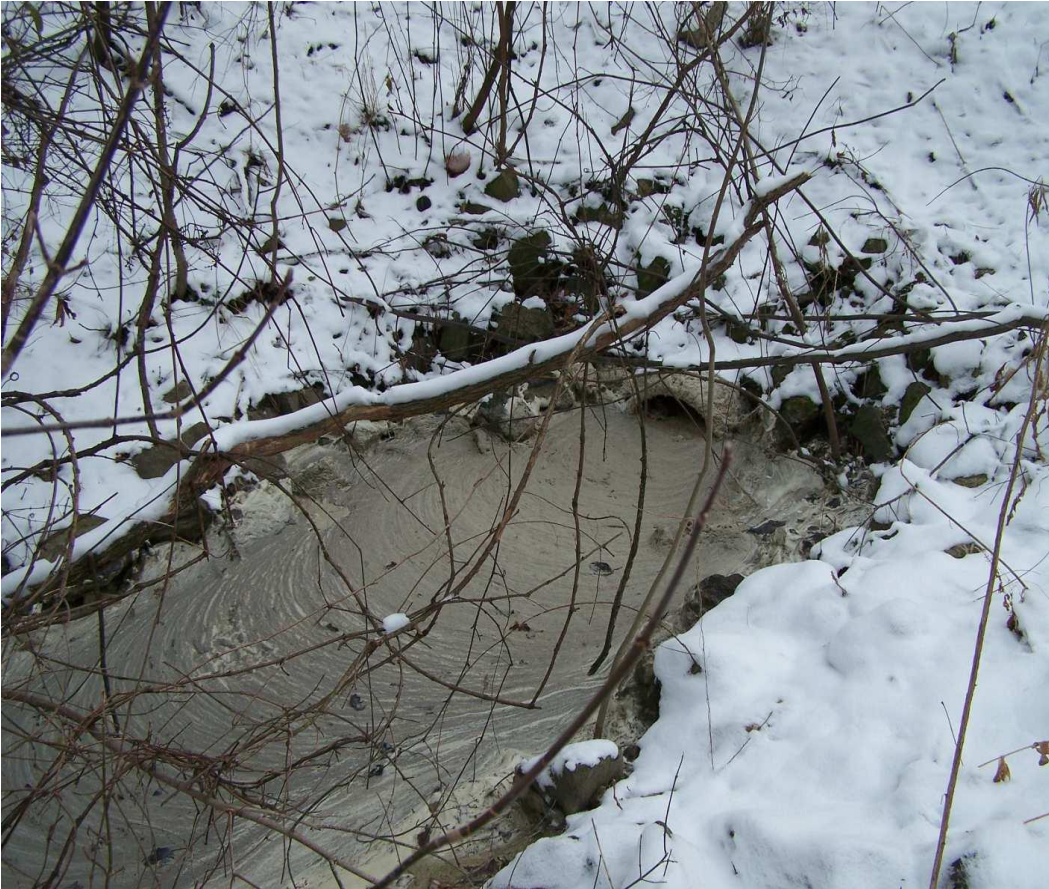
- “fats” floated
- 3 layers in water observed
- some suspended in water
- “milky” layer observed

- Response Techniques
 - Ohio EPA made PRP hire a contractor
 - the on-land spills were excavated
 - the spill to the ditch was collected and put in frac tanks
 - 3 distinct layers were noted in ditch waters
 - analytical of frac tank water revealed styrene and perchloroethylene
 - shows more than “glycerin” spilled
 - Some wastes suspended in the water column were lost

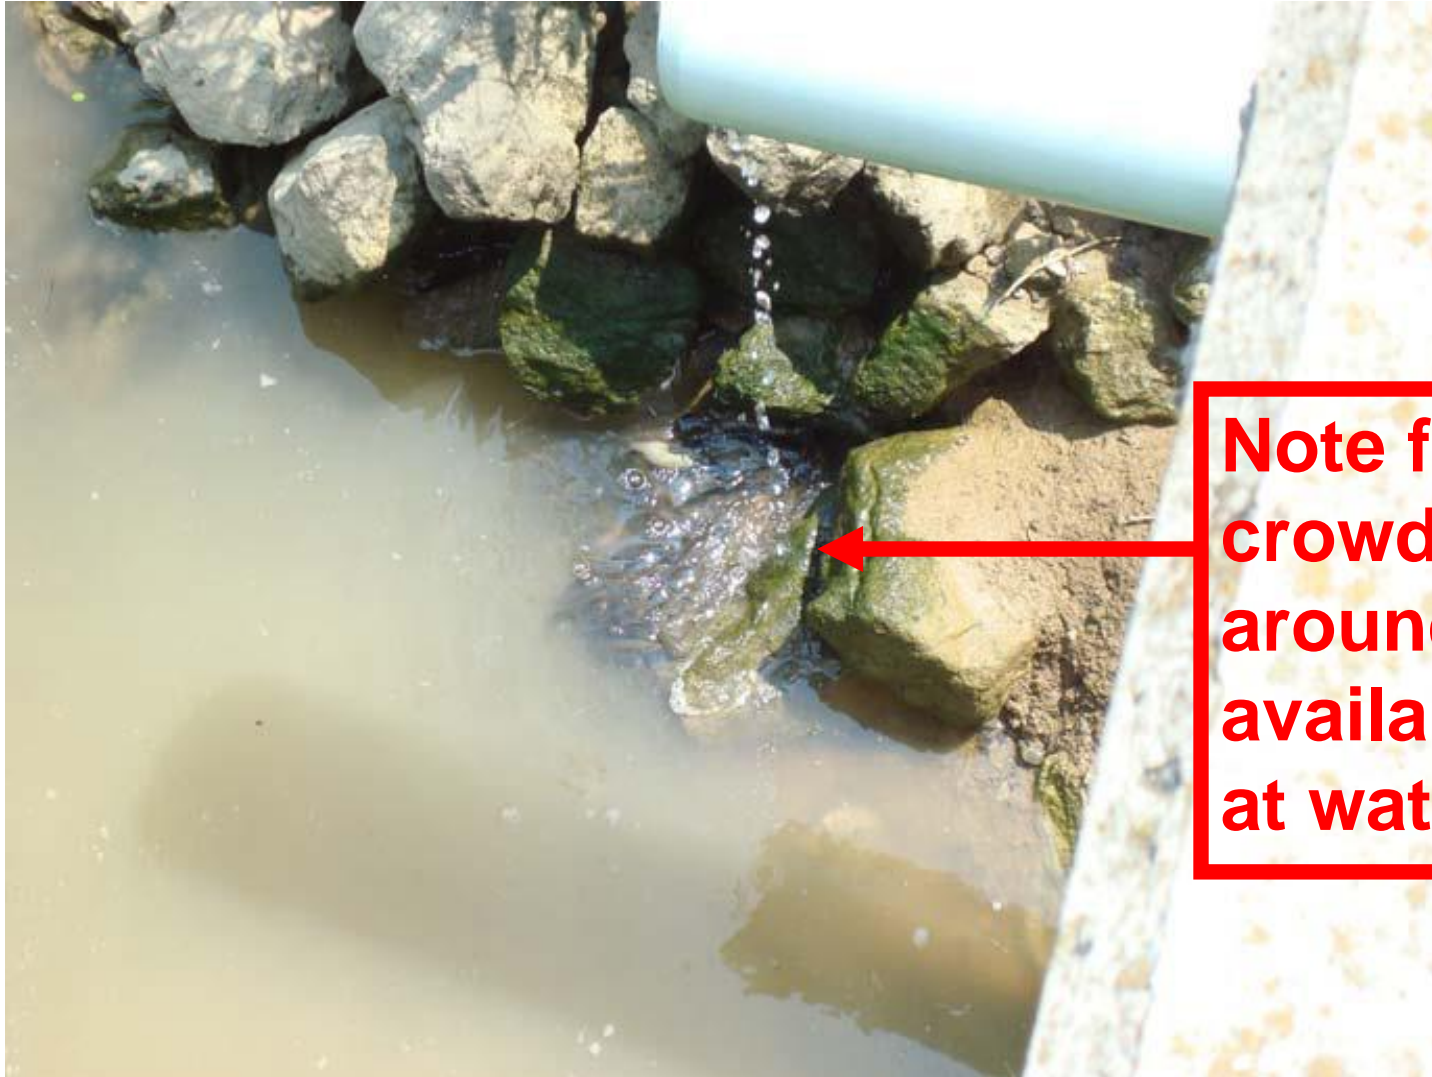
Note fish crowding around available O₂ at water inlet

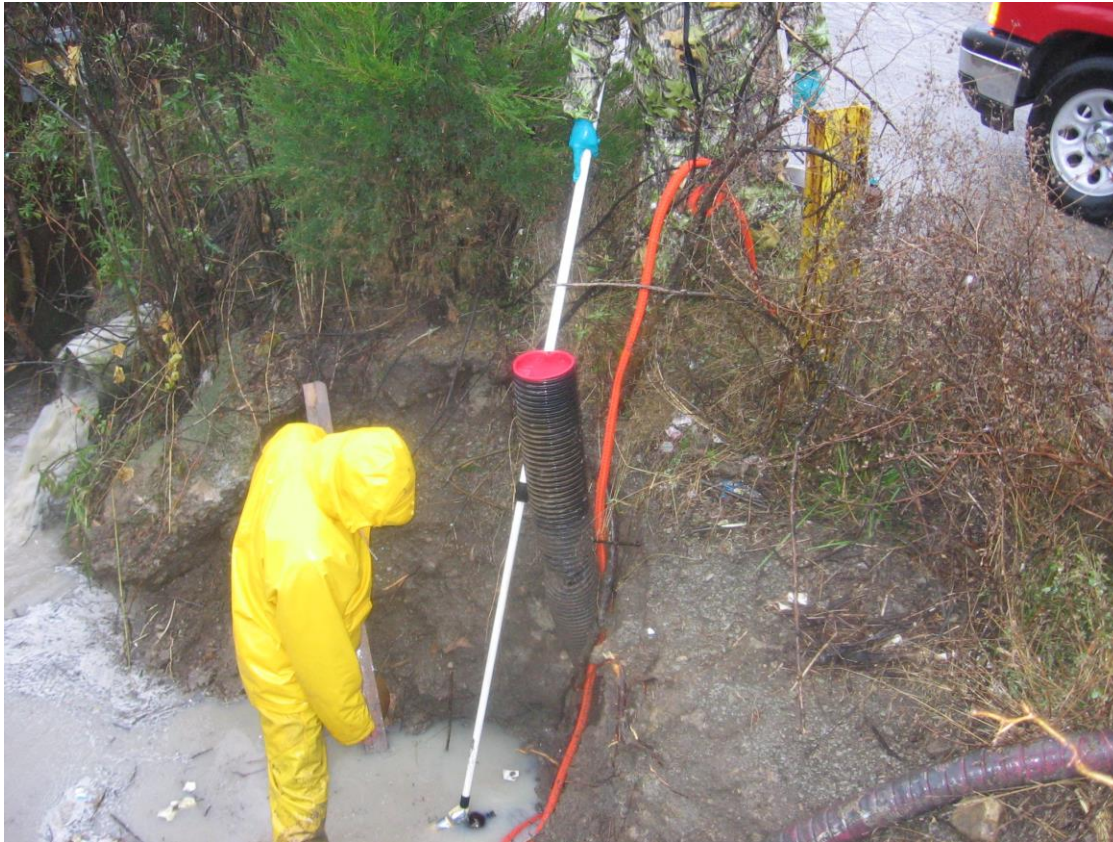
Note “milky” water

Normal fuel spill techniques not effective after initial spill

Ability of surface cleanup not really a viable option

- At biofuels production facility
- Spill from 50,000 gallon tank
- Surface soils and ditch water impacted
- Water in ditch a “milky” white (hear that before???)
- Soils excavated
- Tile field drains intercepted and plugged
