**APEX 3508**  
**MAJOR INLAND SPILL**  
**September 2, 2015**  
**Lower Mississippi River MM 937**

RRT V Brief  
5 NOV 2015

U.S. Coast Guard Marine Safety Unit Paducah, KY

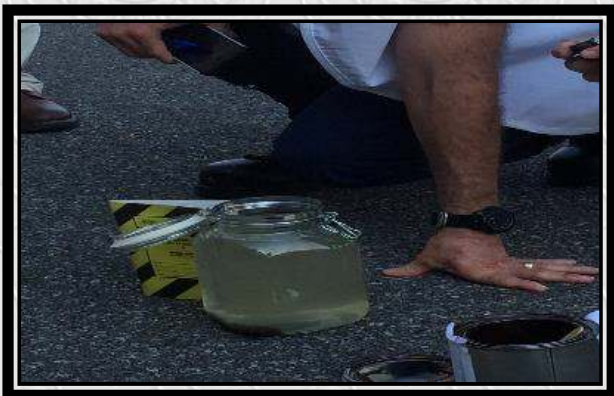
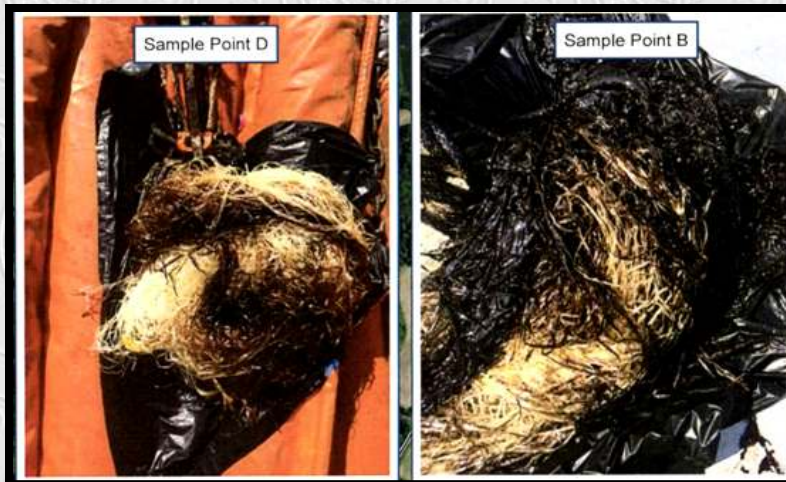
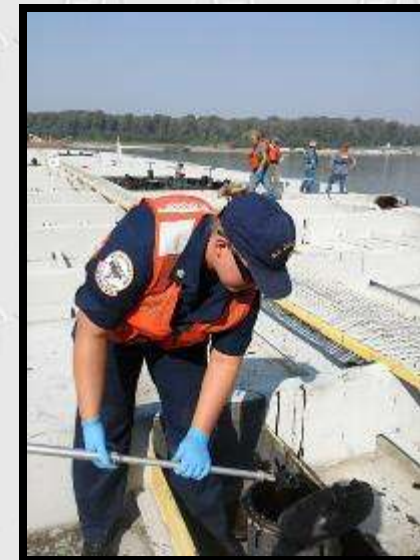
# PRODUCT-Clarified Slurry Oil

- Information on the oil provided in the safety data sheet indicated that the spilled slurry oil had a specific gravity of 1.1. Oils of this type are typically classified as Group V Oils which are known to sink in freshwater. Group V Residual fuels Oils ( GPVRF) referred to by industry as LAPIO (Low API Oils)
- RCRA Information: unused product is not specifically listed by the EPA as a hazardous waste. It does not exhibit the hazardous characteristics of ignitability, corrosivity, or reactivity (ExxonMobil MSDS)
- DOT Haz Class: Combustible Liquids
- ID Number: NA1270
- ERG Number: 1287
- Boiling Point: 400 F
- Needs to be heated to ~120 F to pump from barge
