# Sunken Barge ARTHUR J & Tug MADISON Case Study

LCDR Chico Knight, DBA, M.S.

# July 19, 2012

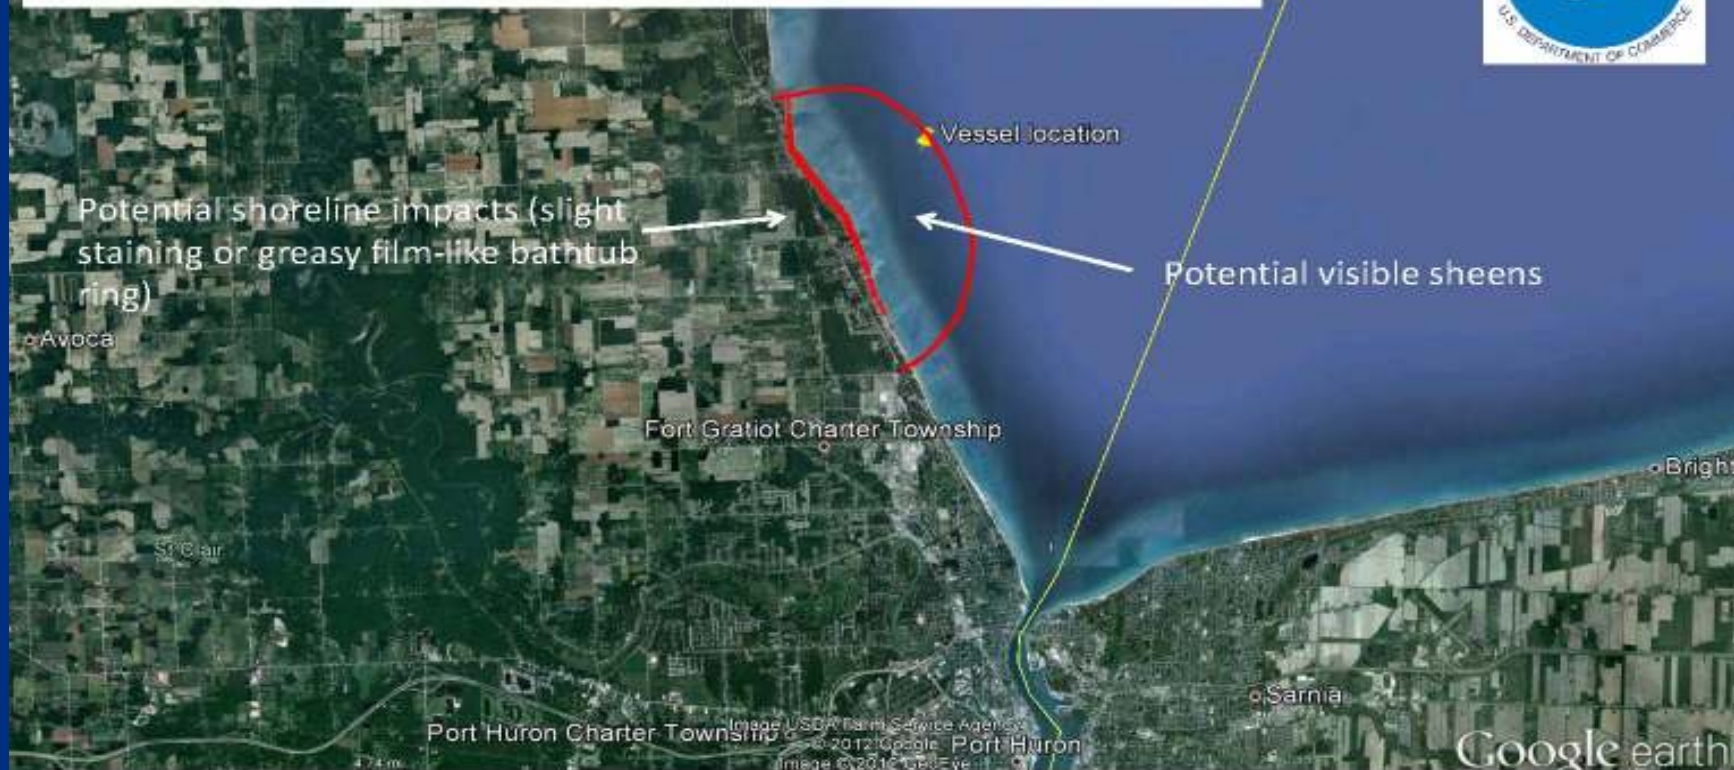
Trajectory for 8300 gallon diesel spill from collision involving Tug Madison  
 Produced: July 19, 2012 16:00 EDT for next 48 hrs  
 NOAA Emergency Response Division

The above map shows the potential regions of visible sheens and shoreline impacts over the next 48 hrs for EITHER a slow continuous release OR an instantaneous release of the entire 8300 gallons. Note that if the release occurs slowly, the likelihood for shoreline impacts is reduced as the diesel will disperse and evaporate fairly rapidly. Light refined products, such as diesel, typically have very high evaporation rates and do not tend to create persistent slicks. If the sheens reach the shoreline in a few hours, a slight staining or greasy film-like bathtub ring is common. These oils usually do not form a stable emulsion and, as a result, do not form a heavy or sticky residual to clean up. Note that lighter refined products do have a relatively high concentration of light aromatic compounds and tend to be more soluble and more toxic than heavier oils. These oils do not generally present an involved cleanup problem. However, they can result in an initial toxic shock to biota and can persist as a biological threat in low energy marine environments.

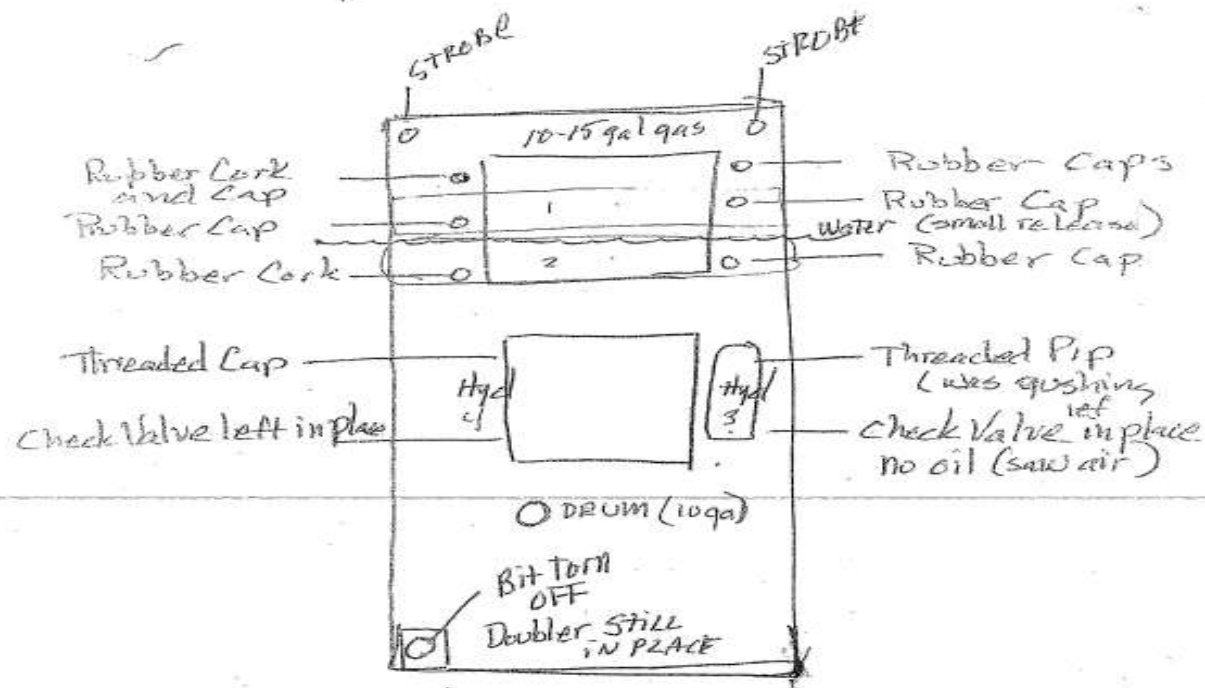
### Oil Budget

- 1 - 1500 gal - Diesel
- 2 - ~100 gal - Diesel
- 3 - 10 gal - Hyd.
- 4 - 10 gal - Hyd.

bit broken off
