PFAS Investigations in North Kent County

**An Introduction to the Wolverine
World Wide Investigation**

MICHIGAN DEPARTMENT OF
ENVIRONMENT, GREAT LAKES, AND ENERGY

**Region 5 Regional Response Team PFAS Webinar – February 4, 2021
Presented By: Abigail Hendershott and Karen Vorce, EGLE-RRD**

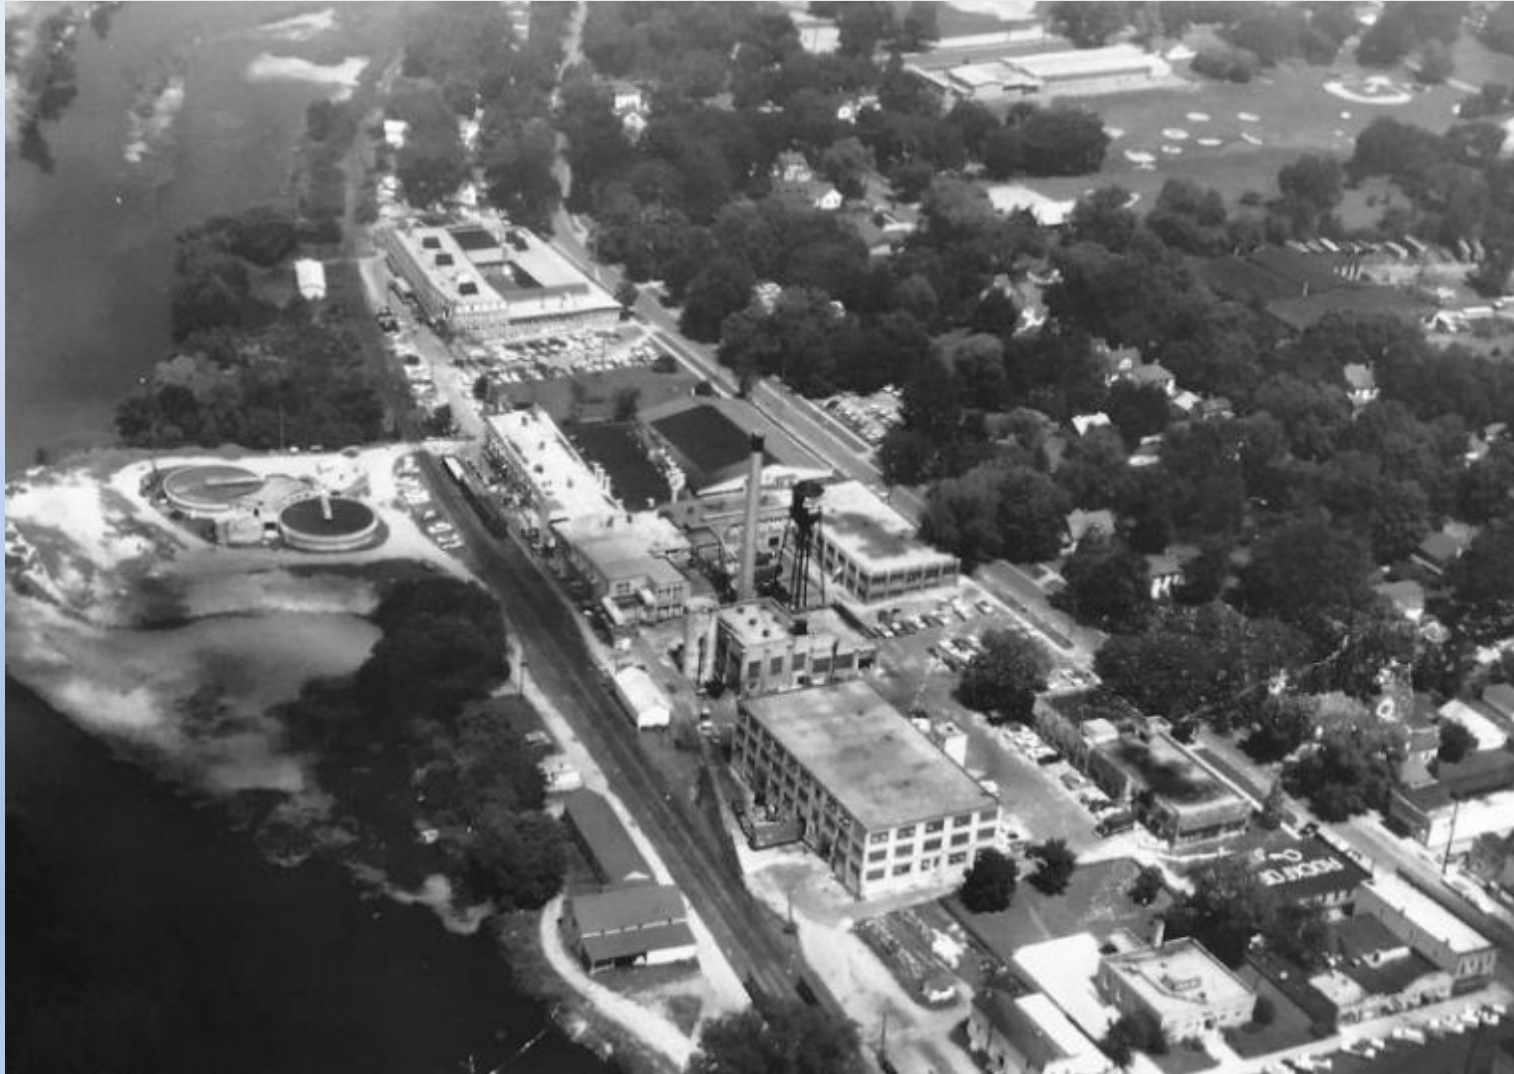
Wolverine World Wide's Rockford Tannery

- 1903 - Shoe production starts under Hirth-Krause Co.
- 1909 - Wolverine Tannery opens
- 1958 - Start of Scotchgard™ use with the introduction of the “Hush Puppies” shoe line
- 2010 - Tannery site demolished and razed

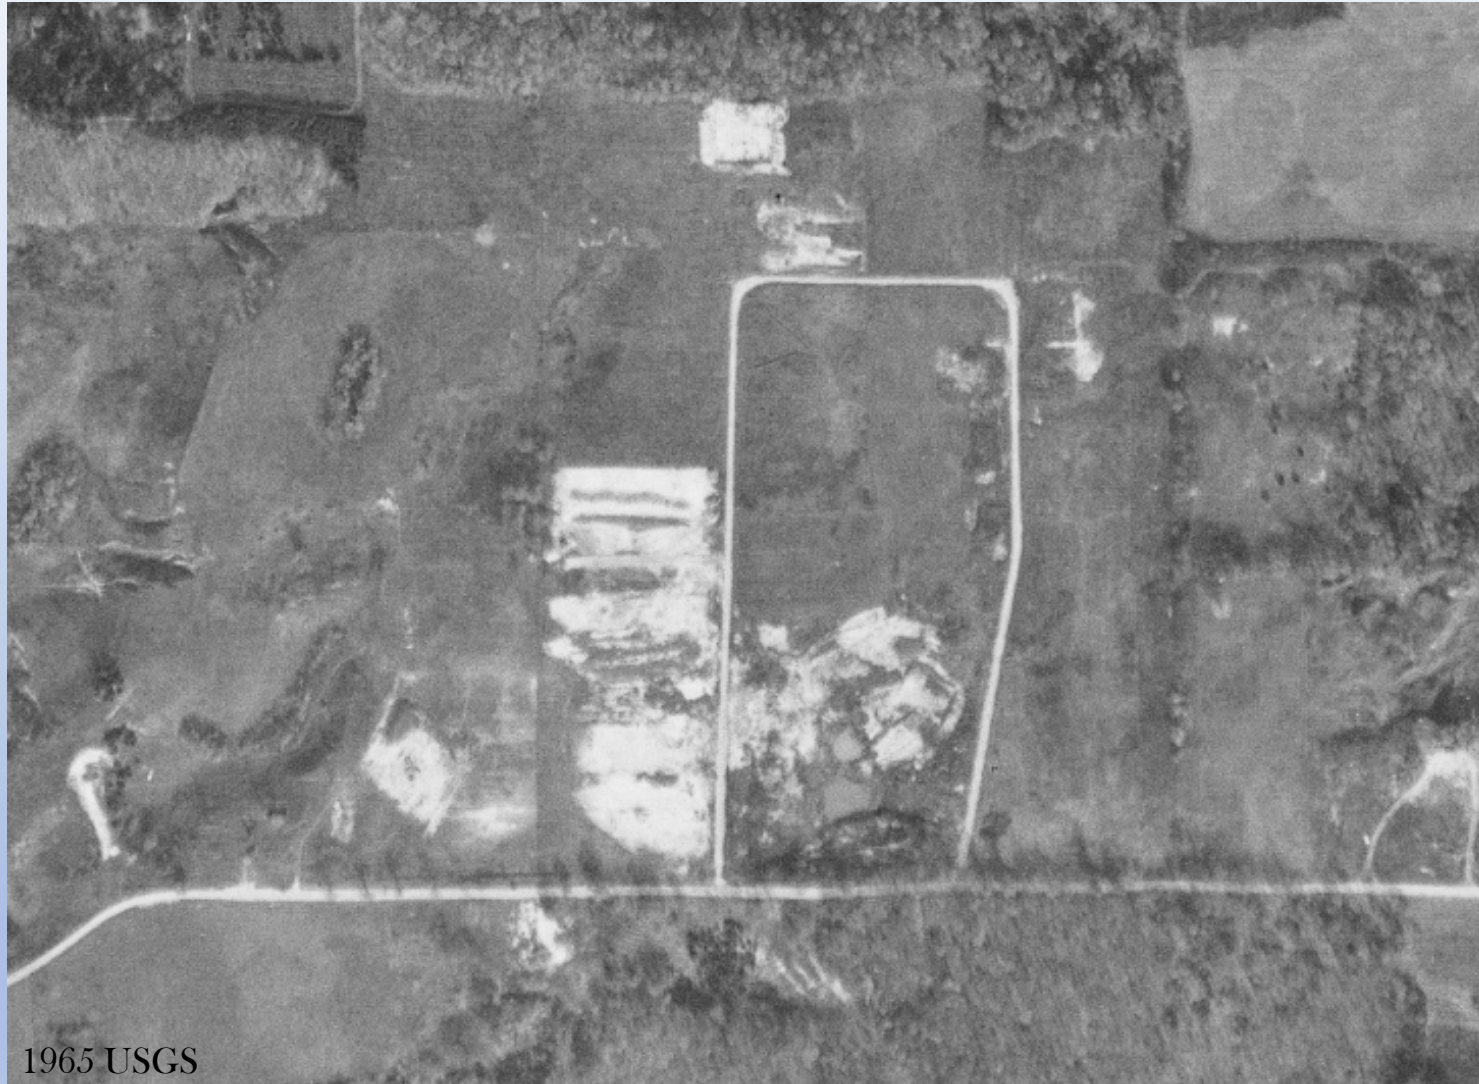
House Street Disposal Site

- Late 1930s- First reference to Wolverine disposal activities on House Street
- 1964 - Wolverine purchases the property
- 1966 - Licensed disposal facility
- 1970 - Disposal activities stop

Waste materials disposed of in unlined trenches, ponds, lagoons and into lowlands/ravines

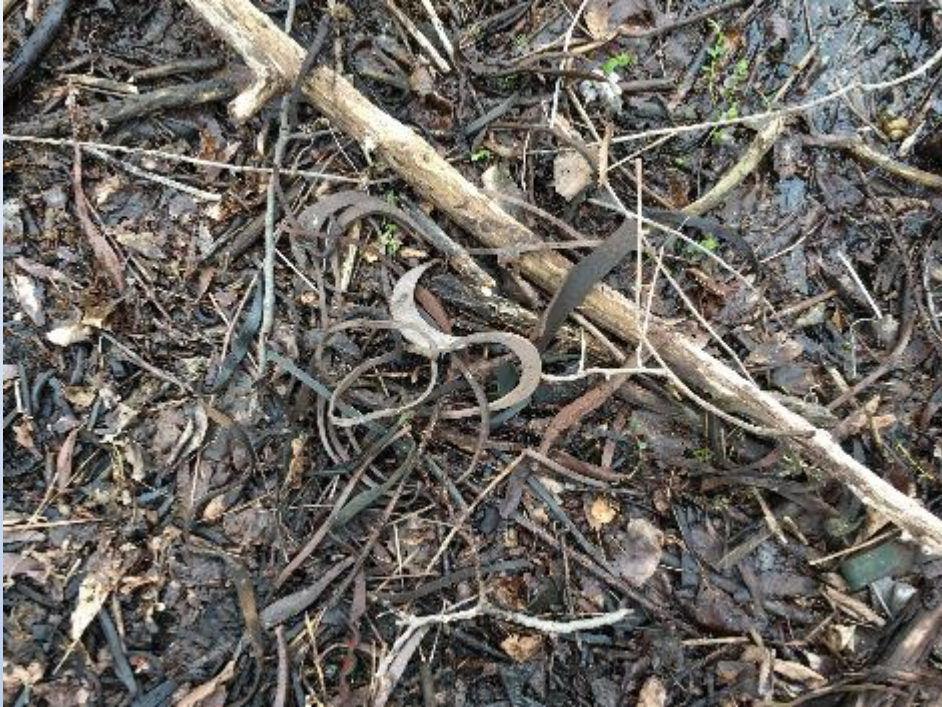
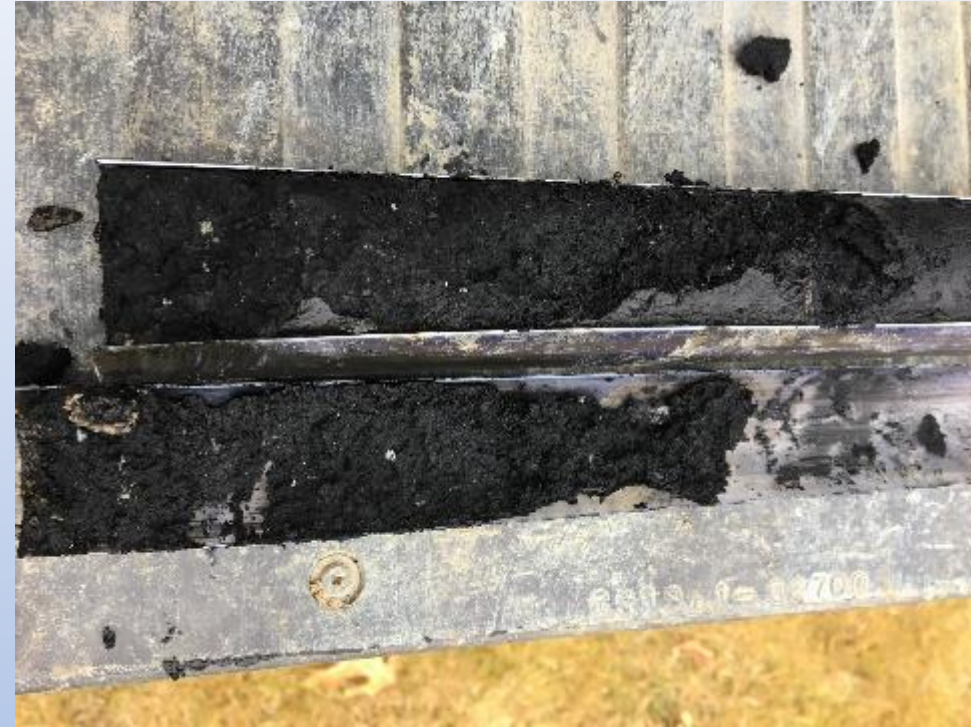
Tannery leather scraps along Rogue River

Tannery waste at
Northeast Gravel Site

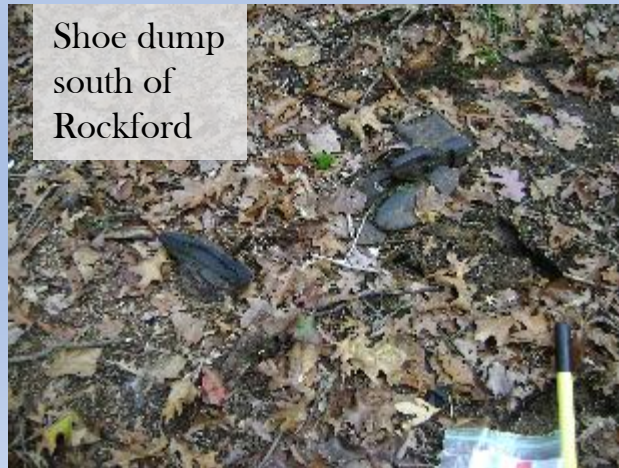
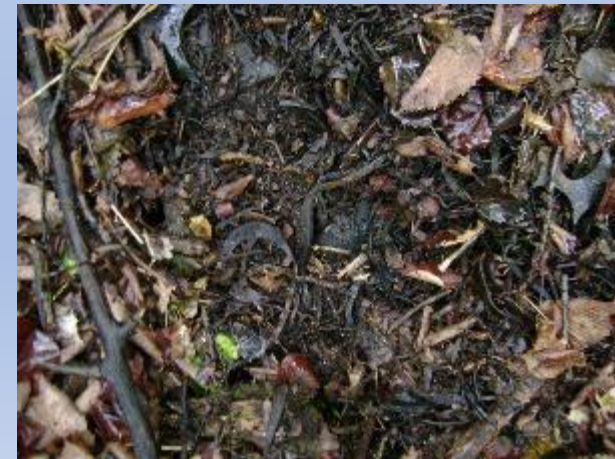
Shoe dump
south of
Rockford

Tannery rubber scraps
in gravel pit east of
Rockford

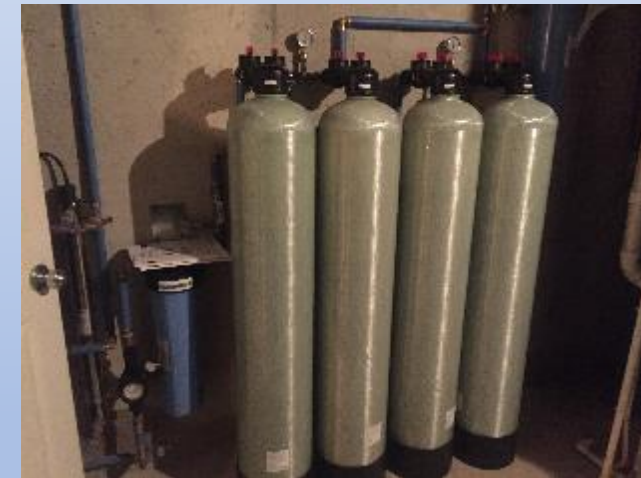
Photo:
Example of a
POE system
installed by
Wolverine

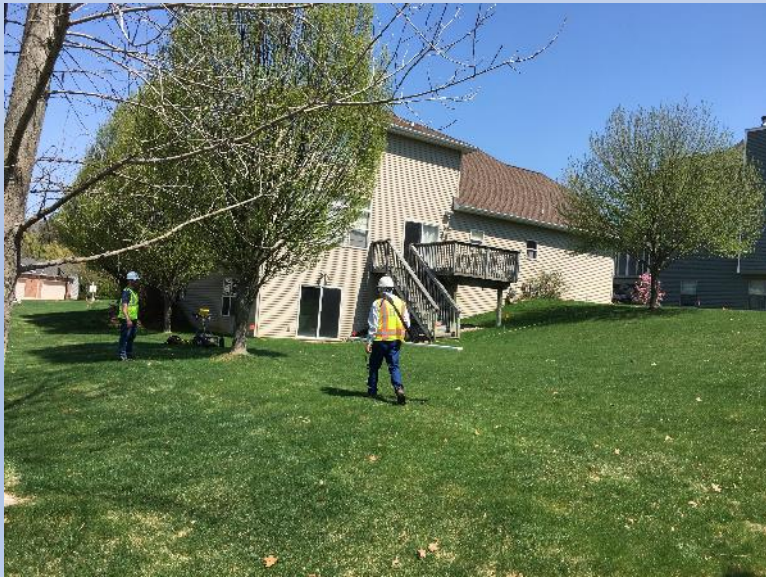
EPA geophysical survey of source area
