## ARGO Incident

Marine Safety Unit Toledo, OH  
U.S. Coast Guard Sector Detroit, MI  
Ohio Environmental Protection Agency

- ARGO Background: Built 1911, sunk in 1937 (78 yrs ago), 120ft x 35ft x 12ft with 4 to 5ft visible above mudline, lays in 50ft of water
  - Carrying approx 200,000 gal of product
  - Thought to be in Canadian waters off Pelee Island, discovered in U.S. waters 9 mi east of Kelly's Island
  - Subject of NOAA RULET in 2013

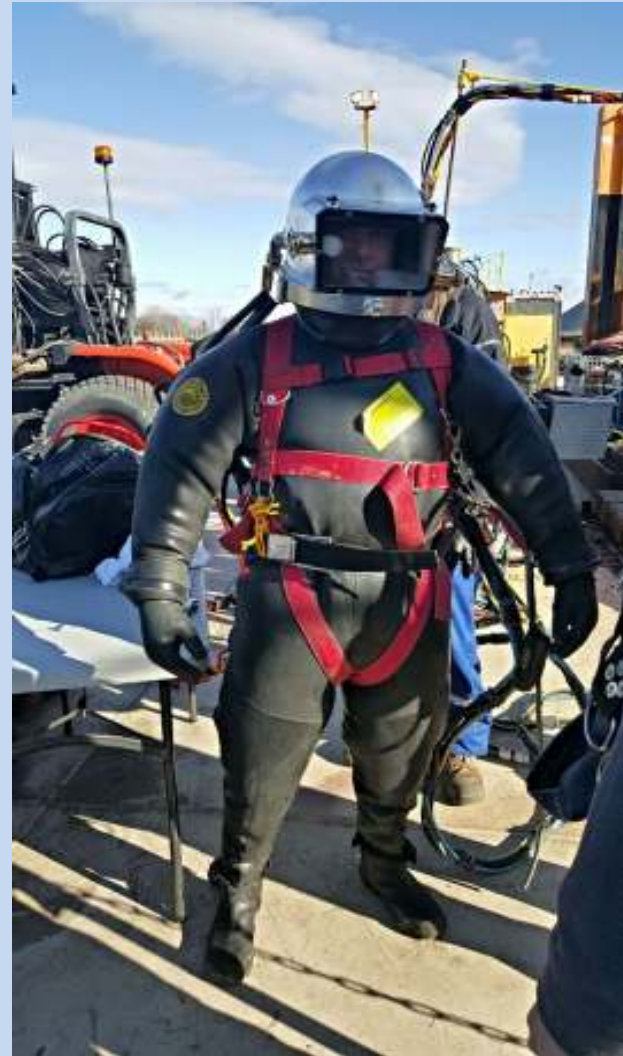
# New dive suit

- Following the release, a new dive suit was used to prevent injury
  - Positive pressure suit to repel product if suit was punctured
  - Upgraded dive helmet

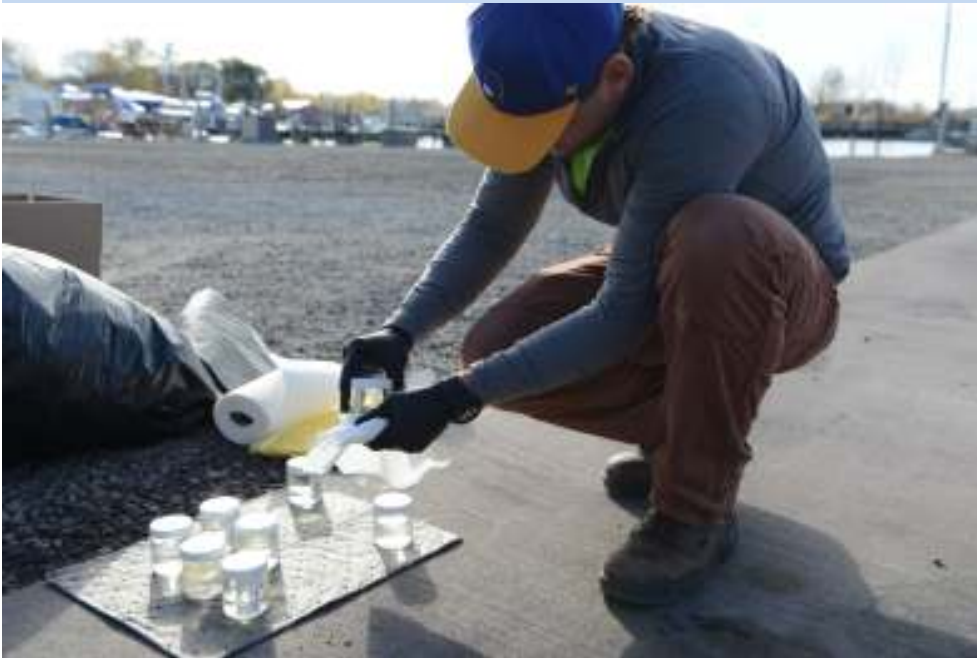
# Samples Taken from Leak Site

- US EPA contractors conducted all product and water sampling during the response

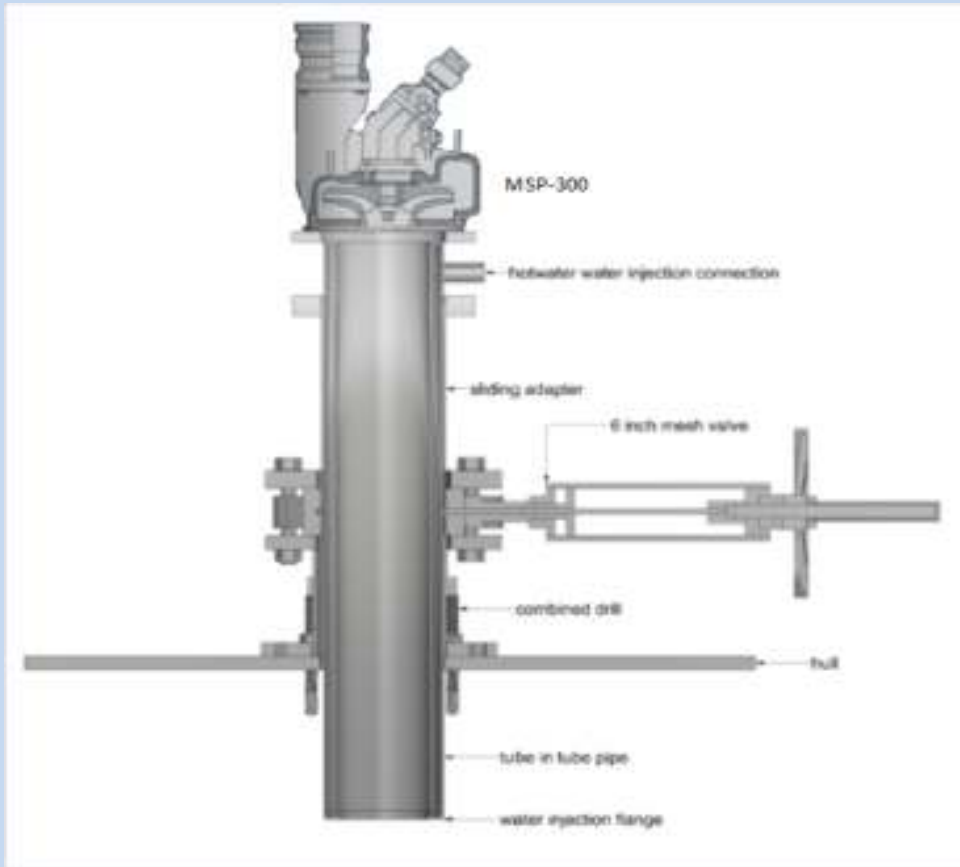
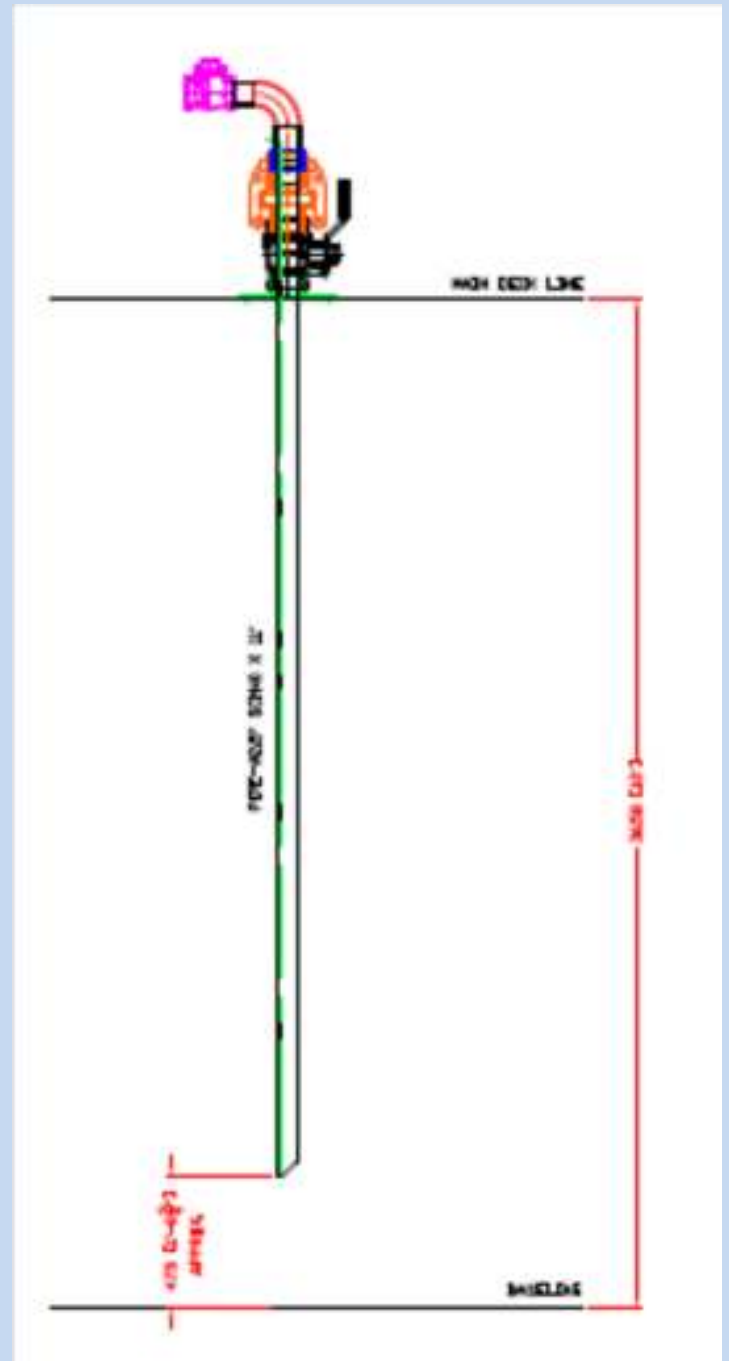
# Hot Tapping

- Hot tapping – making a connection with a vessel/pipe without releasing product
- Argo was encased in mud requiring an innovative hot tapping technique
  - Two taps were placed in the top of the tank
  - A pipe was placed in one tap to allow water to push product from the bottom of the tank to the other tap
