## **Chicory Plant Location**

1125 12<sup>th</sup> Ave Port Huron, MI

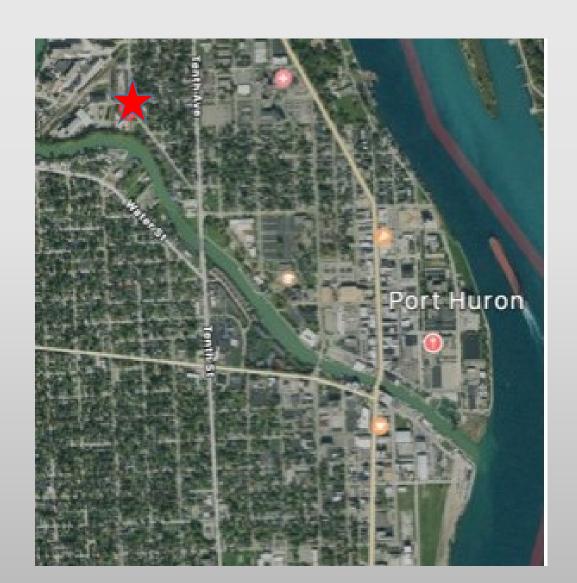
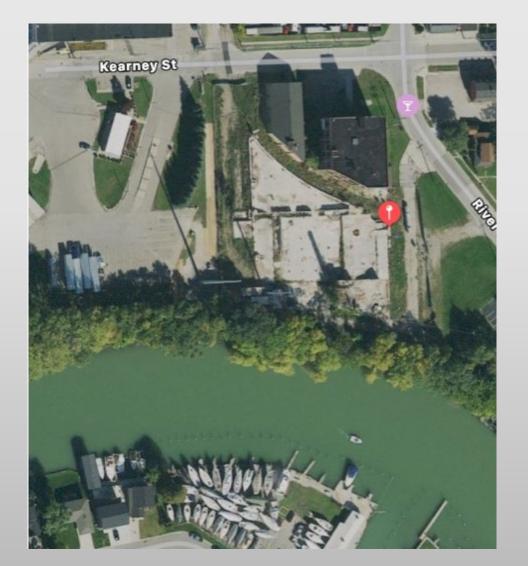
- Located at 1125 12<sup>th</sup> Ave, Port Huron, MI
- Chicory production ended in 1974
- Buildings were purchased and used for a variety of uses including storage

- Plant caught fire on night of June 22, 2018
- Plant contained six 8-10K gallon fuel oil tanks used for roasting chicory
- June 29, 2018, USCG Sector Detroit received report of a discharge of oil into the Black River. Sector responded and initiated clean-up efforts. Product flowed from the basement of the plant through basement drains into the black river. Source of the product was suspected to be a result of the fire and associated valves and piping related to the fuel oil tanks. The property owner reported removing viscous product from the tanks to prevent future discharge. Sector Detroit, MI DEQ(EGLE), and Port Huron Fire Department considered the tanks intact and of sufficient construction to alleviate significant failure or threat of discharge.
