# Enbridge Oil Spill

# Source Area

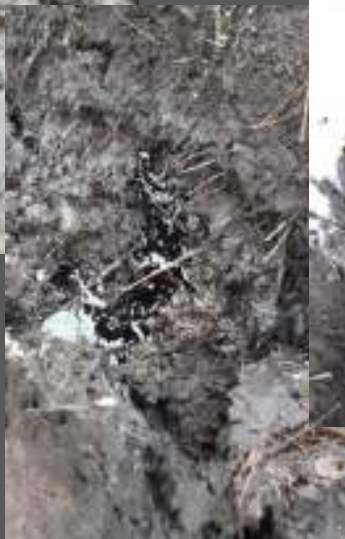
## Impacts Observed During 2011-2012 Remedial Action

Oil accumulated in pockets in the overbanks and presented as seeps during excavation

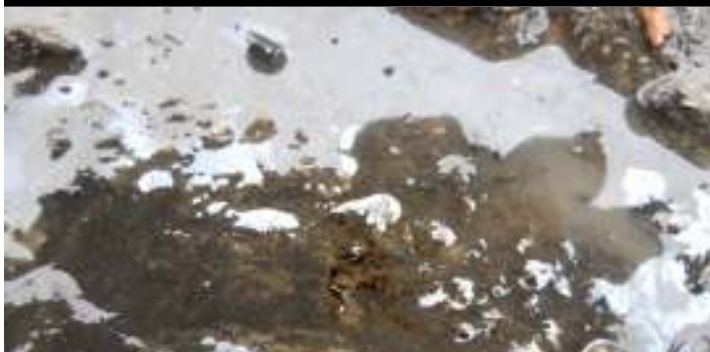
## Talmadge Creek 2011 Remedial Action

During the scraping process oil would seep from the floor of excavations as visible in these photos.
