Great Lakes Fleet Fuel Facility Spill

04 January – 26 January 2011

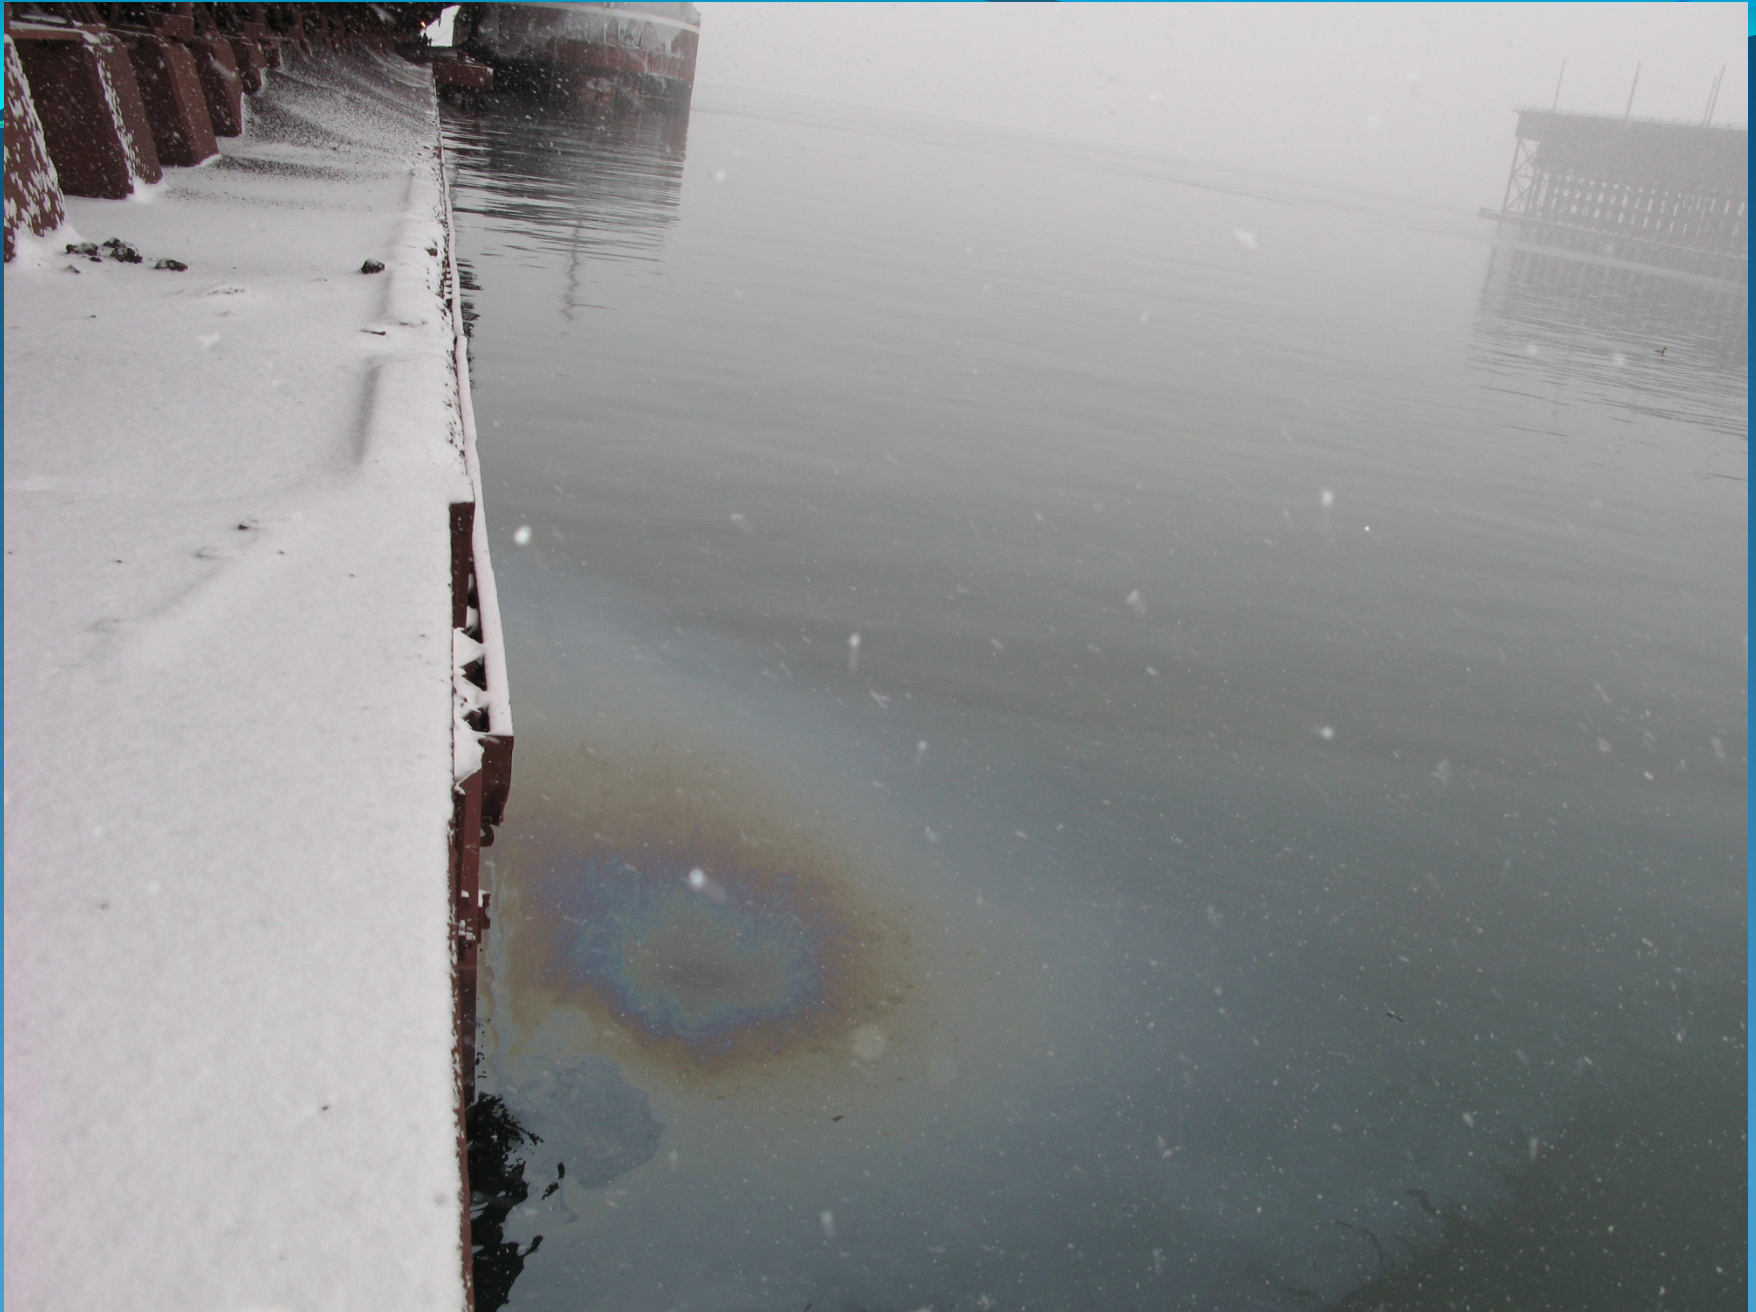
Ping Pong Ball sized tar ball just underneath the surface moving deeper into the slip after the M/V JOSEPH L. BLOCK shifted.
