OSWEGO HARBOR POWER #6 OIL SPILL

OSWEGO, NY MARCH 8, 2022 – AUGUST 10, 2022

LT IAN JOHNS & LTJG JOSHUA WELSH SECTOR BUFFALO / ATLANTIC STRIKE TEAM

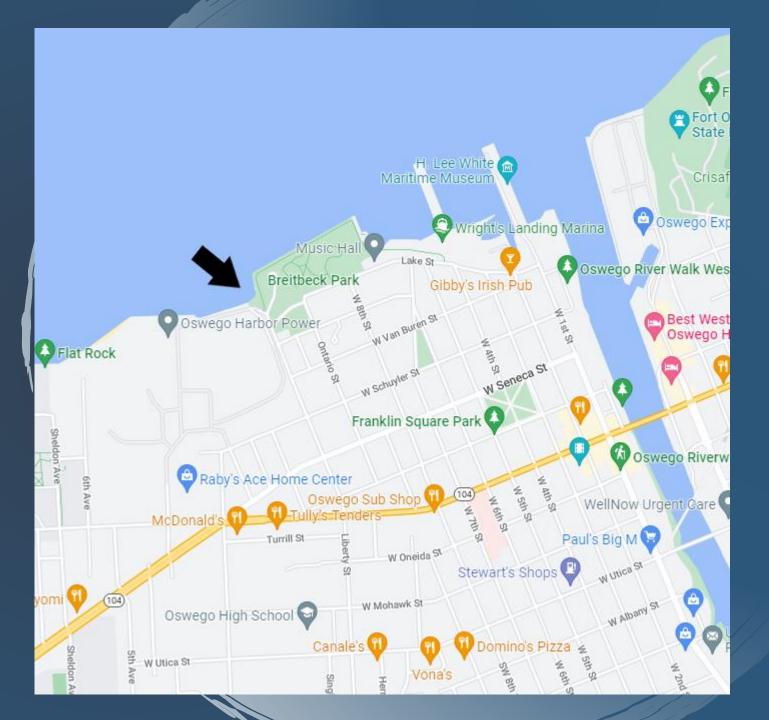
07MAR2022 1900LT: USCG SECTOR BUFFALO RECEIVED A REPORT FROM A CONCERNED CITIZEN OF A PETROLEUM ODOR IN THE VICINITY OF BREITBECK PARK IN OSWEGO, NY.

CALLER STATED IT WAS TOO DARK TO SEE ANYTHING ON THE WATER.

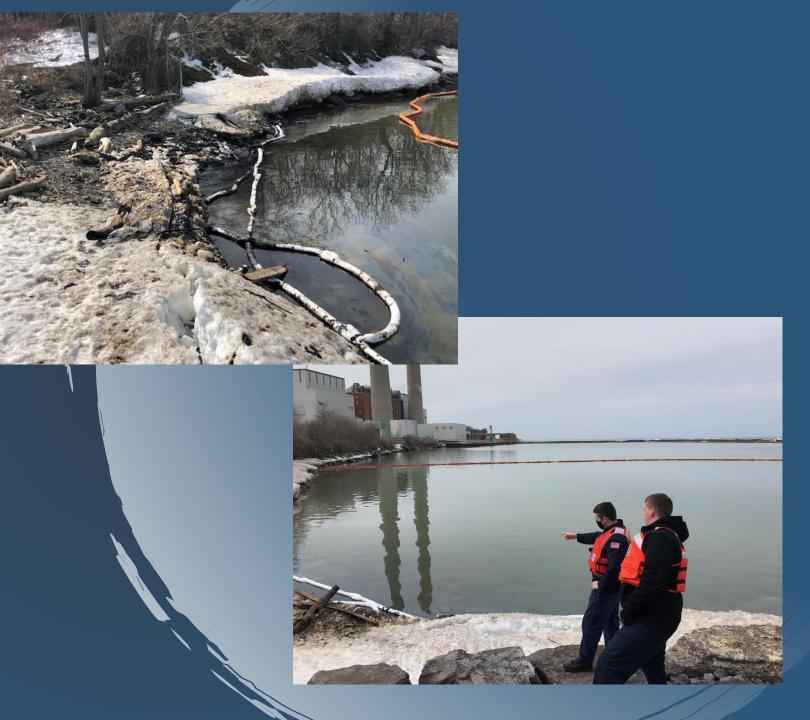
08MAR2022 0700LT: AFTER FURTHER INVESTIGATION IT WAS DETERMINED THAT THE SOURCE OF THE SPILL WAS NOT THE BLACK CONTAINER.

SECTOR BUFFALO & NY DEC RESPONDERS BEGAN SEARCHING FOR POSSIBLE SOURCES.

OSWEGO HARBOR POWER WAS THOUGHT TO BE THE MOST LIKELY SOURCE DUE TO IT'S CLOSE PROXIMITY.

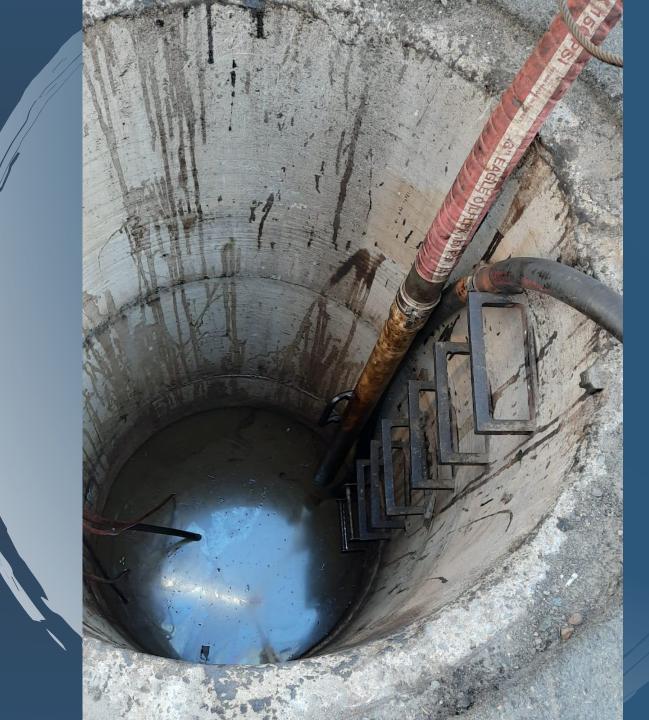
OSWEGO HARBOR POWER DISCHARGED AT LEAST 44,500 GALLONS OF #6 OIL INTO THE SOIL & WATER BASED ON FUEL INVENTORY TAKEN DAYS AFTER INITIAL DISCHARGE IDENTIFICATION INTO LAKE ONTARIO.

THE VAST MAJORITY OF THE DISCHARGE WAS PREVENTED FROM ENTERING LAKE ONTARIO DUE TO QUICKLY SECURING STORM WATER OUTFALLS.

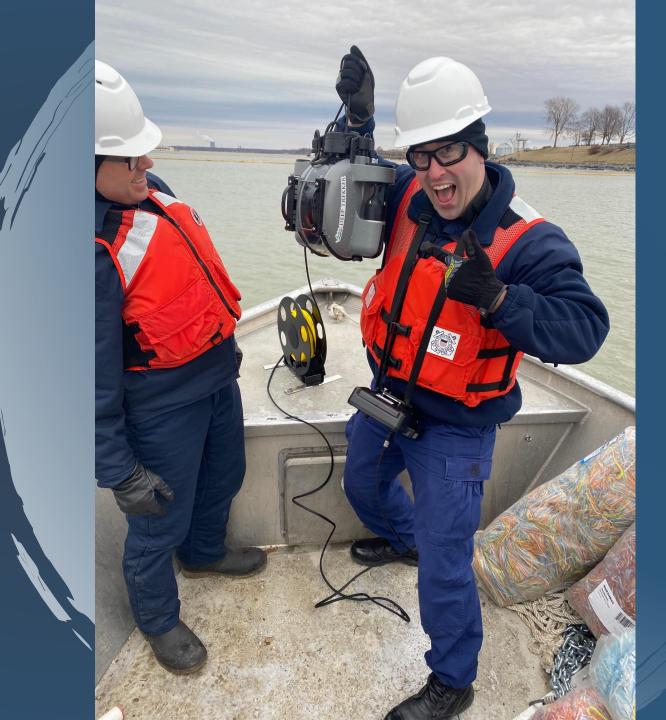
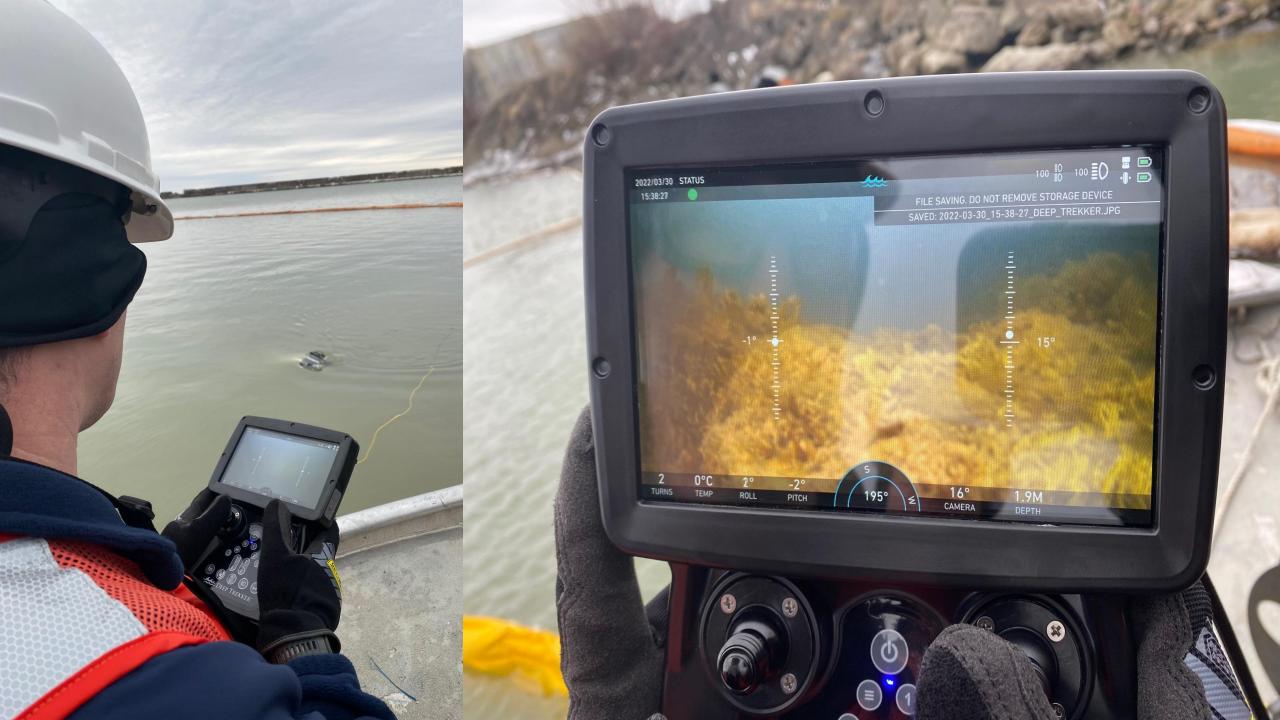
VARIOUS TOOLS WERE USED WHICH MADE SPOTTING OIL, SEDIMENT INVESTIGATIONS & MONITORING OUTFALLS MUCH EASIER.

USCG ATLANTIC STRIKE TEAM PROVIDED AIR DRONE SUPPORT WHICH HELPED SCAT TEAMS COLLECT & DISSEMINATE INFORMATION ALMOST IN REAL-TIME.

SECTOR BUFFALO'S SUBSURFACE REMOTE OPERATED VEHICLE SAVED VALUABLE TIME AS WELL AS MONEY BY MONITORING THE STORM WATER OUTFALL PLUG & ALSO SCOUTING OSWEGO HARBOR FOR POSSIBLE SUNKEN OIL.

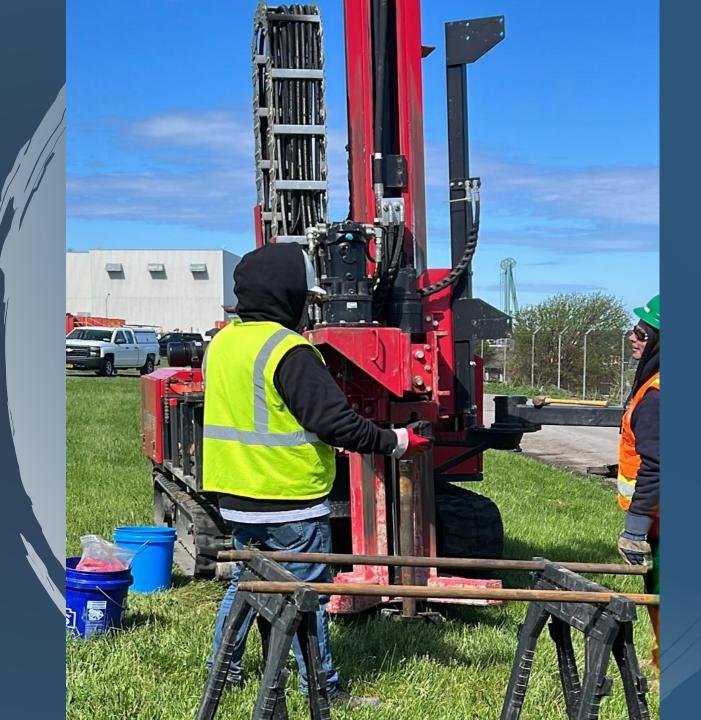
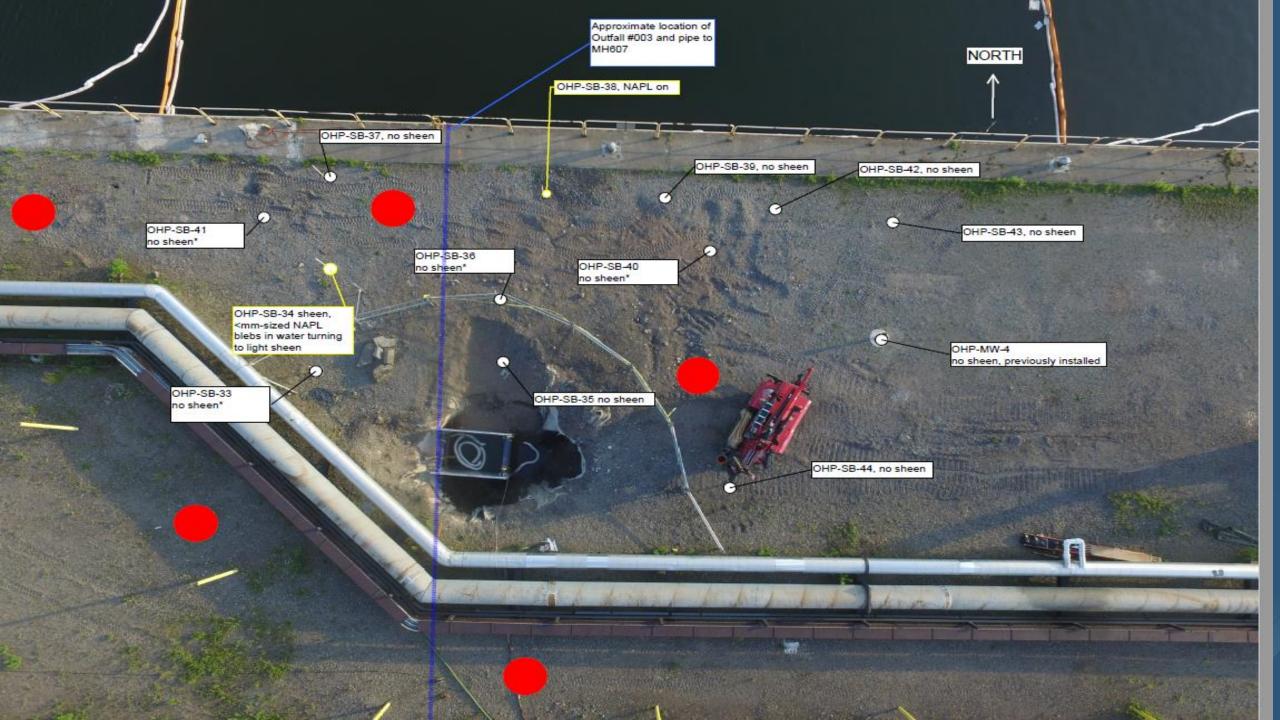
GROUNDWATER EXPERTS WERE BROUGHT IN TO DETERMINE HOW FAR THE UNDERGROUND PLUME HAD SPREAD.

43 GROUND WELLS WERE STRATEGICALLY DRILLED AT VARIOUS DISTANCES FROM THE SOURCE TO DETERMINE EXTENT OF OIL COVERAGE.

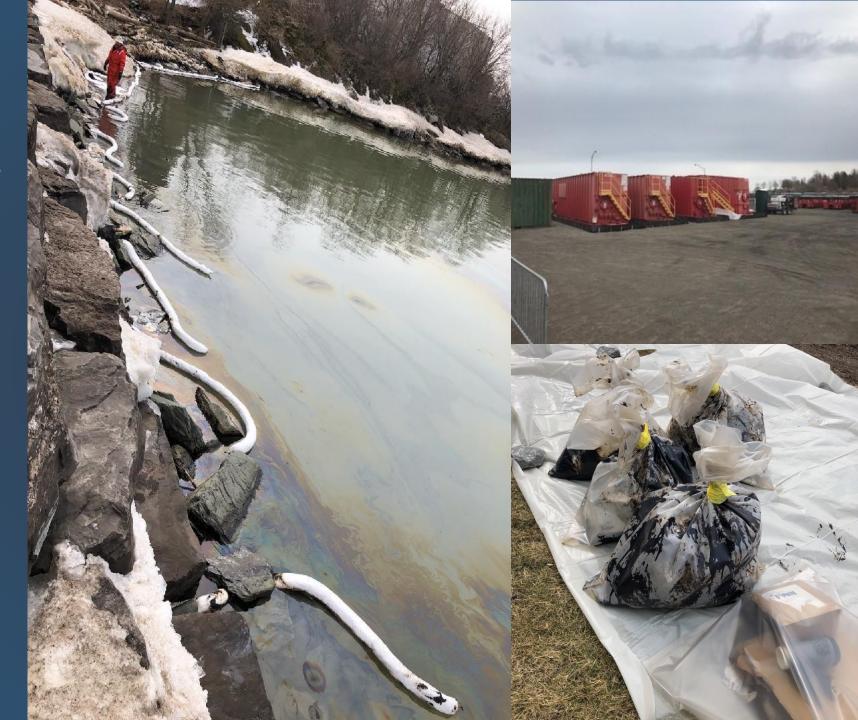
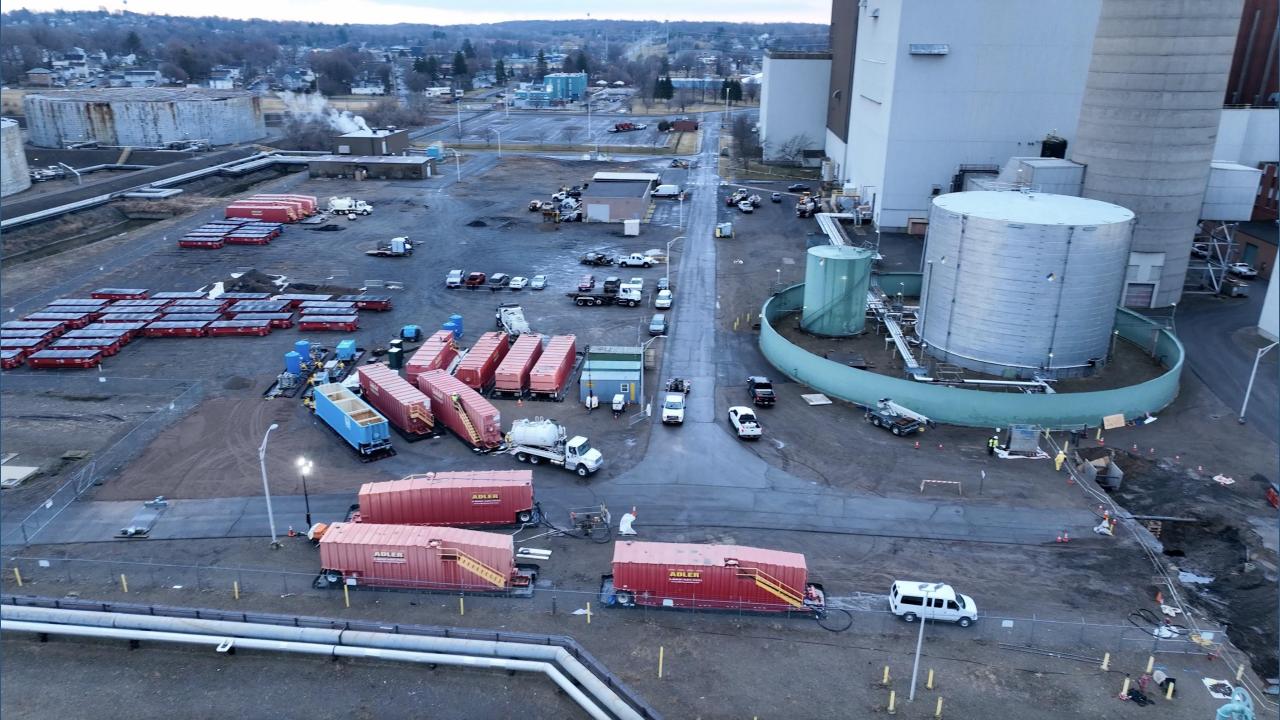
APPROXIMATELY 18,000 GALLONS OF PRODUCT WAS RECOVERED BY EXCAVATION. THE OILED SOIL WAS TAKEN TO A LOCAL LANDFILL FOR REMEDIATION.

4,200 GALLONS OF LIQUID OIL WAS RECOVERED VIA VACUUM TRUCKS FROM STORM DRAIN, TOP WATER SKIMMING AND GROUND WATER.

43 TONS (18 ROLL-OFF CONTAINERS) OF OIL-IMPACTED DEBRIS.

1.4 MILLION GALLONS OF WASTEWATER WAS TREATED AND RETURNED TO LAKE ONTARIO.
