Strategic Protection Plan Response Considerations: Isle Royale National Park

Michael Rancilio
Michael Popa
William Hazel
Marine Pollution Control Corporation
8631 West Jefferson
Detroit, Michigan 48209 USA
313.849.2333 – 24/hour
313.849.1623 – facsimile
www.marinepollutioncontrol.com
info@marinepollutioncontrol.com

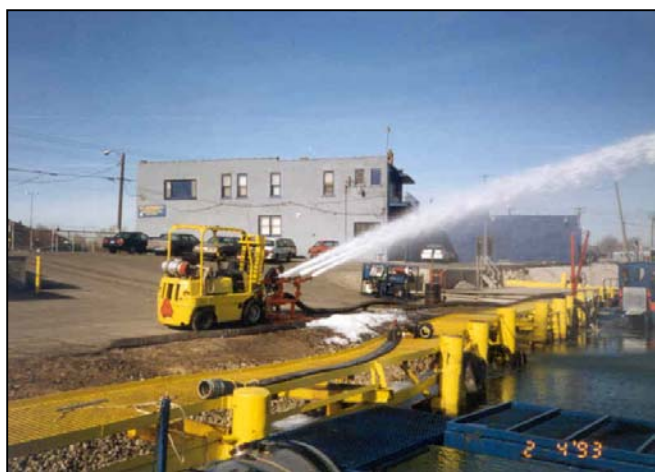
In this photo, a hydraulic submersible pump and portable fire monitor provide a moderate-pressure, high-volume water spray that can be used for oil herding operations. The fire monitor features 3 independently rotating turrets, which can be adjusted by the operators to provide a wide sweep of operations.

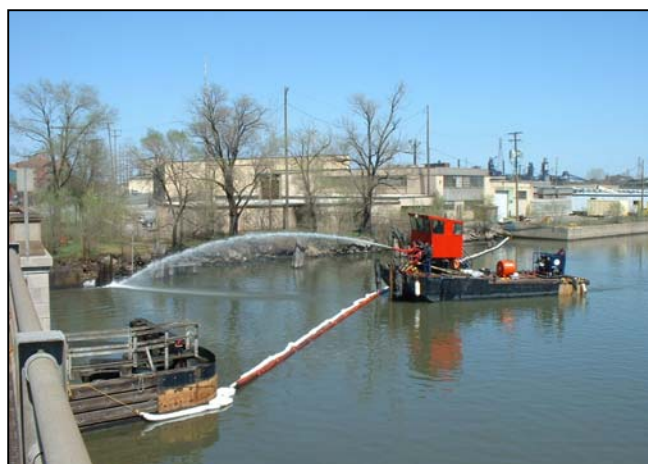
In this photo, the pumping system and fire monitor apparatus have been positioned on the deck of a workboat, allowing responders to access the oil from the waterside and giving them much better latitude to move about (note: here, they are using the spray to wash oil from shoreline fixtures into a containment system for recovery). The water spray produced by this system is delivered at approximately 80-100 psi, and at volumes between 1,500-2,000 gallons per minute.

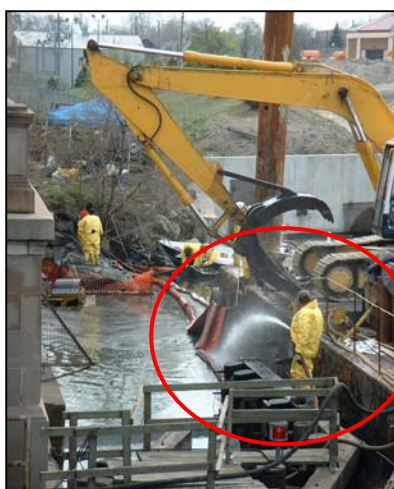
Here, the principle has been applied on a smaller scale, with technicians using water spray produced from a small "trash" pump and hand-held nozzle apparatus to herd oil within a containment area towards a recovery device (an adhesion drum skimmer). Note the excavator unit positioned on the deck barge, which is used to extract contaminated debris from hard-to-reach areas.

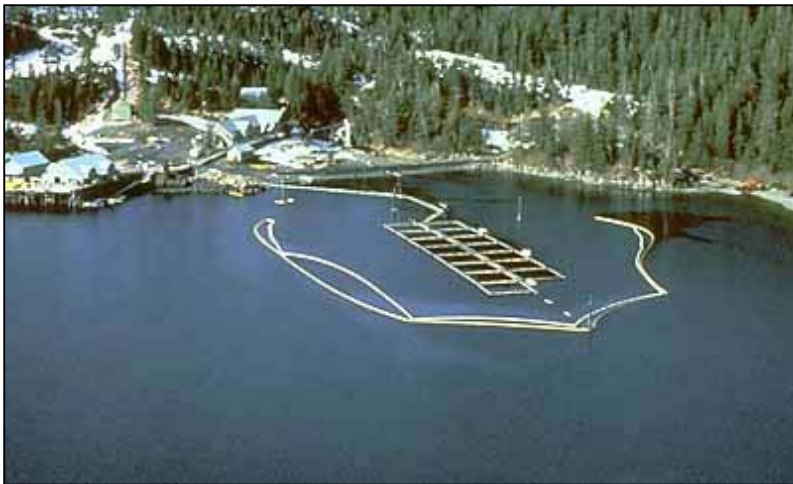
Protective booming strategy deployed around a Salmon hatchery during the response operations for the Exxon Valdez incident (Alaska, 1989).

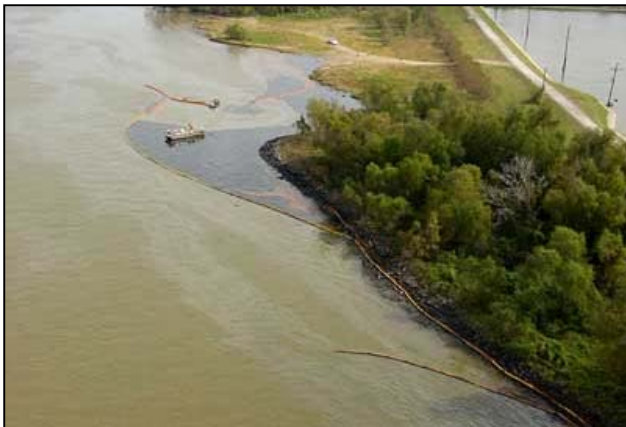
Containment/collection booms (“fingers”) deployed along the shoreline of a river. Note the protective boom installed along the shoreline to prevent unnecessary contamination along that axis (Mississippi River, 2002).

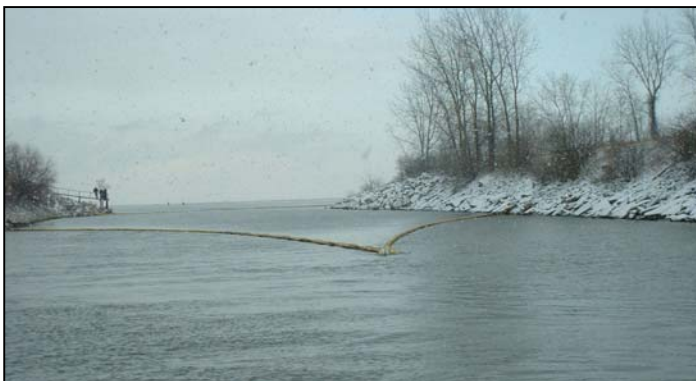
A “Chevron” boom configuration installed on a river. This configuration directs oil to either side of the channel, dependent upon wind and current direction (oil trajectory), forming two recovery points.

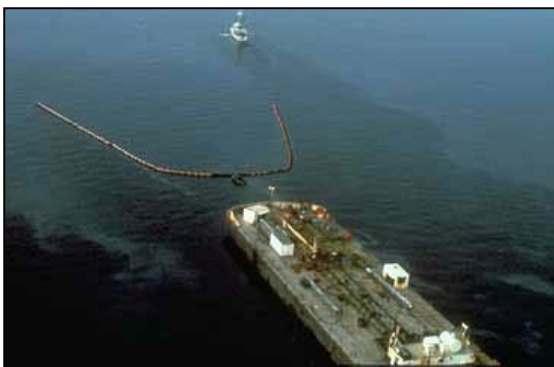
Left: Open water recovery operations during the response to the Exxon Valdez incident (Alaska, 1989).

Right: Workboats utilized to create J-boom containment configurations for recovery operations.

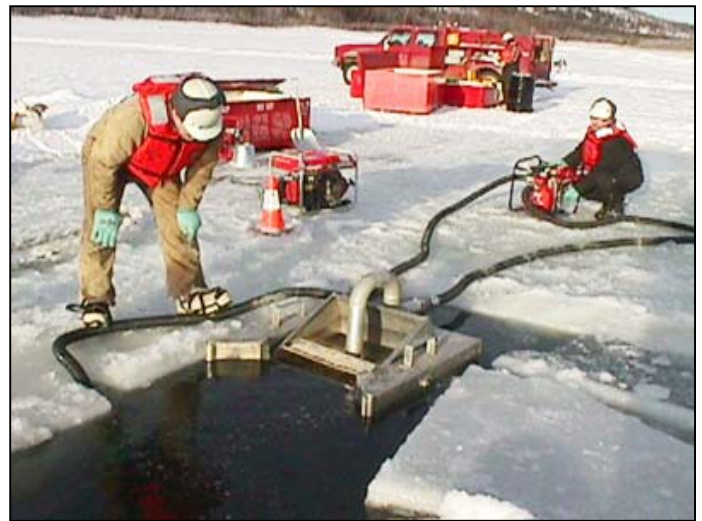
Ice trench with vacuum recovery skimmer installed.

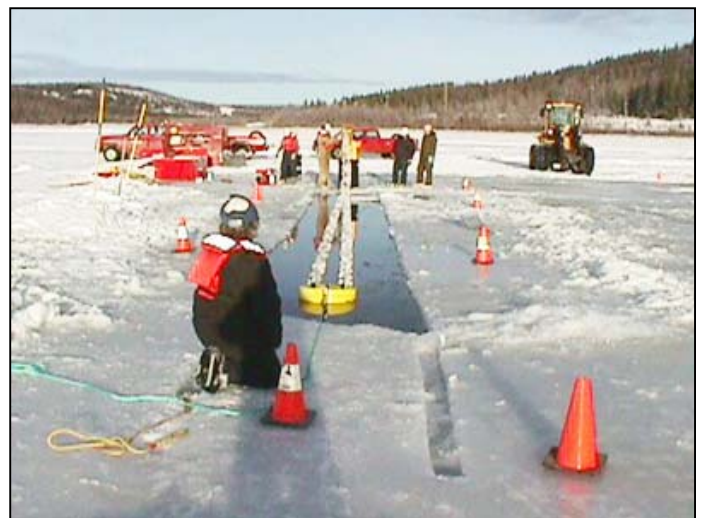
Ice trench with rope-mop recovery skimmer installed.

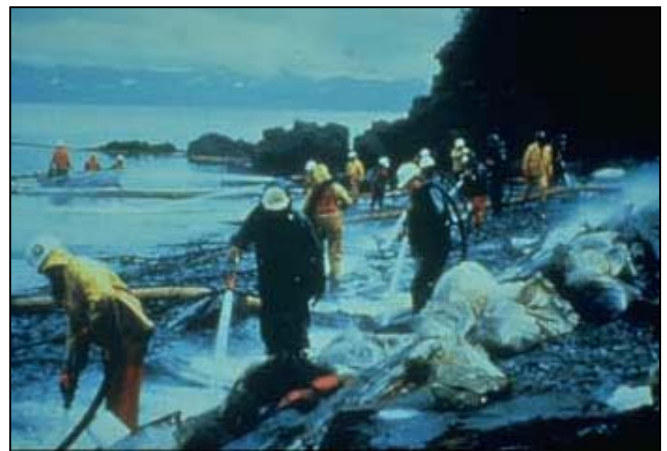
Shoreline washing operations during the response operation for the Exxon Valdez (Alaska, 1989).

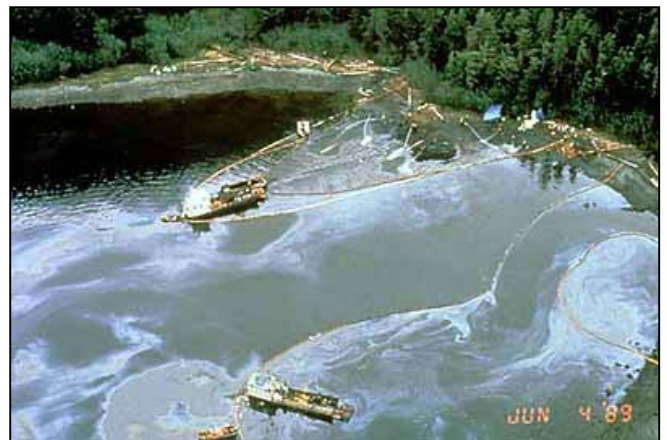
Workboats and barges lend vital logistic support to the shoreline cleaning operations, providing storage capacity for recovered oil and debris, and working platforms for recovery systems and pumping apparatus.

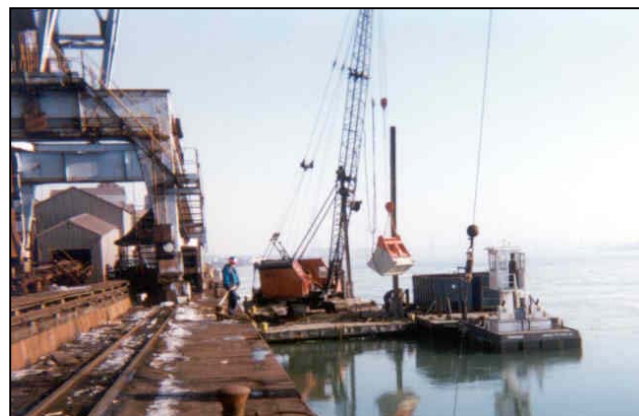
Above: During this response to a Group V oil spill (Coal Tar), responders used two techniques to recover the oil: diver-assisted pumping operations and environmental-clamshell dredging (pictured). All operations were conducted at a depth of 25-35 feet, and in harsh winter conditions where surface temperatures dropped below 0F and water temperatures were 30-32F.
